# pavement evaluation

**PAVEMENT EVALUATION OF MARGOREJO ROAD  
KARANGMALANG DISTRICT SRAGEN REGENCY BASED ON  
DYNAMIC CONE PENETROMETER TEST**

**Mego Purnomo\*, Andyt Tegar Zakahfi and Untoro Nugroho**

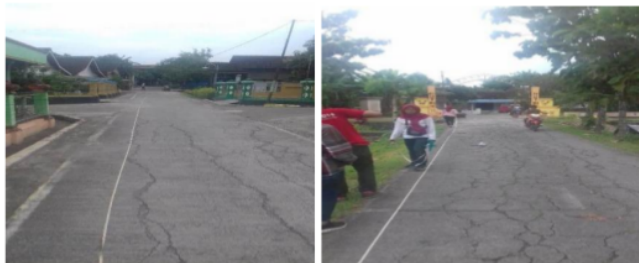
One of the factors that causes damage to Margorejo road's pavement is it doesn't have a base and subbase layer. Without a base and subbase layer, fine particles from the subgrade course will rise to the surface course, and the ground water will gather on the surface course, which will quickly reduce the life and strength of the pavement structure. The existing pavement data of Margorejo road can be seen in Table 3. below :

**Figure 3. Vertical Cracking (a) and Crocodile Skin Cracking (b)**

surface layer is only 10 cm. Because of that, it is necessary to re-plan or increase Margorejo road pavement.
