Understanding of Petobo liquefaction flowslide by 2018.09.28 Palu-Donggala Indonesia earthquake based on site reconnaissance

Keywords Liquefaction flowslide · Site reconnaissance · Morphological characterisation · 2018 Palu earthquake

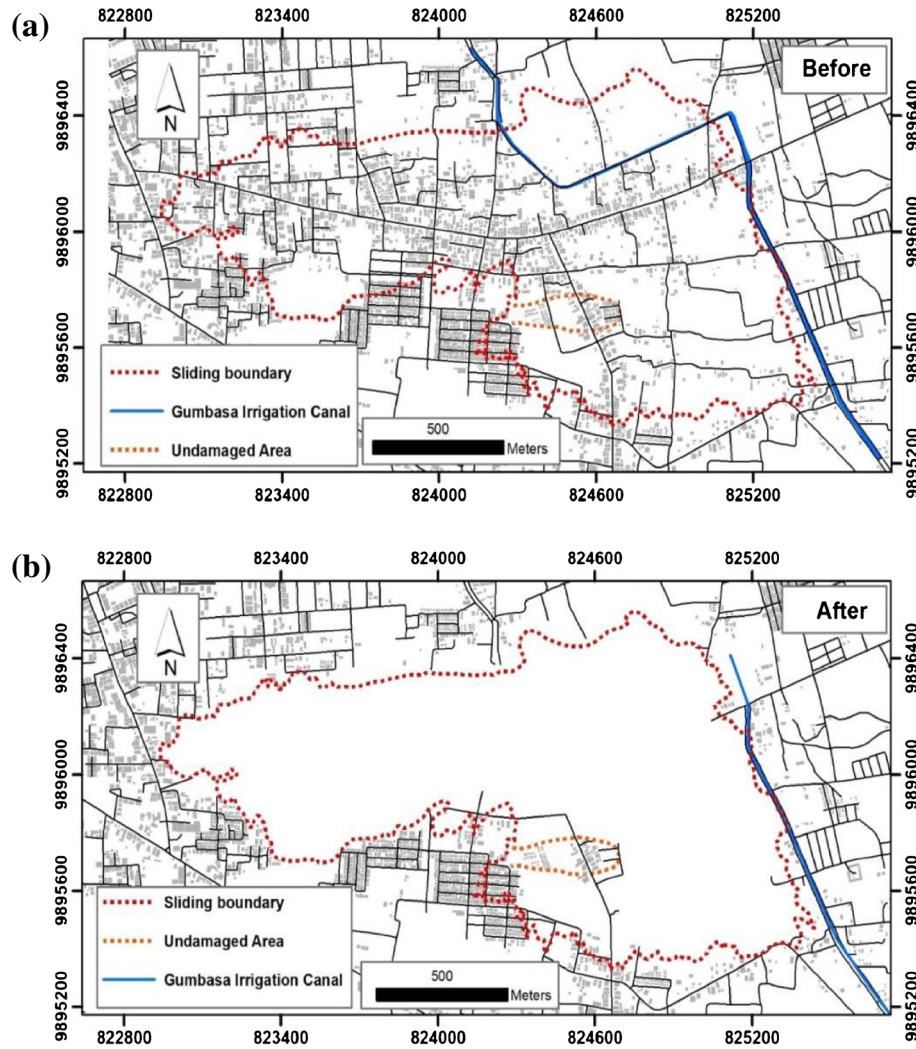
Fig. 7 The site condition before and after the earthquake. **a** Condition before earthquake where Gumbasa irrigation canal passed across the flowslide area. **b** Situation after the earthquake where Gumbasa irrigation canal in the NE portion of the sliding was swept away and an undamaged area was found in the southern part of the sliding area

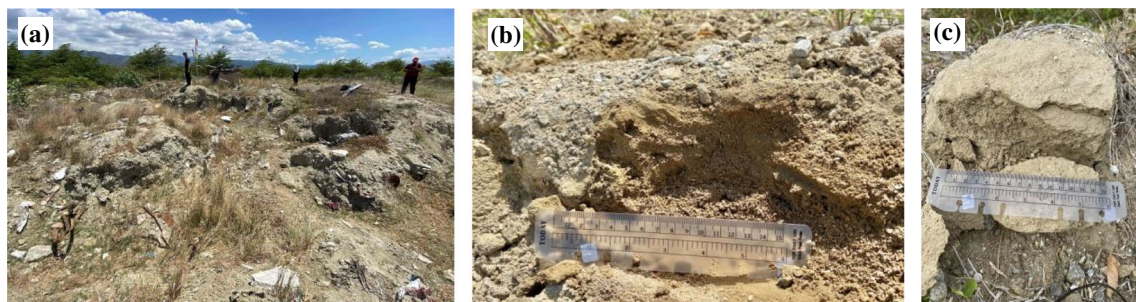
during the sliding (Fig. 8). We noticed the ground surface was rugged and piled with sands, suggesting severe liquefaction outflows or eruptions might have occurred during the earthquake shaking. In the southern part, we found an undamaged area (Fig. 7b), where houses and people were not hit directly but surrounded by the flowslides.

Fig. 8 **a**, A site with big eruptions of sands during earthquake based on the interviews with Witnesses G and H. The location was near District Office of Petobo (Kantor Kelurahan Petobo). **b**, **c** Exposed sands as evidences of soil liquefaction

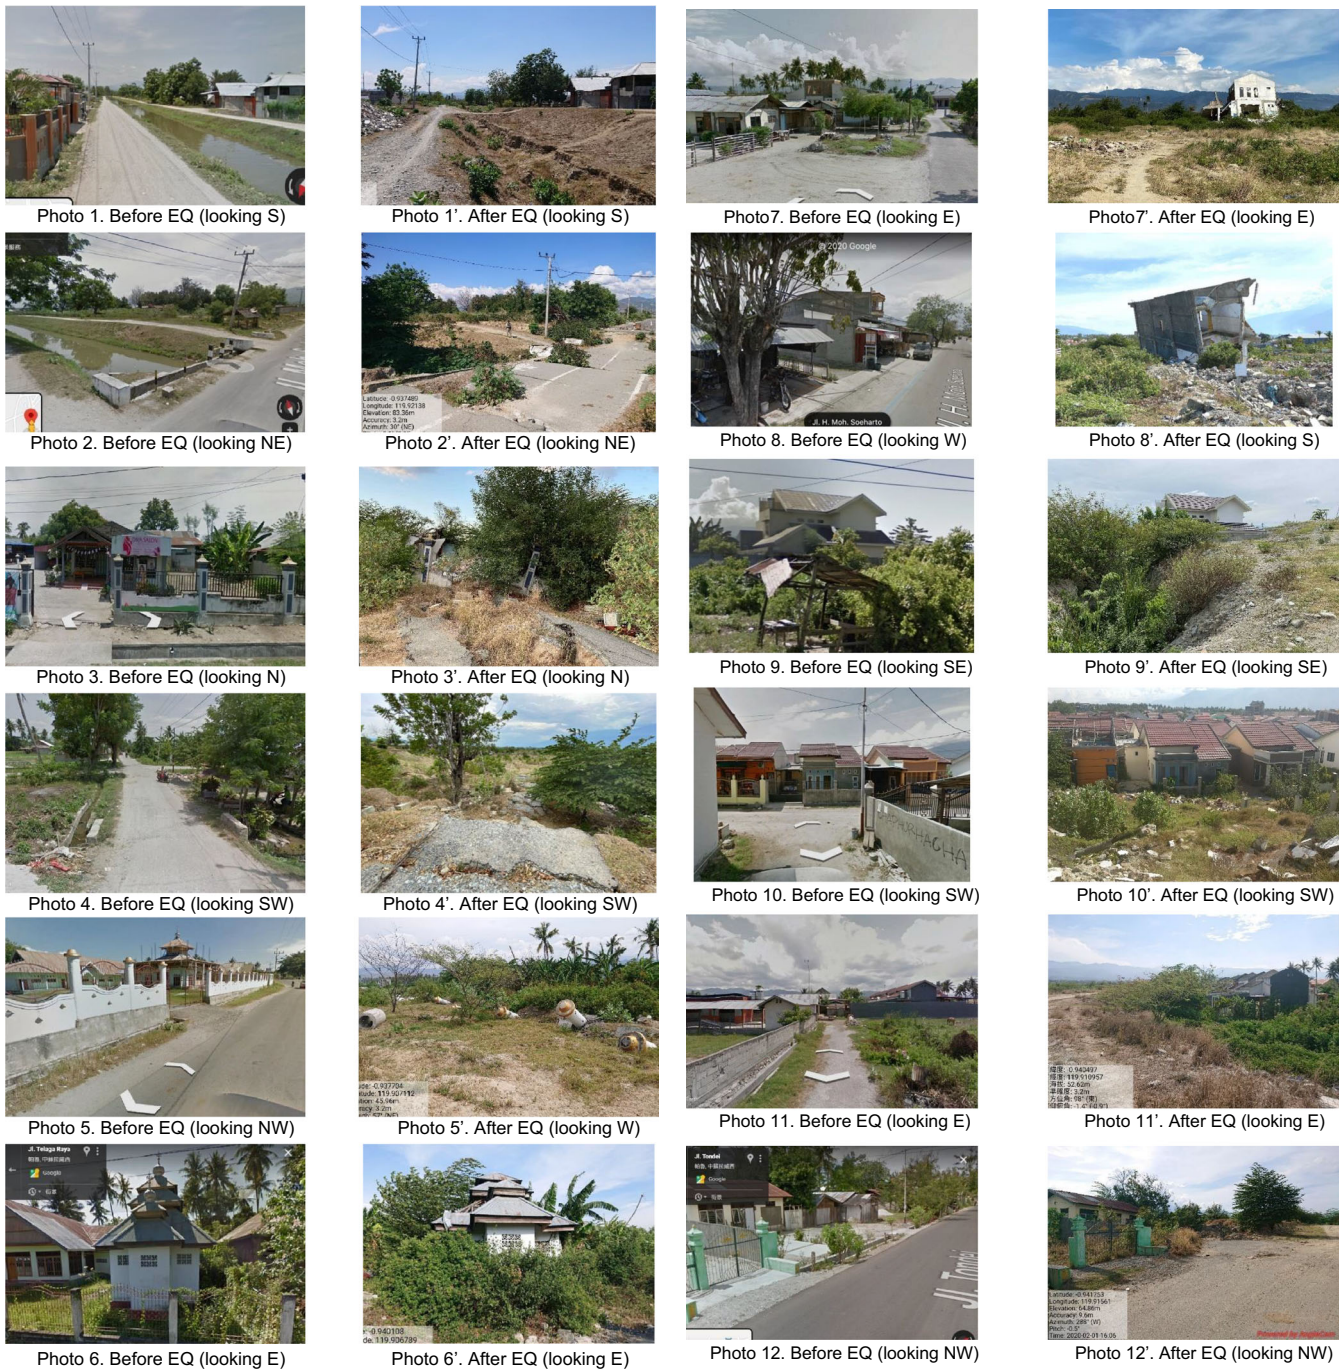
Photos 1 and 2 show the Gumbasa irrigation canal located along the eastern boundary of the sliding area. As seen, the canal was unlined and full with water prior to the earthquake. However, the earthquake had triggered slippages of the ground, causing cracks and drainage of the canal. Photos 3 and 4 are for surface features at east side and northeast corner of the sliding area. As indicated, the ground had been seriously distorted and displaced, apparently the result of liquefaction spreading during the earthquake.

As indicated by local residents and in Google Earth images, Gumbasa irrigation canal was constantly filled with water before the earthquake (Photos 1 and 2; Fig. 10) and the paddy fields were also inundated with water for about 8-month plantation time annually, which are based on our site reconnaissance as summarised in Table 1. During the plantation, the paddy fields

Fig. 10 Photo pairs showing some key features at Petobo site before and after the earthquake. Pre-earthquake photos are captured from Google street view. Locations of the photo pairs are indicated in the previous figure

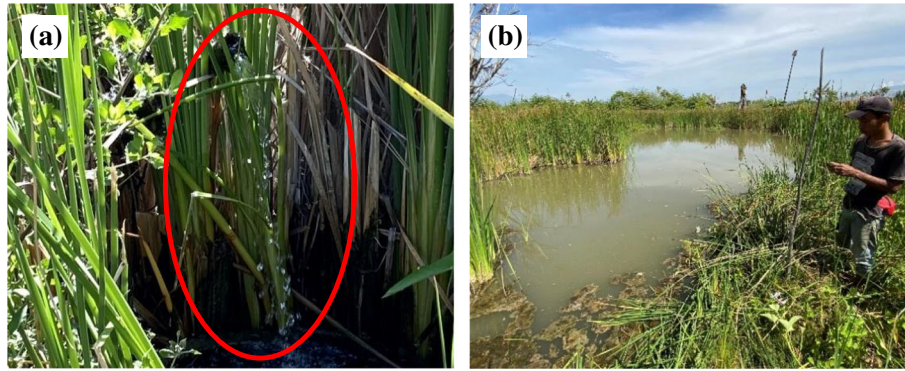
During onsite investigation, the authors found several locations in the middle portion of the sliding area were inundated with swamps and presented with artesian waters (Fig. 11). It is evidenced that these the ground water levels at locations should be very high, and presumably the results due to previously severe liquefaction events.

Fig. 11 a The presence of artesian waters in the flowslide area. b A swamp with ponded water in the middle part of the sliding area

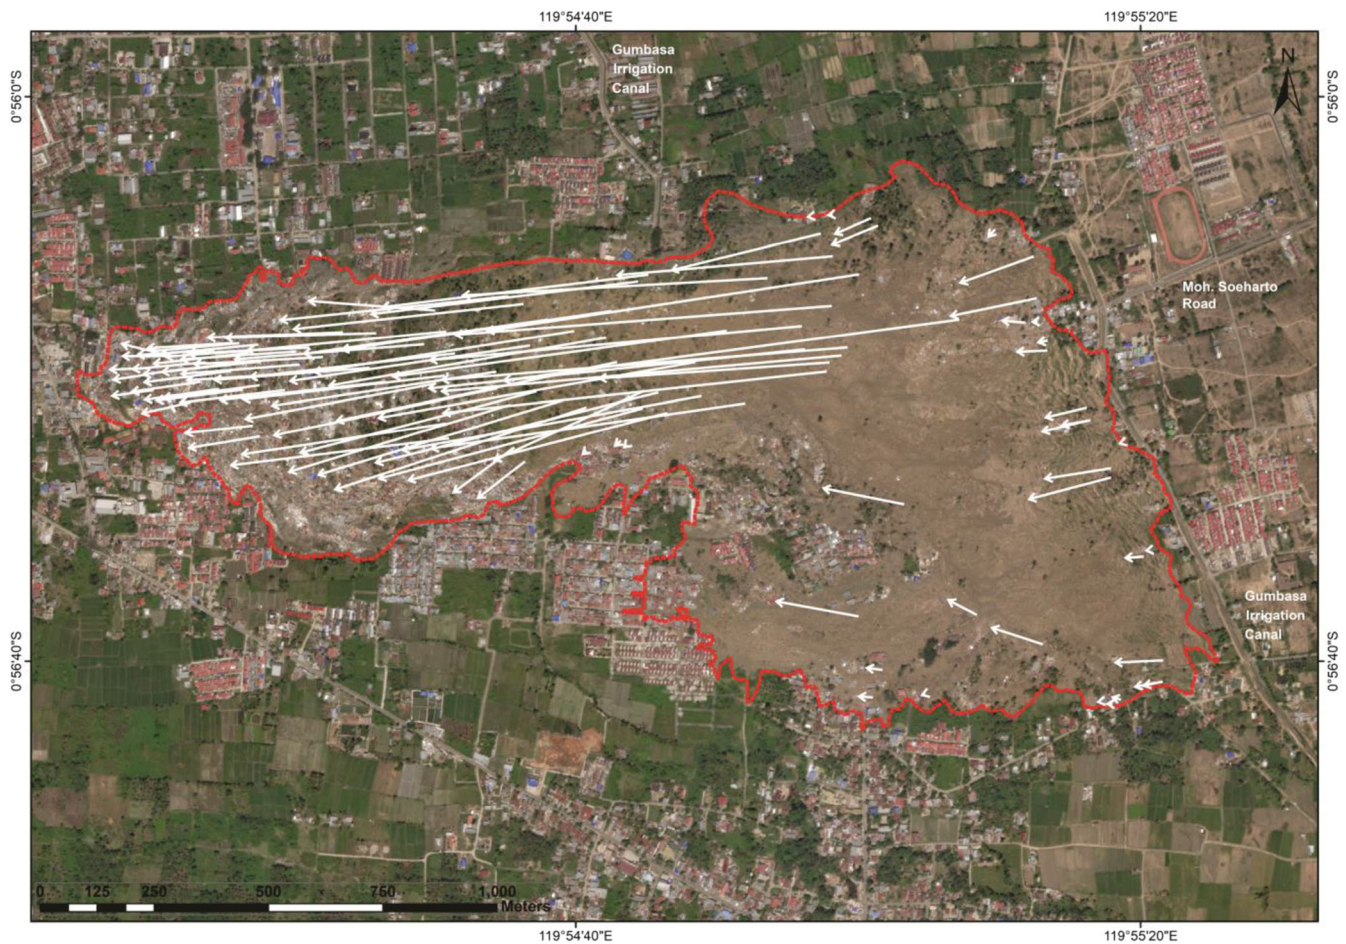
Fig. 12 Displacement vectors of surface objects identified by onsite investigation as well as based on Google Earth satellite images before the after the earthquake. The white arrows are the direction of displacements. Base photo is taken from Google Earth satellite image of 2019.05.23

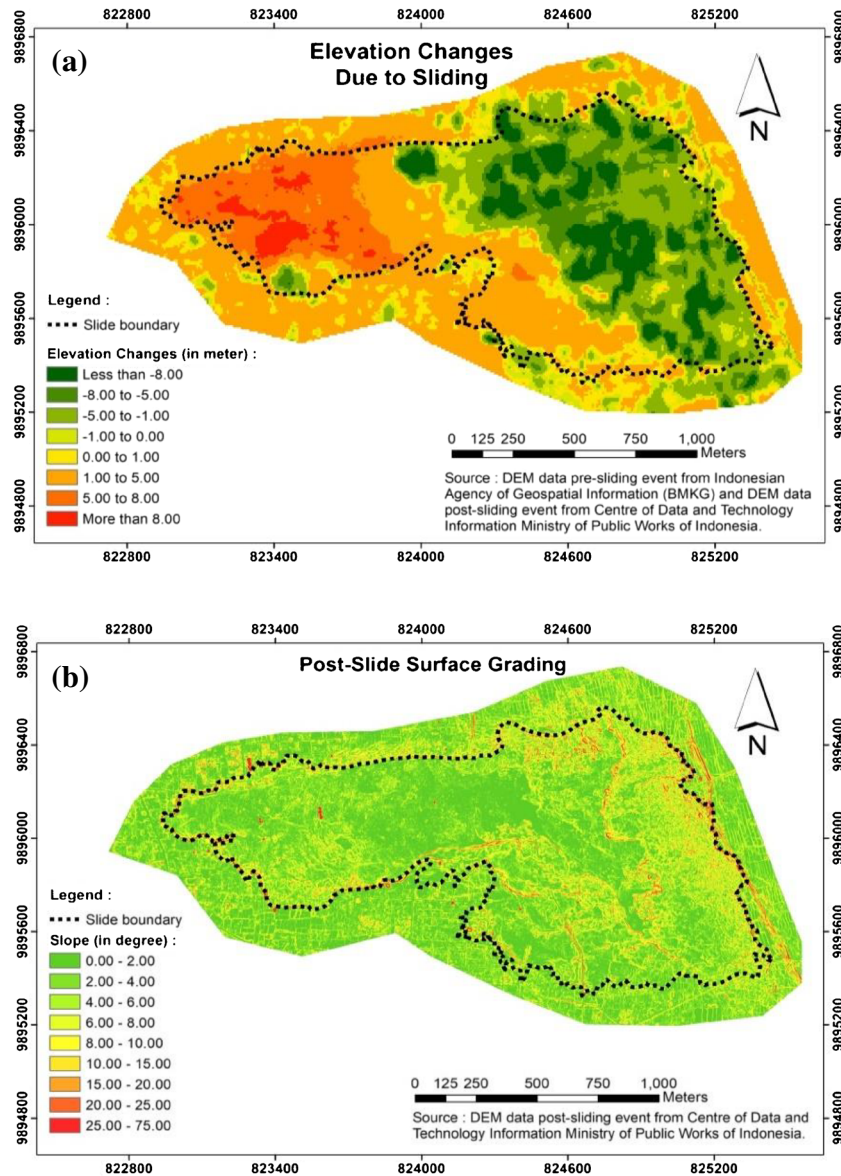
Fig. 13 a The elevation changes due to sliding. b The grading of ground surface after the earthquake. The elevation changes varied approximately between -8 and 8 m. In the eastern part, the elevation dropped down more than 8 m (green colour) and in the western part raised more than 8 m (red colour). Before the earthquake the surface grading in the study area was gentle, with an angle of about 2° . After the earthquake, however, the surface grading changed locally, with an inclination of up to 25° in eastern part. In the middle part, the ground surface was generally flat, but then became rougher again to the western part of the flowslide area

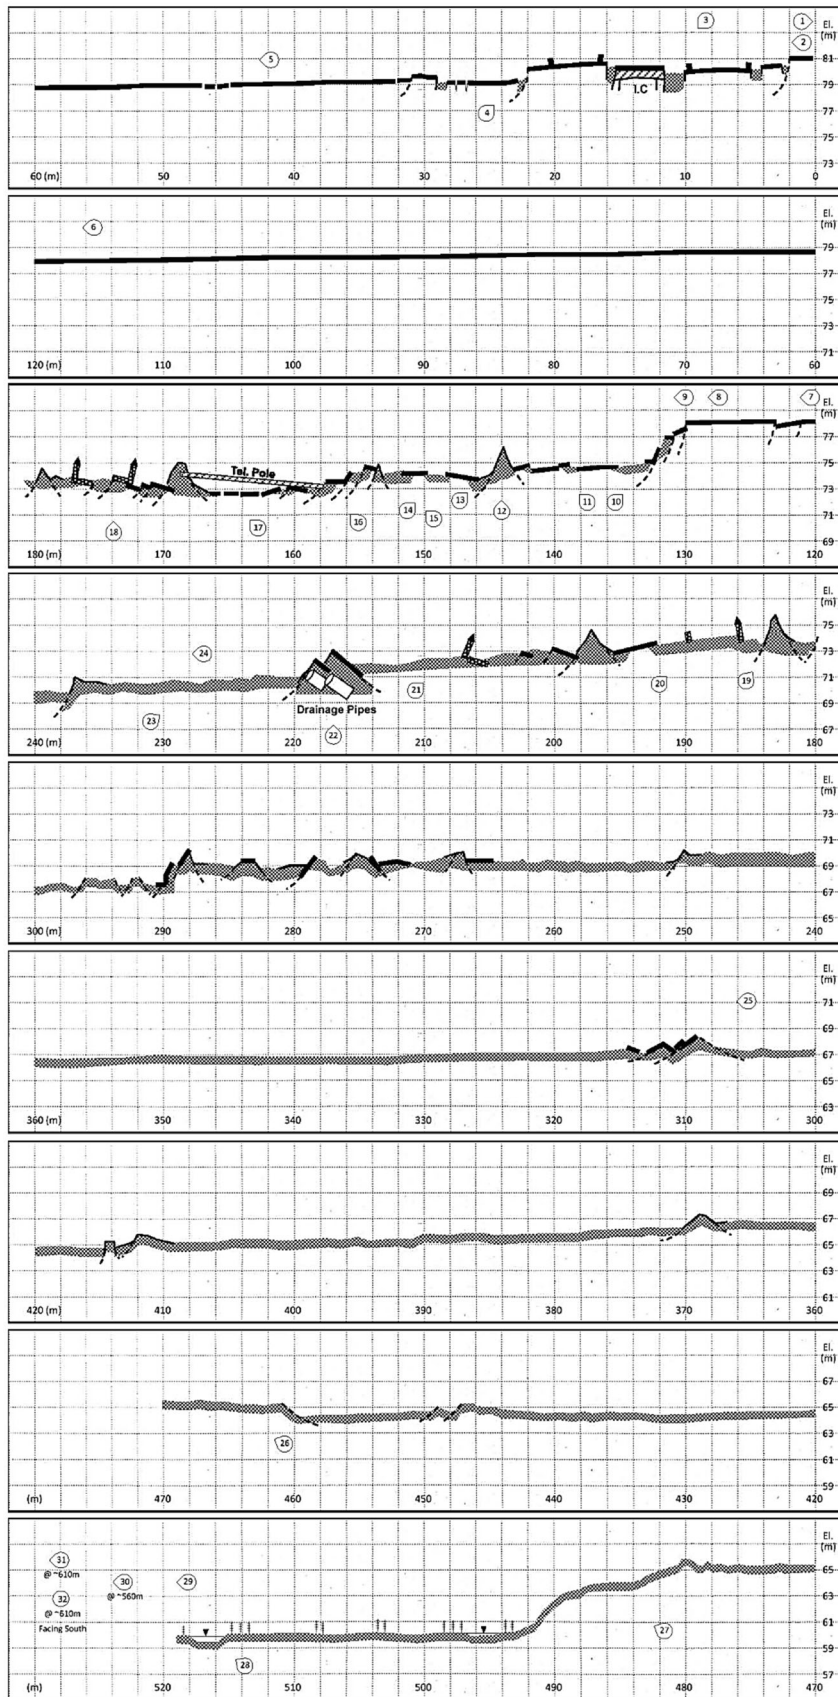
Fig. 15 Mapping of east section of Moh. Soeharto road in Petobo sliding area

The research team had conducted a detailed mapping on the surface along the east section of Moh. Soeharto road, to examine phenomena of the ground that would help the characterisation of morphological features and zonation of the site as well as our understanding on the initiation and process of sliding due to liquefaction of this earthquake incident. The mapping was started approximately 10 m east of Gumbasa irrigation canal and headed westwards along the road with a distance of about 520 m, accounted for roughly 1/4 of the length of Moh. Soeharto road that passed longitudinally (from east to west) across the sliding area. Figure 15 illustrates results of the mapping and Fig. 16 shows associated photos taken along the road with the numbers marked on the mapped sketch. Location of the mapped section is indicated in Fig. 9 and Fig. 19.

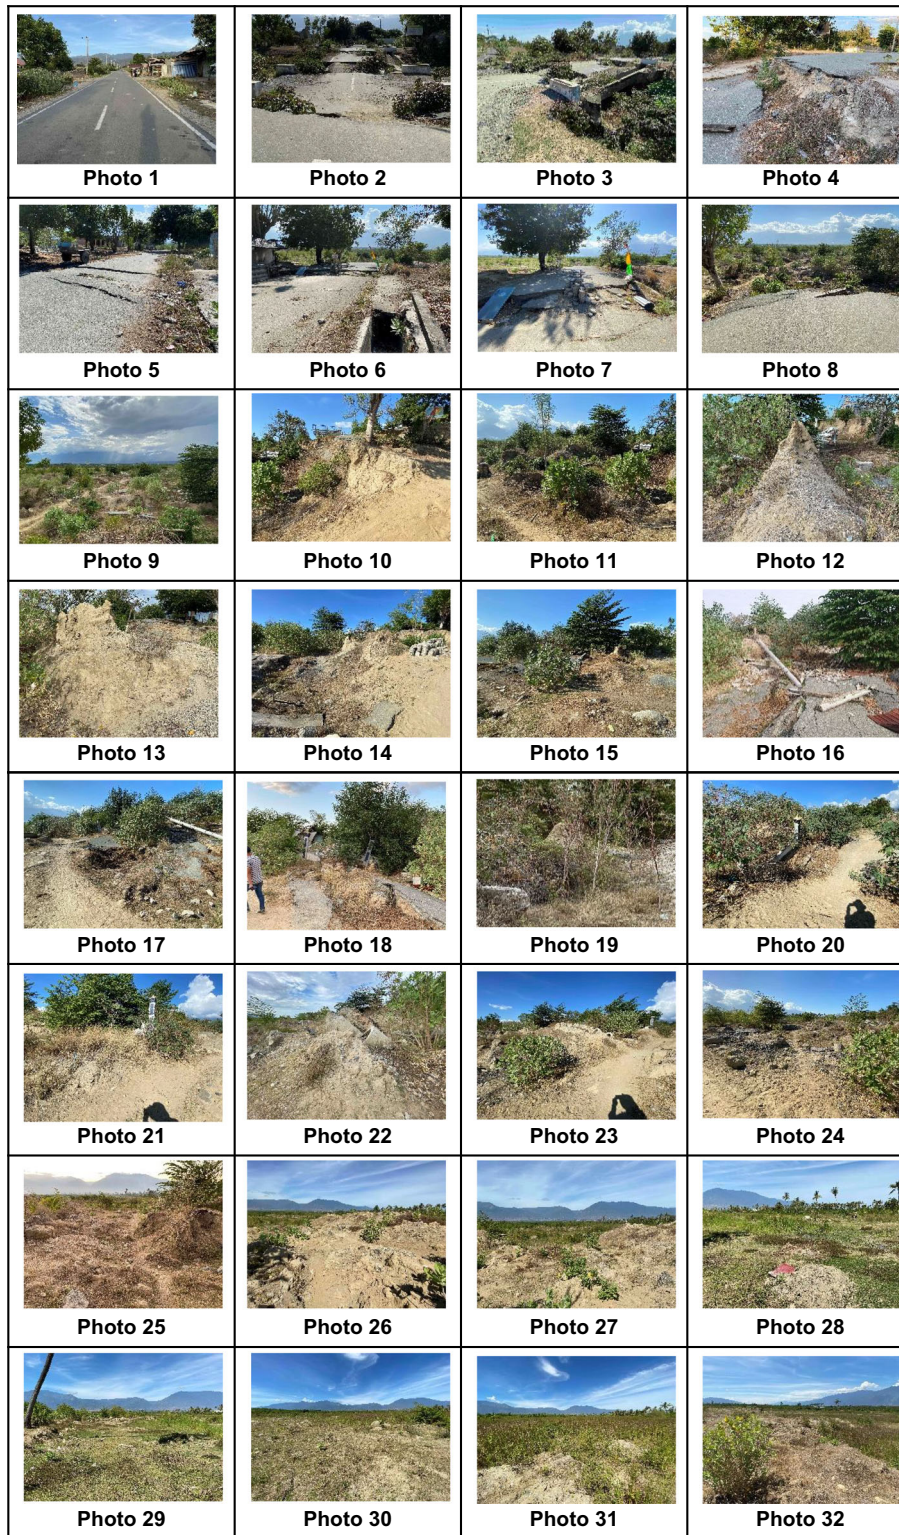
To the east of starting point (Mileage 0), the pavement of Moh. Soeharto road was almost intact (Photo 1; Fig. 16). However, several fractures and slippages were observed to the west and along the road up to a mileage of about 30 m (Photos 2–4; Fig. 16). The surface cracking became scarce until a mileage of 130 m (Photos 5 and 6; Fig. 16). Then a serious slippage was apparent with a head scarp of 3 m high (Photos 7–10; Fig. 16), an indication where the slide had initiated. In the subsequent mapping range with Mileages 130–290 m, the ground elevations subsided approximately 6 m, on

which the surface was extremely rugged, fractured and filled with extruded sands (Photos 11–24; Fig. 16).

Within this range of mapping, we noticed several earthen ridges of 1–2 m high, an example shown in Photo 12 (Fig. 16), which were observed periodically for approximately 10–20 m distance apart. This phenomenon would appear to be in relation to the testimonies by Witnesses G, K, L and M, who had indicated a wavy form of ground sliding, with vertical amplitudes of 1.5–2 m and travelling distances of around 15 m (Table 1). In view of the locations of witnesses during the earthquake, we expect these peoples might have been experiencing a liquefaction spreading

during the earthquake shaking. Photos 18, 20–23 (Fig. 16) are indicative of tearing, tilting and settling of houses and water pipes as a result of the spreading of the ground.

Fig. 16). The observed phenomena in this mapping range would suggest the ground might have liquefied significantly during the shaking and flowed further to the west (lower lands) after the earthquake. Photos 26 and 27 (Fig. 16) show the forefront of the liquefaction flow.

became more flat, but wet, swampy and full of aquatic plants that had prevented the research team to approach further. Photos 28–32 (Fig. 16) show distant views of the lower lands. As seen, the ground was exposed with sands, water ponds and aquatic plants. These areas were also suggested a separate stage of liquefaction flow that followed subsequently the previous flow stage as identified in Mileages 290~492 m.

Fig. 16 Associated photos as indicated in the mapping sketch along Moh. Soeharto road to the east of Petobo sliding area

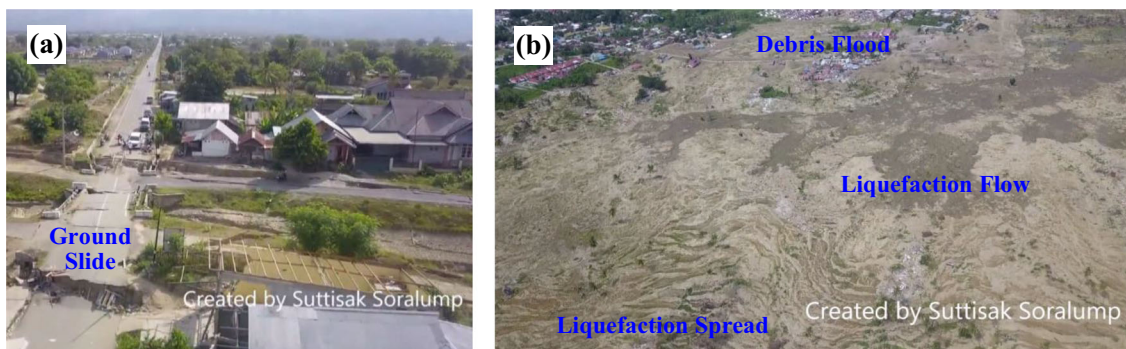
The characterised morphological features can generally be visualised through the bird’s-eye views of drone photos by Soralump (2018). As shown in Fig. 18 a, a ground slide (GS) zone is found along Moh. Soeharto road adjacent to the east boundary of Petobo slide, where cracks and slips are visible on the surface and divide the ground into several earthen blocks. Figure 18 b indicates the zones of liquefaction spread (LS), liquefaction flow (LF) and debris flood (DF) on the south-eastern portion of the sliding area. Liquefaction spread is signified by a series of curvilinear features on the ground, as a result of cyclic spreading during shaking. The liquefaction flow emerges next to the downstream side of the spread zone, with relatively smoother ground surface, due to monotonic flow after the shaking. Debris flood would be the liquefied soils that flow over and inundate the existing ground, as seen in the far side of the photo (Fig. 18b), where the surroundings of a small area with existing houses had been destroyed and buried in the debris.

Fig. 18 Morphological features observed from the snapshots of drone videos by Soralump (2018). a Photo of the ground slide feature along Moh. Soeharto road to the east boundary of Petobo slide (facing east). b Photo of the features of liquefaction spread, liquefaction flow and debris flood on the south-eastern portion of Petobo slide (facing west)

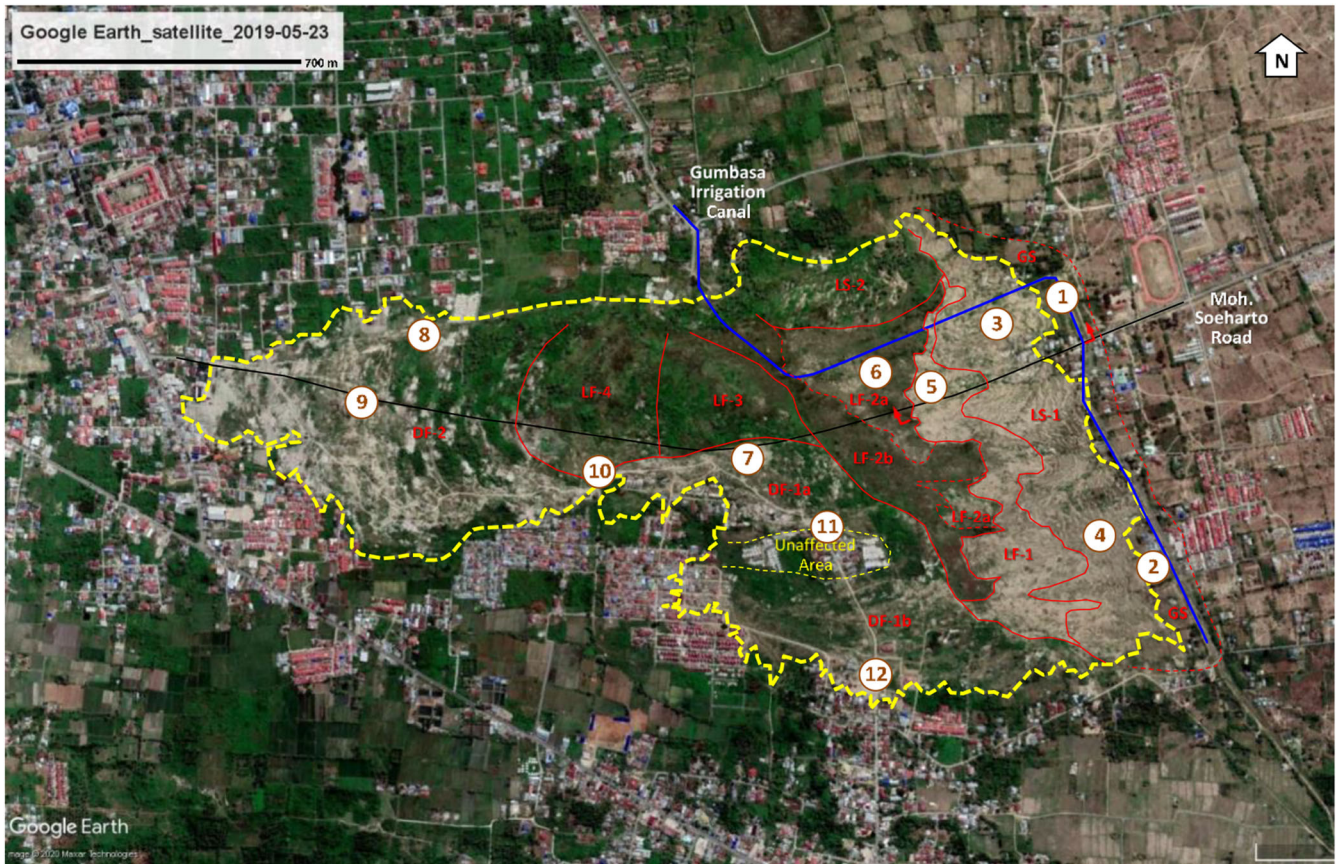
The characterised and defined morphological features, mainly based upon the mapping along Moh. Soeharto road, are further applied for the zonation of entire sliding area in Petobo, and the results are shown in Figs. 19 and 20. As seen in Fig. 19, the ground slide (GS) falls in a narrow zone approximately along Gumbasa

Fig. 19 Zonation of morphological features at Petobo sliding area, with locations of photos of representative morphologic features showing in the subsequent figure, as well as the location of mapped section along Moh. Soeharto road

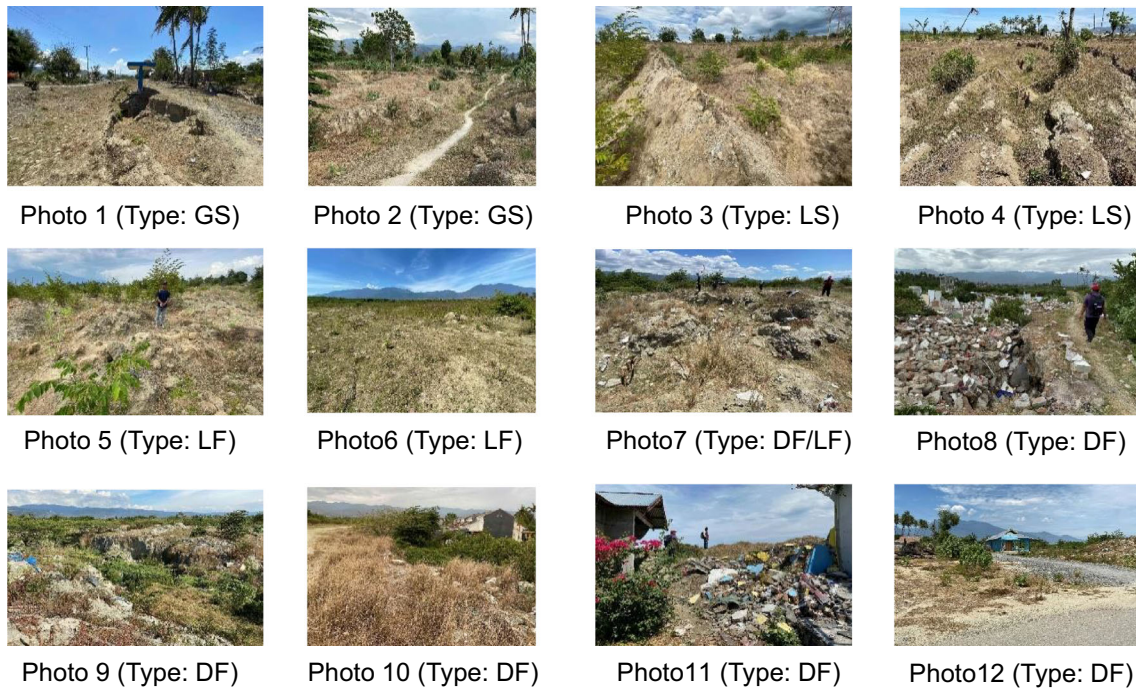
irrigation canal and in adjacent to the eastern boundary of the sliding area. Photos 1 and 2 of Fig. 20 show representative features (i.e. cracks and slides) of the ground slide surface. Liquefaction spread (LS) zone is neighbouring to the west of GS zone, with a width of about 300 m in east-west direction. Photos 3 and 4 of Fig.

20 indicate the linear pattern of earthen ridges and cracks observed on the spreading ground.

Liquefaction flow (LF) zones are further to the west of the LS zone. As seen in Photos 5 and 6 of Fig. 20, the liquefaction flow surface is generally uneven and bumpy with extensive exposures of liquefied sands. During onsite investigation, we observed the liquefaction flow area could be subdivided into several small zones or stages, as depicted in Fig. 19. It is speculated that the causes might have been due to the changes in viscosity of liquefied soils during slide, the reoccurrence of post-shakings to the site or some other reasons yet to be found.

Fig. 20 Photos of associated morphological features identified on Petobo sliding area, with locations indicated on the previous figure of morphological zonation
