Onsite Observations of Petobo Liquefaction Area due to 2018.9.28 Palu-Donggala, Indonesia Earthquake

ABSTRACT

Liquefaction-induced flowslides occurred in several places of Palu City, in the Central Sulawesi of Indonesia, due to Palu-Donggala earthquake with a magnitude (M_w) 7.5 on September 28, 2018. One of the landslides was in Petobo Village, which is close to Mutiara SIS Al-Jufrie Airport of the city. Petobo landslide, with an area of approximately 1.64 km², has caused most fatalities among other areas affected by this earthquake. To have a better understanding of the flowslide, onsite observations through witness interviews, drone photos and site mapping have been conducted in the early of 2020. Additional information from satellite images and Google Street views are also compared with the onsite observations. The study reveals that Petobo landslide could possibly be divided into four types of morphology. Ground slip (GS) is due to a sudden loss of support and results in cracks and soil blocks. Lateral spread (LS) is characterized by a series of parallel cracks and earthen ridges as a result of lateral spreading and shaking. Liquefaction flow (LF) occurs in the liquefied gro

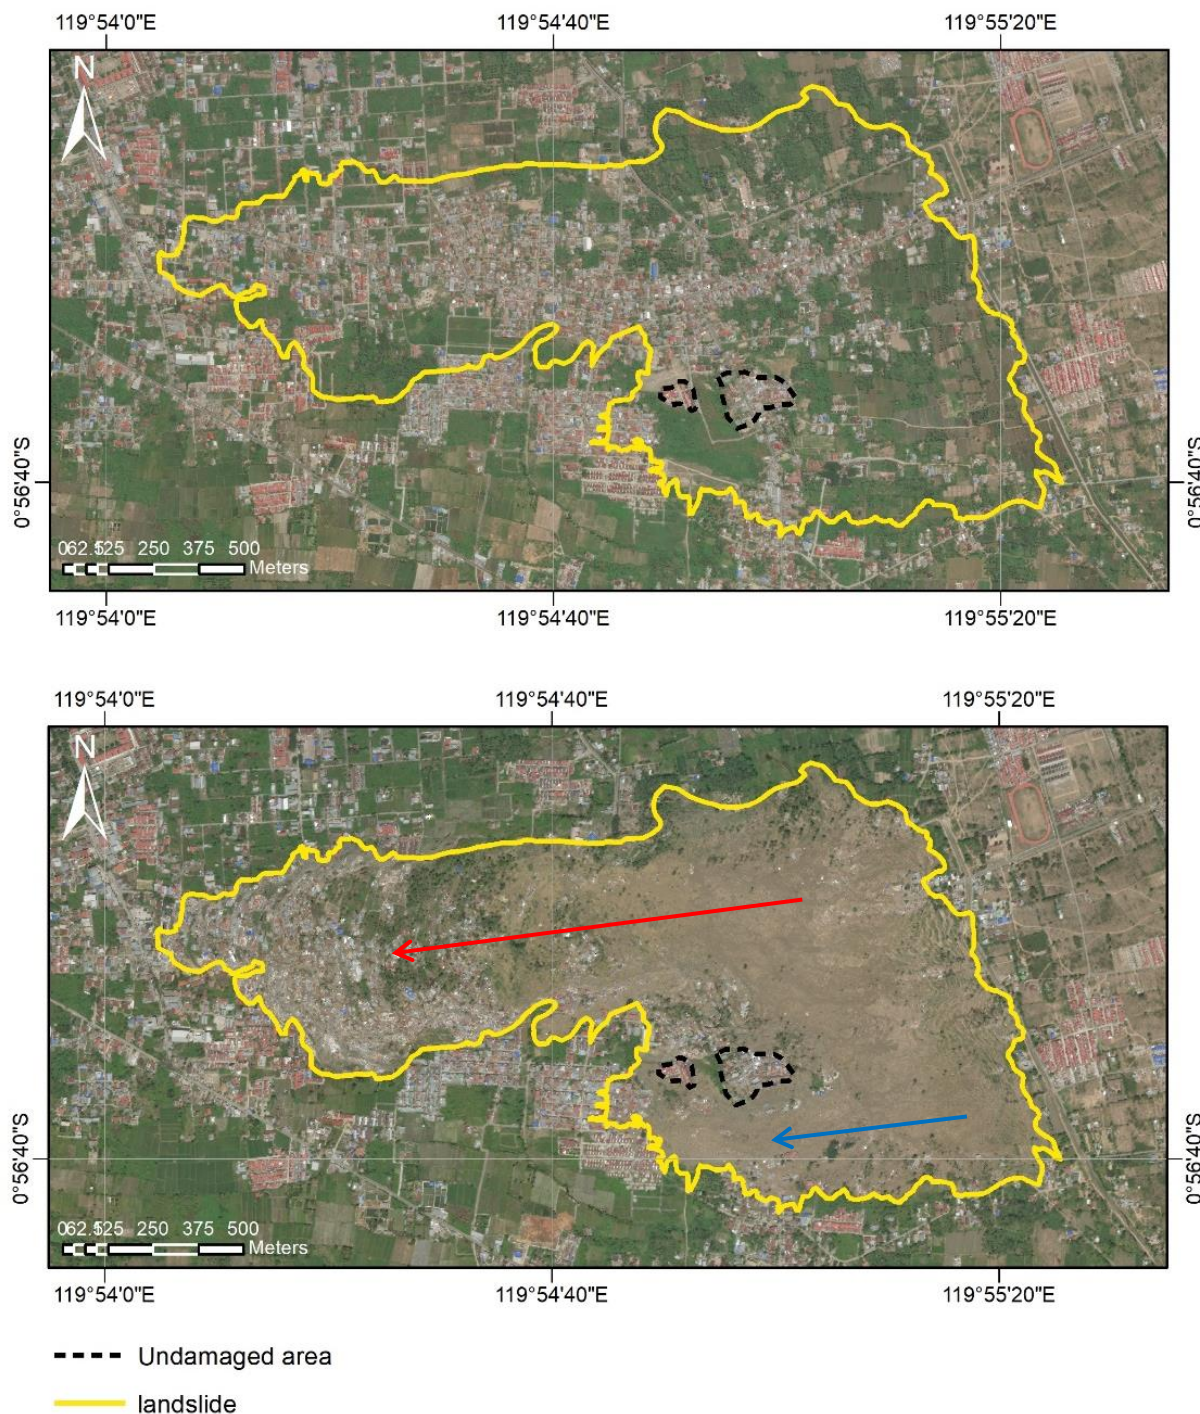
Fig. 3 Pre-slide and post-slide satellite images of liquefaction-induced landslide in Petobo

Fig. 3 presents the satellite photos captured from Google Earth for the Petobo landslide area in its pre-slide (date picture taken: 18 June 2018) and post-slide (date picture taken: 2 October 2018) time periods. The boundaries of the area affected by landslides are marked with yellow lines. The black dashed lines represent the areas that had not been affected by the landslide, where some houses were not damaged and remained intact.

Approximately 1920 buildings were reported collapsed and affected by the mass movements, with the majority being residential houses (BNPB 2018). Based on the pre-slide image in Fig. 3, the middle and western part of the sliding area were residential with a large number of buildings. Fig. 3 also shown that the eastern portion of the sliding area was primarily paddy fields.

Petobo liquefaction flowslide generally moved from east to west. The major slide in the northern part of the sliding area had moved approximately up to 1 km along Jl. Moh Soeharto (the EW main road of the site). The

slide in southern part of the area was generally shorter, about 0.5 km or less. In Fig. 3, the red arrow shows general direction of sliding of the northern part, while the blue arrow indicates the direction of sliding of the southern part. Among the landslides triggered by earthquakes, the flow-like long-runout landslides, with large-volume and high-speed, are generally considered most destructive (Huang 2014). The surface grading of the ground before the sliding was very gentle, with an average inclination of 2–3% (Hidayat 2019).

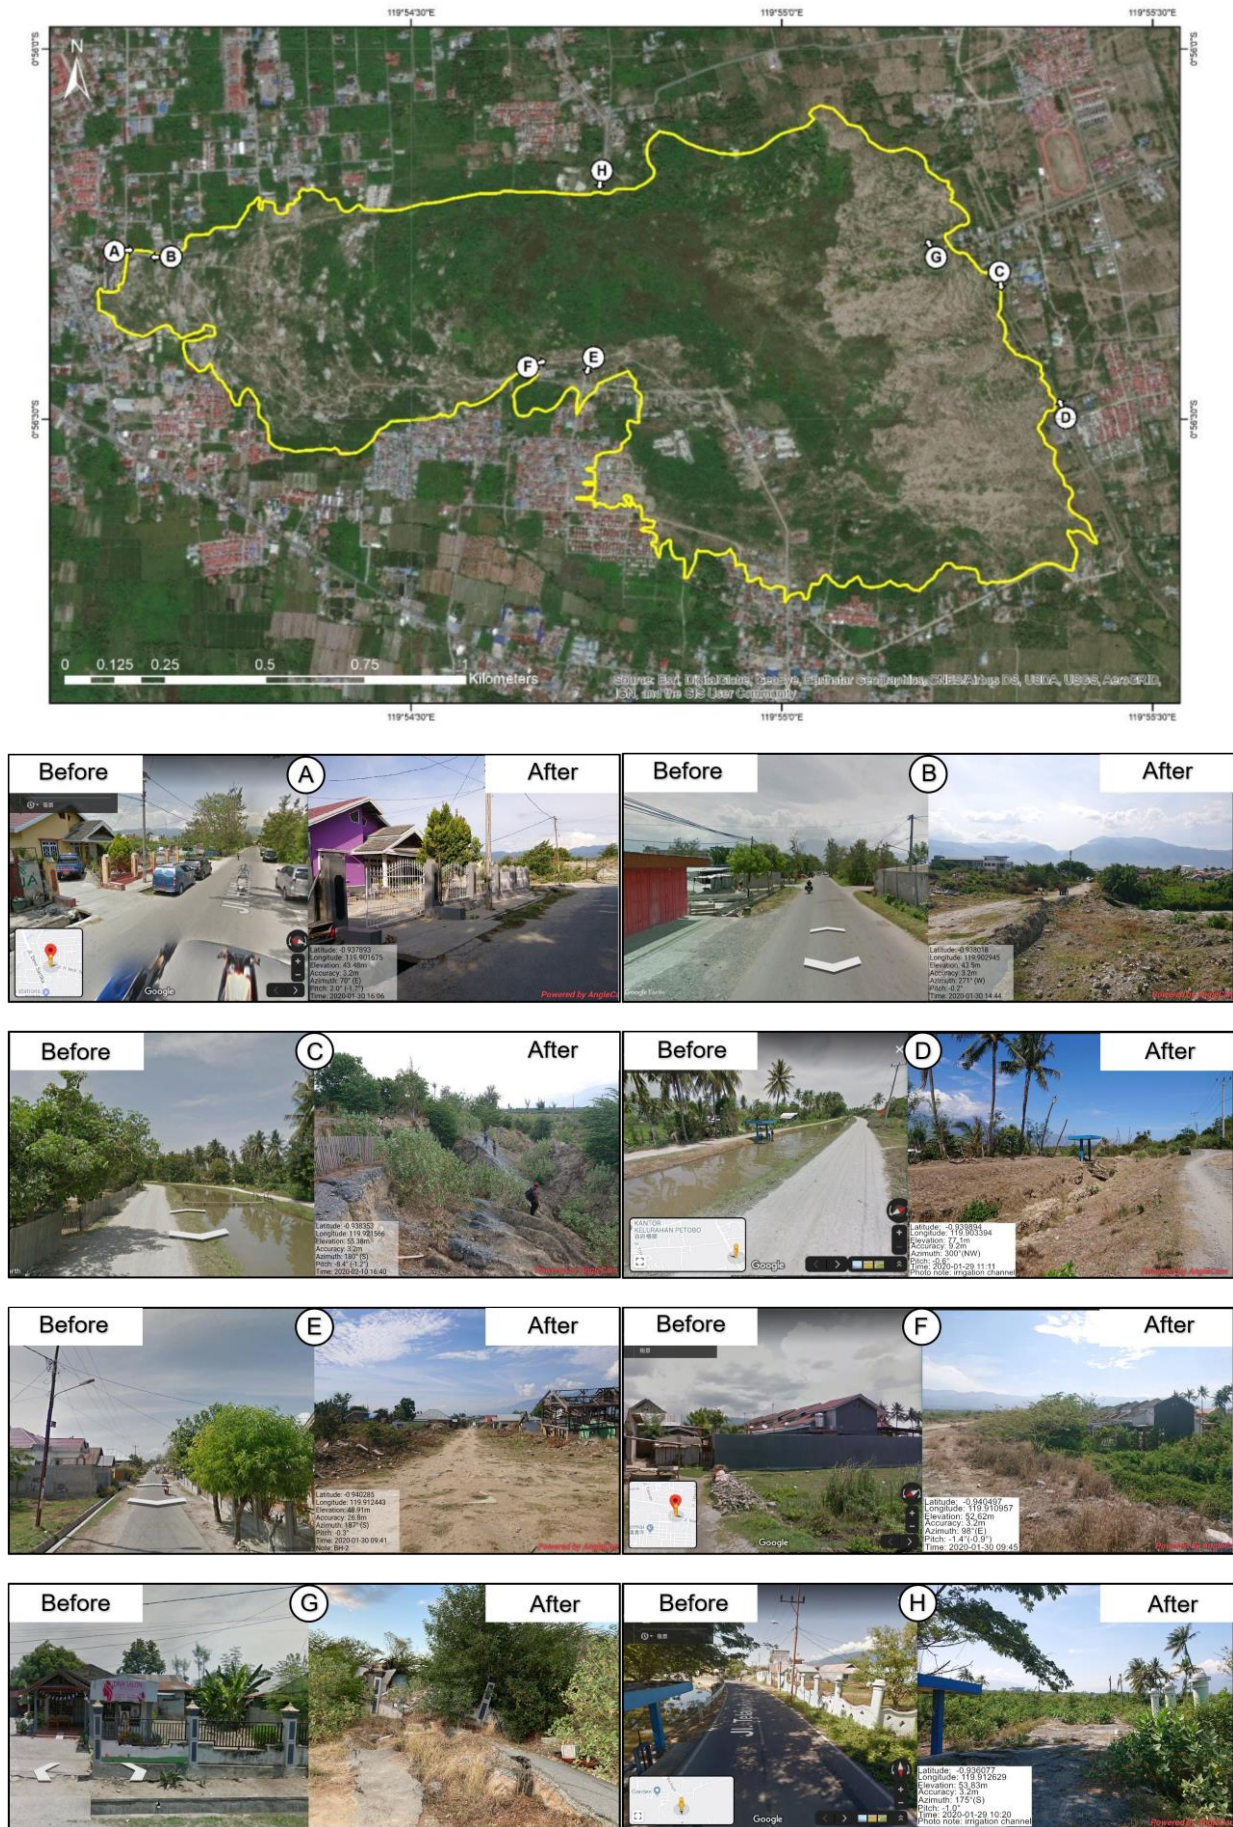
Fig. 4 Location map and photographs of feature before and after earthquake

To identify damages caused by the landslide, field observations were implemented. Fig. 4 shows the post-slide satellite images taken on 11 June 2019. The white dots in the image are the post-slide locations of features indicated in Figs. 4A-4H. The arrows along with the white dots indicate the direction of viewing or shooting. The photograph pairs for features before and after the sliding were taken along the sliding boundary. Conditions of post-slide features are compared with those of pre-slide images using Google Street View. To ensure the correctness, coordinates of the shooting location and camera angle had to be confirmed.

Figs. 4A and 4B were taken from eastern part of the slide area near the toe. Fig. 4A shows the roads that had been cut off due to the debris. This picture was taken from outside of the boundary line facing to the east direction. It was remarkable that the buildings outside the slide area were merely unaffected. From the opposite side, Fig. 4B was taken facing west direction. It can be seen from the picture that the red building and the road had completely buried by the thick soils deposited after the flow.

The unique feature to the eastern part of Petobo landslide area is the irrigation channel (Gumbasa canal) that bordered the eastern boundary of the site. Figs. 4C and 4D were taken from eastern part of the sliding area. Fig. 4C shows the irrigation channel that had slip away toward downslope direction. Several crack along the irrigation channel in Fig. 4D could be seen and the blue water gate only suffered minor movements. These two pairs of pictures clarified that the water in the irrigation channel had disappeared after the earthquake.

Fig. 4E shows the damage of a road and several building that had already covered by the debris due to the landslide. This road which was originally asphalted has changed into a dust road made by local people after they removed the debris materials. It is one of the access roads used by the local people leading to the landslide area, which is now already covered with vegetation. They also usually bring their livestock (cows and goats) to the landslide area. Fig. 4F shows the ground surface level increased almost as high as half of the building. The houses shown in the photo are no longer inhabited. These two figures were taken in the southern boundary.

Fig. 4G shows a comparison of the pre-slide and post-slide conditions of a house. The fence and the road suffered severe cracks and tilts. Fig. 4H shows a road that lay between the irrigation channel on the left and the Islamic School on the right. The irrigation channel could not be seen with only the blue water gate left in the figure. Some part of the Islamic School buildings in the south had been moved away by the slide further to the west. From the post-slide picture, only portions of the

fence remained in the original place.

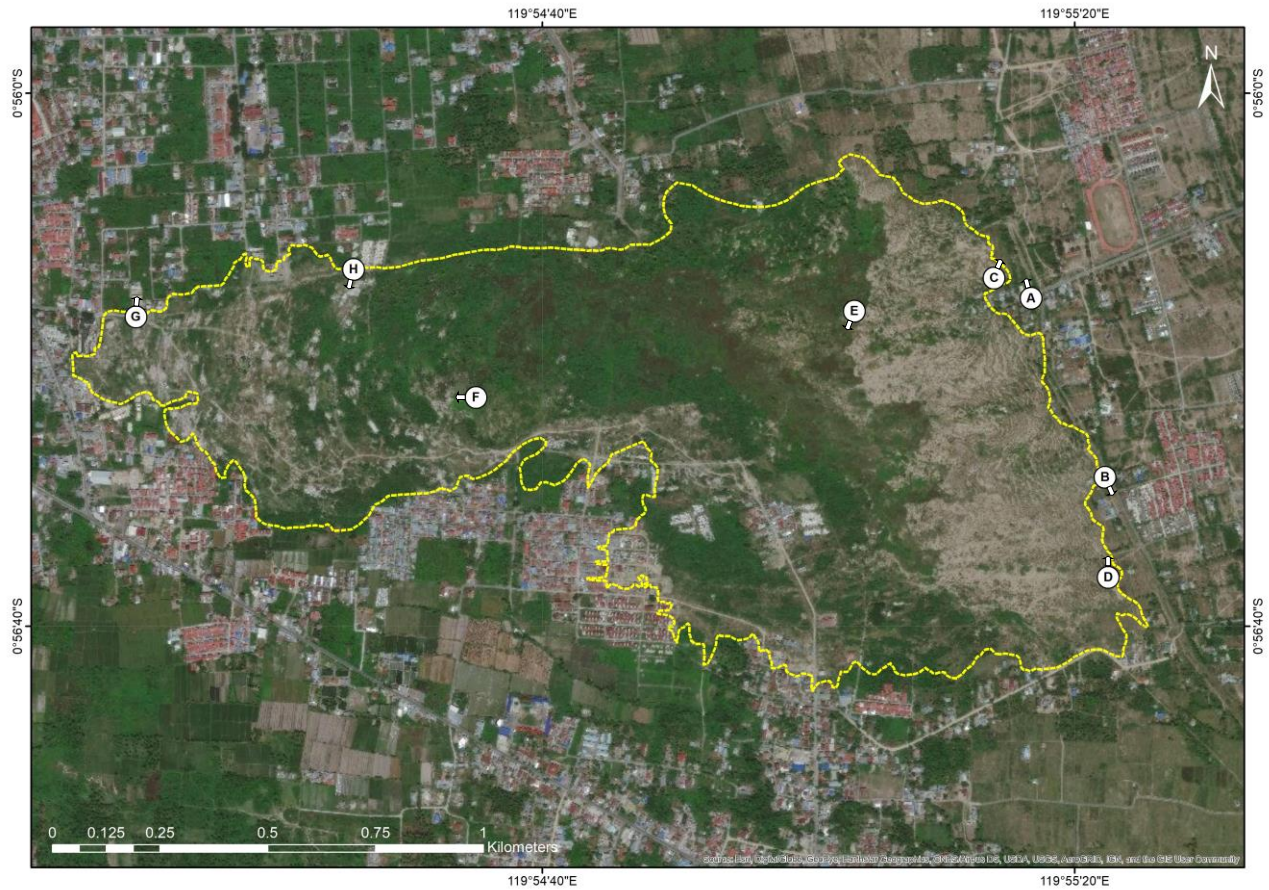
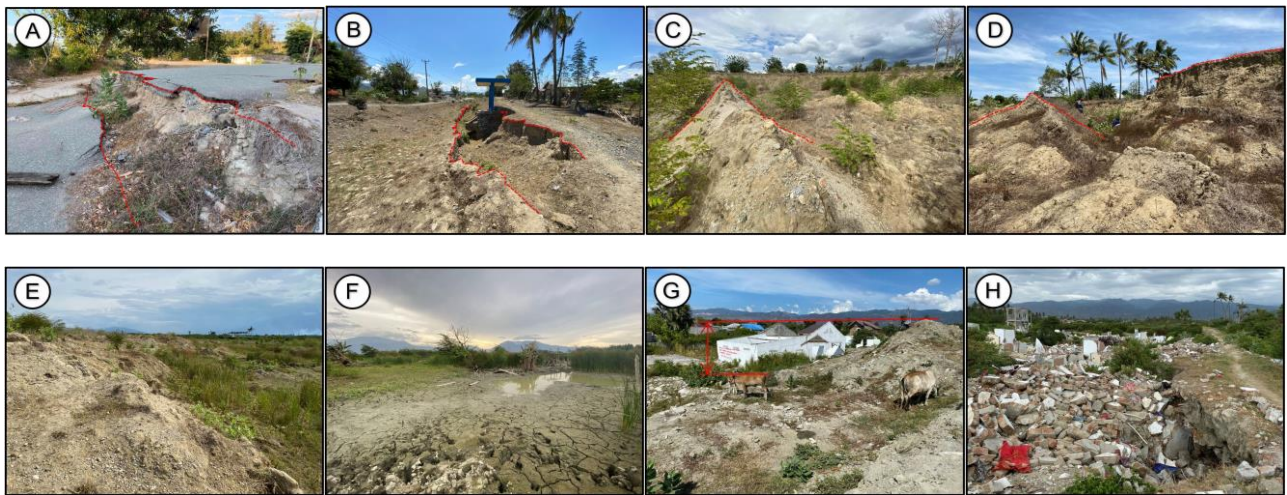
Fig. 5 Morphological features observed at the site

“Ground Slip” is a failure phenomenon caused by slippages in soil materials. Several soil blocks divided by cracks or scraps usually can be observed at the ground surface (Figs. 5A and 5B). Ground slips can be triggered by a sudden increase in ground inertia, such as an earthquake shaking, and/or a drop or loss of a downhill support, such as a slope toe cut. The slip surface practically passes through the intact soil mass which does not liquefy during the ground shaking.

“Lateral Spread” is a failure phenomenon due to cyclic lateral spreading of liquefied soil materials during earthquake shaking. The surface appearance of lateral spreading may include a series of linear fractures or earthen peaks (ridges) with broken and lowered ground sideways (Figs. 5C and 5D). Surface structures can be destroyed, bent, or damaged by cyclic motions and the spreading of liquefied soils. Extruded liquefied sands are found on the ground in areas of cracking and peaking (Fig. 6). Lateral spreads are due to liquefaction of the soil. Due to the cyclical nature of shaking, the liquefied soils move back and forth laterally, leading to a gradual spreading and a decrease in the height of the liquefied mass.

“Liquefaction Flow” is a failure phenomenon due to the monotonic sliding or flowing of fully liquefied earthen materials, which occurs mainly after the earthquake. The ground surface of the liquefaction flows generally uneven and bumpy with extensive exposures of liquefied sands (Figs. 5E and 5F). Structures on the liquefied surface can sink, tilt or flow with sliding over a long distance. Liquefaction flows generally occur in sloping ground in which earthen materials are completely saturated and liquefied due to ground shaking. Due to the gravity and/or additional driving forces from the upper side of the slope, such as by ground slip or lateral spreads, the liquefied soil materials can start flowing downslope right after the ground shaking. The liquefaction flow can be accomplished in stages, depending on the viscosity of the liquefied soil materials, the degree of liquefaction that sliding mass can carry, the geometry of the ground and sliding surface, etc.

“Debris Flow” is a failure phenomenon similar to the “Liquefaction Flow”, an overflowing of liquefied earthen materials mixed with construction debris. However, the debris flow is different with the aspect that the existing ground of debris flow area is generally non-liquefied but covered with liquefied soils and debris from the upstream side. The liquefied soils with mixed debris are whacking and destructive for structures on the existing

ground. Surface manifestations of the debris flow are characterized by the irregular surface of liquefied soil materials and debris, the destroyed existing and transported structures, and the elevated ground surface as opposed to the adjacent areas unaffected by the debris flows, etc. (Figs. 5G and 5H). The causes of debris flow are similar to those of liquefaction flow. When an earthquake is shaking, the soil on the upstream side is completely liquefied, dragged by gravity, and then flowing downward.

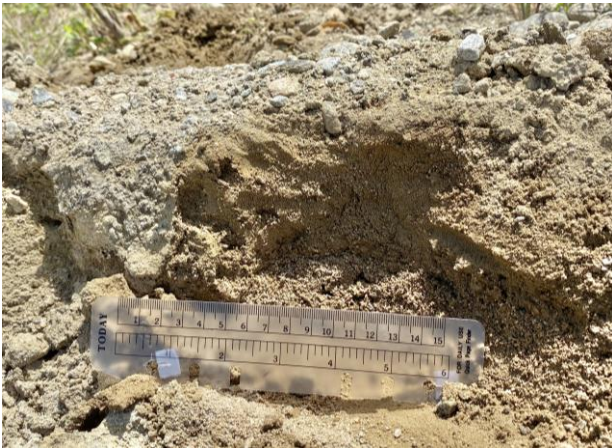
Fig. 6 Extruded sands in areas of lateral spread (LS)
