Landslides (2021) 18:3163–3182
 DOI 10.1007/s10346-021-01700-x
 Received: 9 December 2020
 Accepted: 13 May 2021
 Published online: 6 June 2021
 © Springer-Verlag GmbH Germany
 part of Springer Nature 2021

Rini Kusumawardani · Muhsung Chang · Togani Cahyadi Upomo · Ren-Chung Huang ·
 Muhammad Hamzah Fansuri · Galih Ady Prayitno

Understanding of Petobo liquefaction flowslide by 2018.09.28 Palu-Donggala Indonesia earthquake based on site reconnaissance

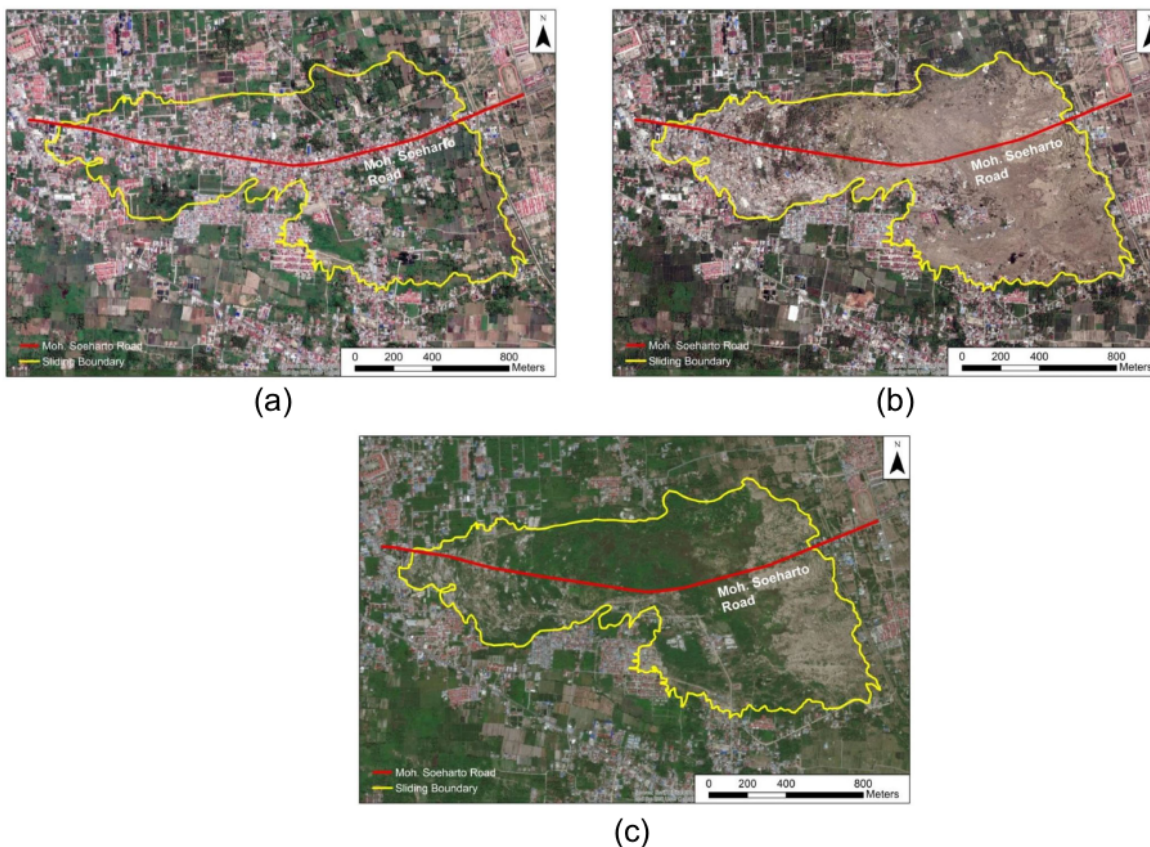
The earthquake caused land-use changes in Petobo area. Figure 6 illustrates the land-use changes at different periods. As shown in Fig. 6 a, the eastern and southern parts of the Petobo flowslide area before earthquake were mostly paddy fields, while residential area was densely populated in the western and middle parts. A main

road of Moh. Soeharto passed across the flowslide zone from east to west. The earthquake shaking obviously destructed the eastern part of site and swept away everything, such as people, properties and houses, westwards. Figure 6 b indicates the area hit by liquefaction flowslide was covered by debris on the surface in brown colour. Figure 6 c shows the condition of the site 1 year after the disaster. As can be seen, the area was almost preserved, as confirmed by our team during site investigation, where no reconstruction was noticed and the damaged infrastructures could be observed as an accumulation of ruined debris in the western part of flowslide area.

Fig. 6 Site conditions before and after earthquake are documented at three different times taken from Google Earth. a Before the slide on 2018.08.17, the site could be seen with dense population. b Four days after the slide on 2018.10.02. c Recent image on 2019.11.06

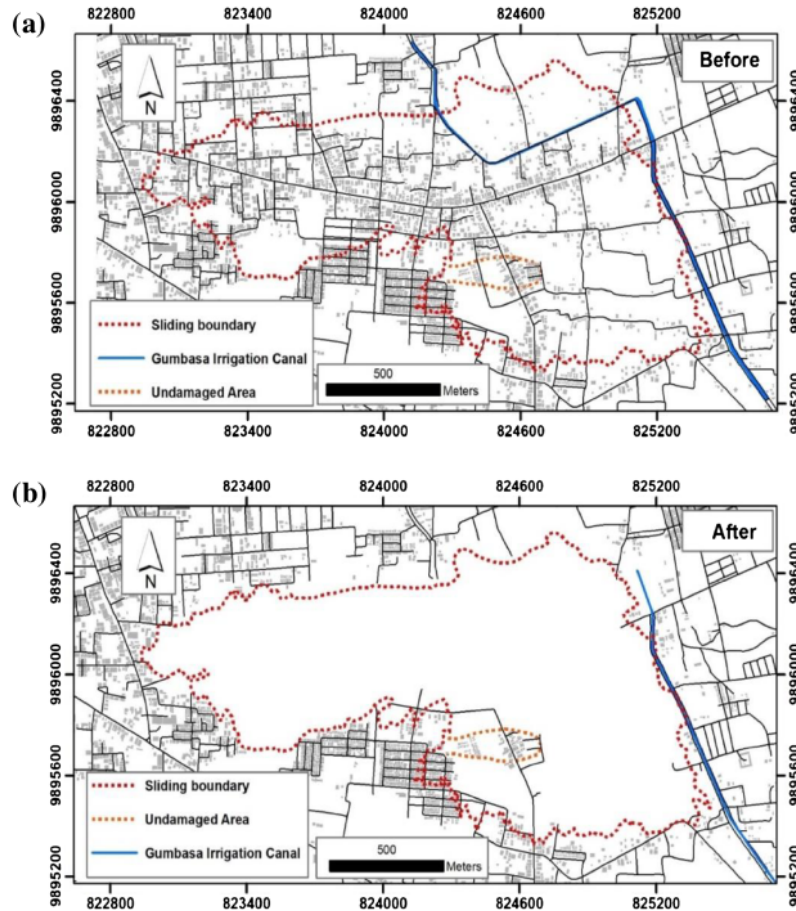
Fig. 7 The site condition before and after the earthquake. **a** Condition before earthquake where Gumbasa irrigation canal passed across the flowslide area. **b** Situation after the earthquake where Gumbasa irrigation canal in the NE portion of the sliding was swept away and an undamaged area was found in the southern part of the sliding area

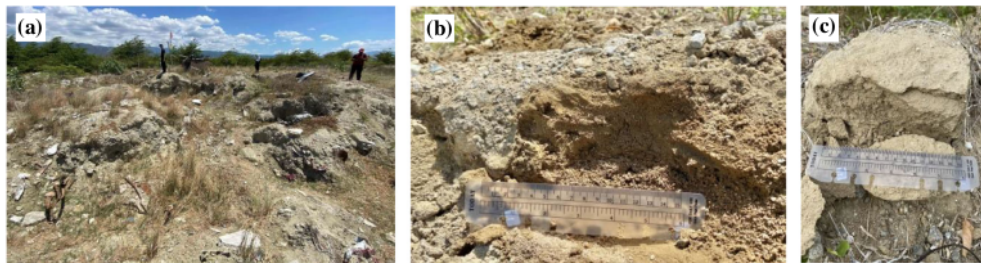
during the sliding (Fig. 8). We noticed the ground surface was rugged and piled with sands, suggesting severe liquefaction outflows or eruptions might have occurred during the earthquake shaking. In the southern part, we found an undamaged area (Fig. 7b), where houses and people were not hit directly but surrounded by the flowslides.

Fig. 8 **a.** A site with big eruptions of sands during earthquake based on the interviews with Witnesses G and H. The location was near District Office of Petobo (Kantor Kelurahan Petobo). **b, c** Exposed sands as evidences of soil liquefaction

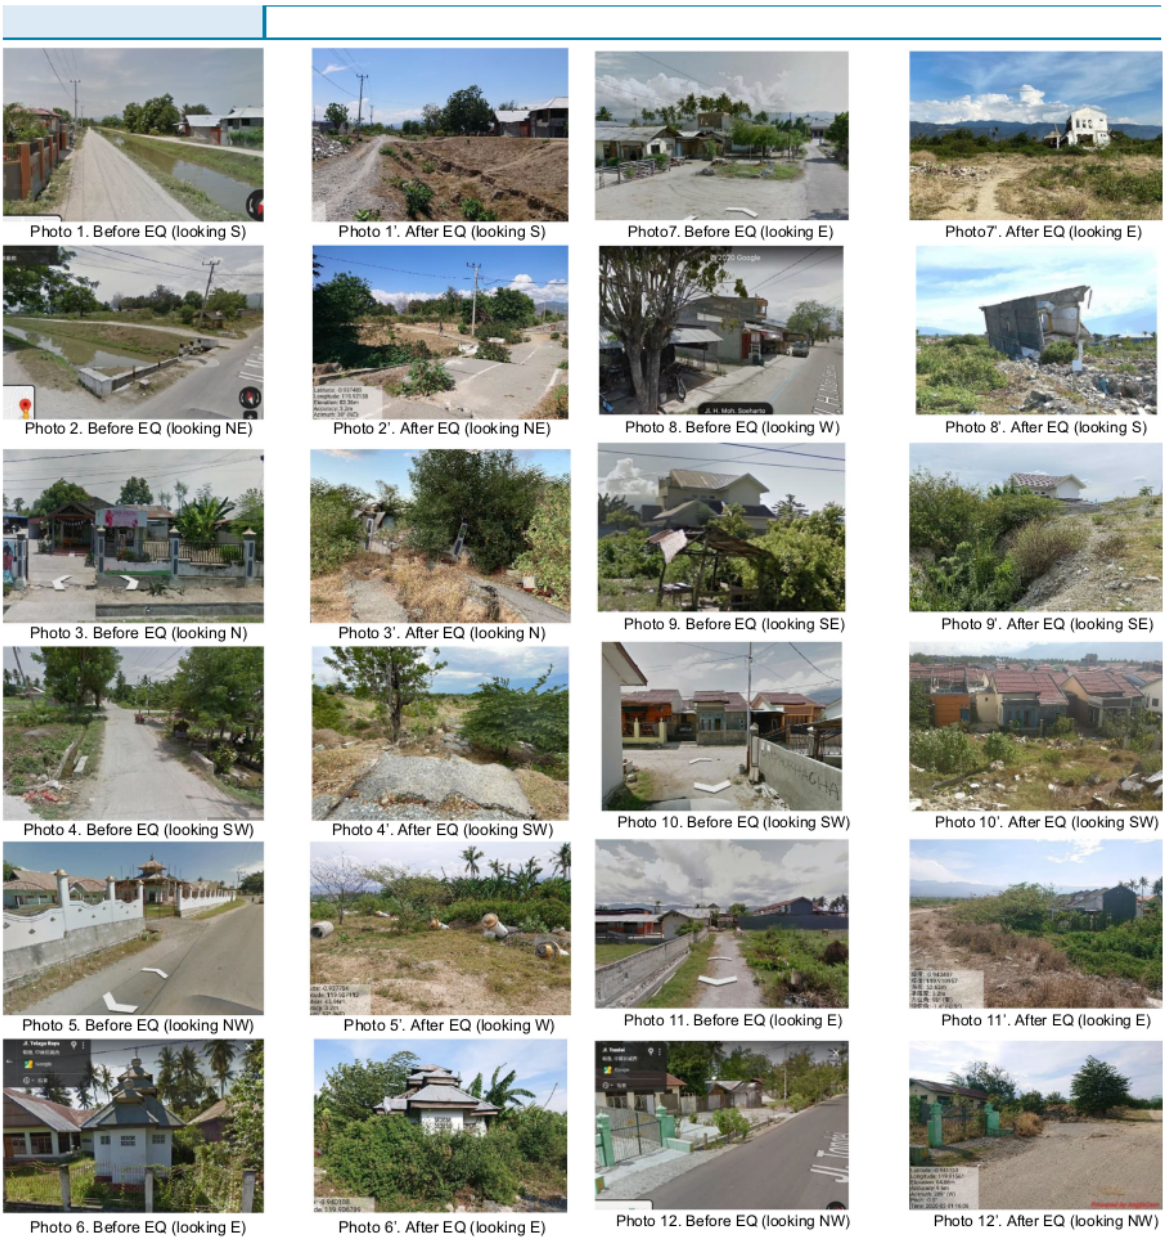
Photos 1 and 2 show the Gumbasa irrigation canal located along the eastern boundary of the sliding area. As seen, the canal was unlined and full with water prior to the earthquake. However, the earthquake had triggered slippages of the ground, causing cracks and drainage of the canal. Photos 3 and 4 are for surface features at east side and northeast corner of the sliding area. As indicated, the ground had been seriously distorted and displaced, apparently the result of liquefaction spreading during the earthquake.

damaged or torn (Photos 7 and 8, residential buildings). The phenomena would suggest the ground had been liquefied as a result of earthquake shaking and flowed, with driving forces and low resistance, for a large distance.

Photos 9–12 illustrate three surface features sitting around the western peripheral of the sliding area and one feature located near the previously mentioned undamaged area (Fig. 7b) to the southern portion of Petobo site. As shown in these

photos, the sliding debris had deposited and piled up on the ground to a height of 3–6 m, as compared with the adjacent unaffected area.

As indicated by local residents and in Google Earth images, Gumbasa irrigation canal was constantly filled with water before the earthquake (Photos 1 and 2; Fig. 10) and the paddy fields were also inundated with water for about 8-month plantation time annually, which are based on our site reconnaissance as summarised in Table 1. During the plantation, the paddy fields

Fig. 10 Photo pairs showing some key features at Petobo site before and after the earthquake. Pre-earthquake photos are captured from Google street view. Locations of the photo pairs are indicated in the previous figure

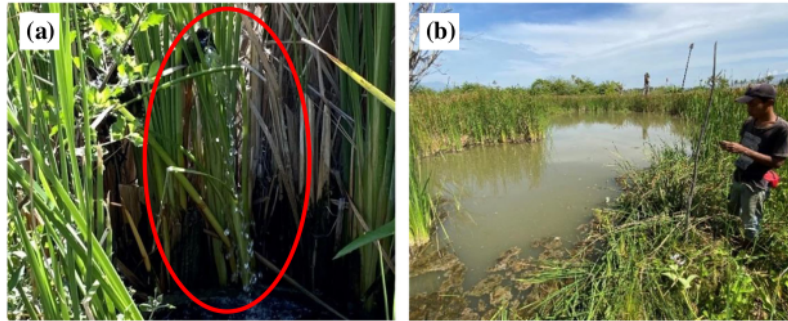
During onsite investigation, the authors found several locations in the middle portion of the sliding area were inundated with swamps and presented with artesian waters (Fig. 11). It is evidenced that these the ground water levels at locations should be very high, and presumably the results due to previously severe liquefaction events.

Fig. 11 a The presence of artesian waters in the flowslide area. b A swamp with ponded water in the middle part of the sliding area

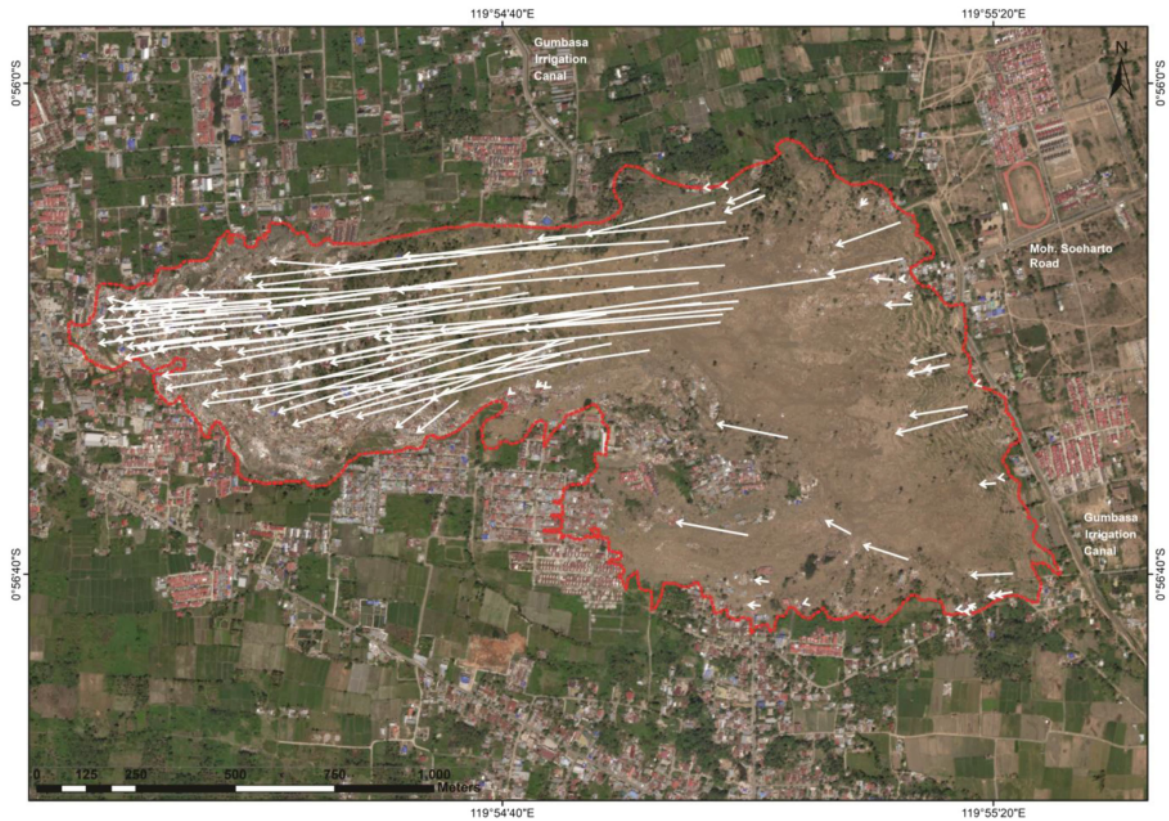
Fig. 12 Displacement vectors of surface objects identified by onsite investigation as well as based on Google Earth satellite images before the after the earthquake. The white arrows are the direction of displacements. Base photo is taken from Google Earth satellite image of 2019.05.23

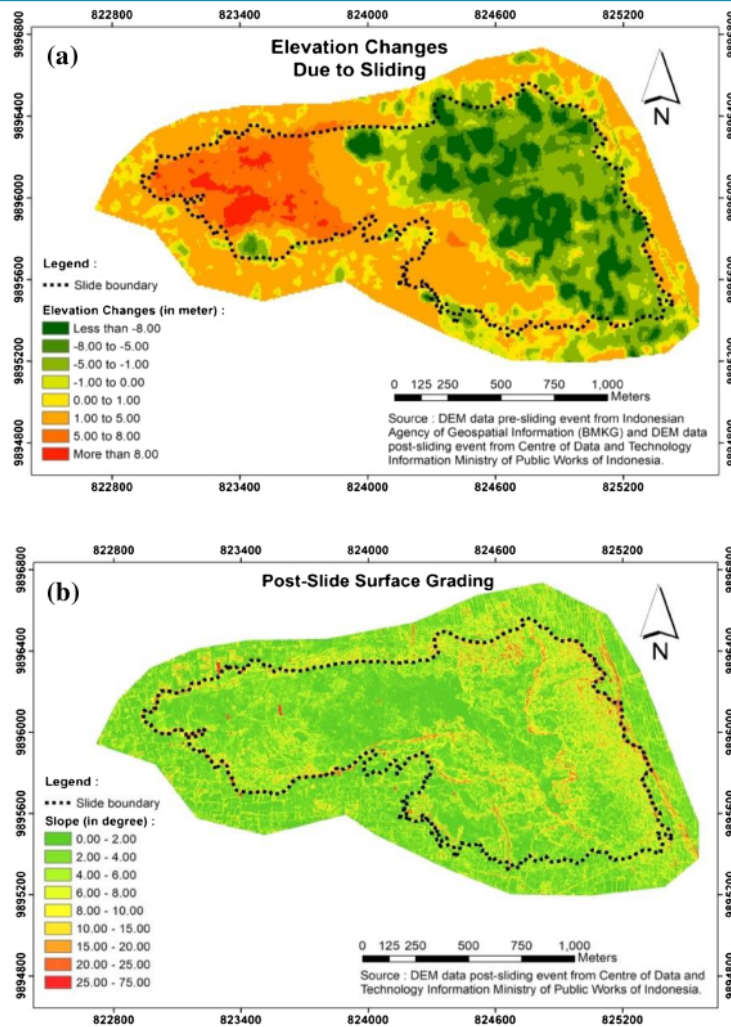
Fig. 13 a The elevation changes due to sliding. b The grading of ground surface after the earthquake. The elevation changes varied approximately between -8 and 8 m. In the eastern part, the elevation dropped down more than 8 m (green colour) and in the western part raised more than 8 m (red colour). Before the earthquake the surface grading in the study area was gentle, with an angle of about 2° . After the earthquake, however, the surface grading changed locally, with an inclination of up to 25° in eastern part. In the middle part, the ground surface was generally flat, but then became rougher again to the western part of the flowside area

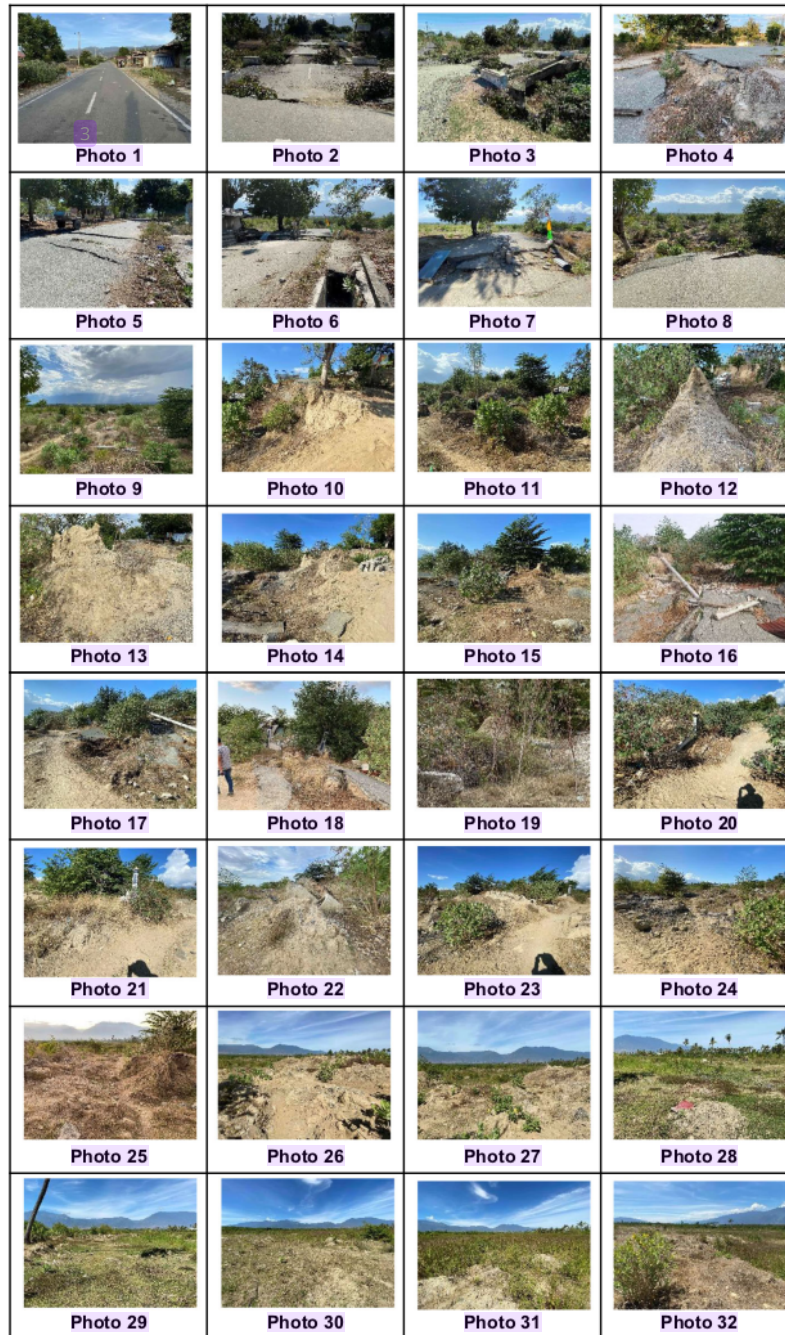
To the east of starting point (Mileage 0), the pavement of Moh. Soeharto road was almost intact (Photo 1; Fig. 16). However, several fractures and slippages were observed to the west and along the road up to a mileage of about 30 m (Photos 2–4; Fig. 16). The surface cracking became scarce until a mileage of 130 m (Photos 5 and 6; Fig. 16). Then a serious slippage was apparent with a head scarp of 3 m high (Photos 7–10; Fig. 16), an indication where the slide had initiated. In the subsequent mapping range with Mileages 130–290 m, the ground elevations subsided approximately 6 m, on

which the surface was extremely rugged, fractured and filled with extruded sands (Photos 11–24; Fig. 16). Within this range of mapping, we noticed several earthen ridges of 1–2 m high, an example shown in Photo 12 (Fig. 16), which were observed periodically for approximately 10–20 m distance apart. This phenomenon would appear to be in relation to the testimonies by Witnesses G, K, L and M, who had indicated a wavy form of ground sliding, with vertical amplitudes of 1.5–2 m and travelling distances of around 15 m (Table 1). In view of the locations of witnesses during the earthquake, we expect these peoples might have been experiencing a liquefaction spreading

during the earthquake shaking. Photos 18, 20–23 (Fig. 16) are indicative of tearing, tilting and settling of houses and water pipes as a result of the spreading of the ground.

Fig. 16). The observed phenomena in this mapping range would suggest the ground might have liquefied significantly during the shaking and flowed further to the west (lower lands) after the earthquake. Photos 26 and 27 (Fig. 16) show the forefront of the liquefaction flow.

became more flat, but wet, swampy and full of aquatic plants that had prevented the research team to approach further. Photos 28–32 (Fig. 16) show distant views of the lower lands. As seen, the ground was exposed with sands, water ponds and aquatic plants. These areas were also suggested a separate stage of liquefaction flow that followed subsequently the previous flow stage as identified in Mileages 290–492 m.

Fig. 16 Associated photos as indicated in the mapping sketch along Moh. Soeharto road to the east of Petobo sliding area

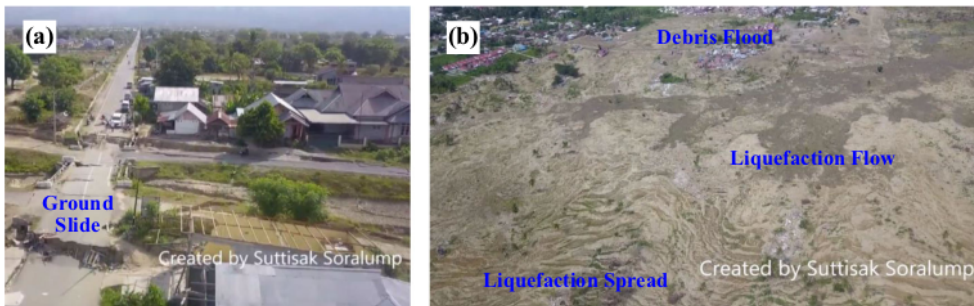
The characterised morphological features can generally be visualised through the bird’s-eye views of drone photos by Soralump (2018). As shown in Fig. 18 a, a ground slide (GS) zone is found along Moh. Soeharto road adjacent to the east boundary of Petobo slide, where cracks and slips are visible on the surface and divide the ground into several earthen blocks. Figure 18 b indicates the zones of liquefaction spread (LS), liquefaction flow (LF) and debris flood (DF) on the south-eastern portion of the sliding area. Liquefaction spread is signified by a series of curvilinear features on the ground, as a result of cyclic spreading during shaking. The liquefaction flow emerges next to the downstream side of the spread zone, with relatively smoother ground surface, due to monotonic flow after the shaking. Debris flood would be the liquefied soils that flow over and inundate the existing ground, as seen in the far side of the photo (Fig. 18b), where the surroundings of a small area with existing houses had been destroyed and buried in the debris.

Fig. 18 Morphological features observed from the snapshots of drone videos by Soralump (2018). a Photo of the ground slide feature along Moh. Soeharto road to the east boundary of Petobo slide (facing east). b Photo of the features of liquefaction spread, liquefaction flow and debris flood on the south-eastern portion of Petobo slide (facing west)

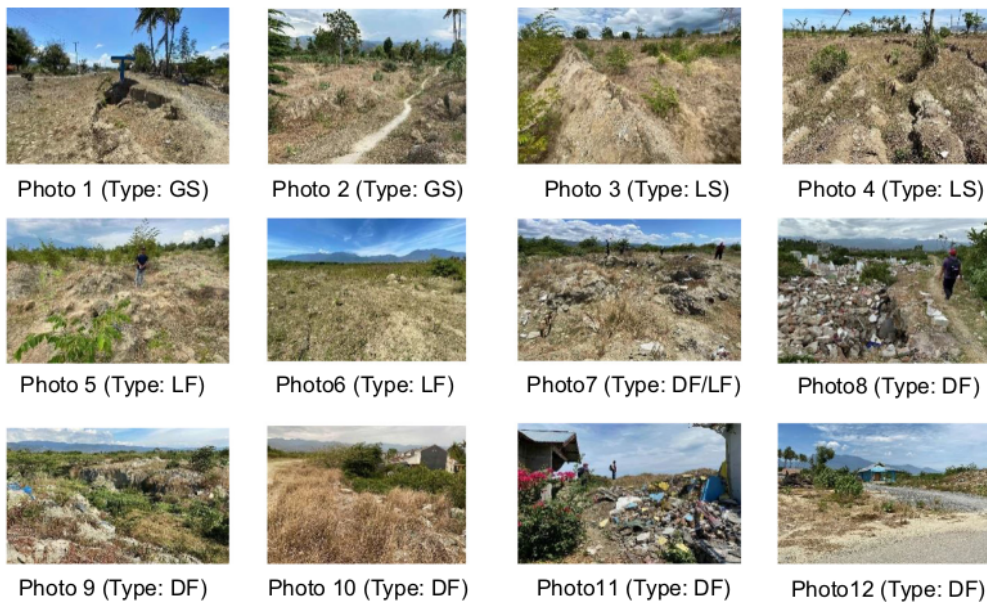
irrigation canal and in adjacent to the eastern boundary of the sliding area. Photos 1 and 2 of Fig. 20 show representative features (i.e. cracks and slides) of the ground slide surface. Liquefaction spread (LS) zone is neighbouring to the west of GS zone, with a width of about 300 m in east-west direction. Photos 3 and 4 of Fig.

20 indicate the linear pattern of earthen ridges and cracks observed on the spreading ground.

Liquefaction flow (LF) zones are further to the west of the LS zone. As seen in Photos 5 and 6 of Fig. 20, the liquefaction flow surface is generally uneven and bumpy with extensive exposures of liquefied sands. During onsite investigation, we observed the liquefaction flow area could be subdivided into several small zones or stages, as depicted in Fig. 19. It is speculated that the causes might have been due to the changes in viscosity of liquefied soils during slide, the reoccurrence of post-shakings to the site or some other reasons yet to be found.

Fig. 20 Photos of associated morphological features identified on Petobo sliding area, with locations indicated on the previous figure of morphological zonation
