**BUKTI KORESPONDENSI ARTIKEL PADA
JURNAL INTERNASIONAL BEREPUTASI**

| Judul | : | Understanding of Petobo liquefaction flowslide by 2018.09.28 Palu-Donggala Indonesia earthquake based on site reconnaissance |
| Jurnal | : | <i>Landslide Journal</i> |

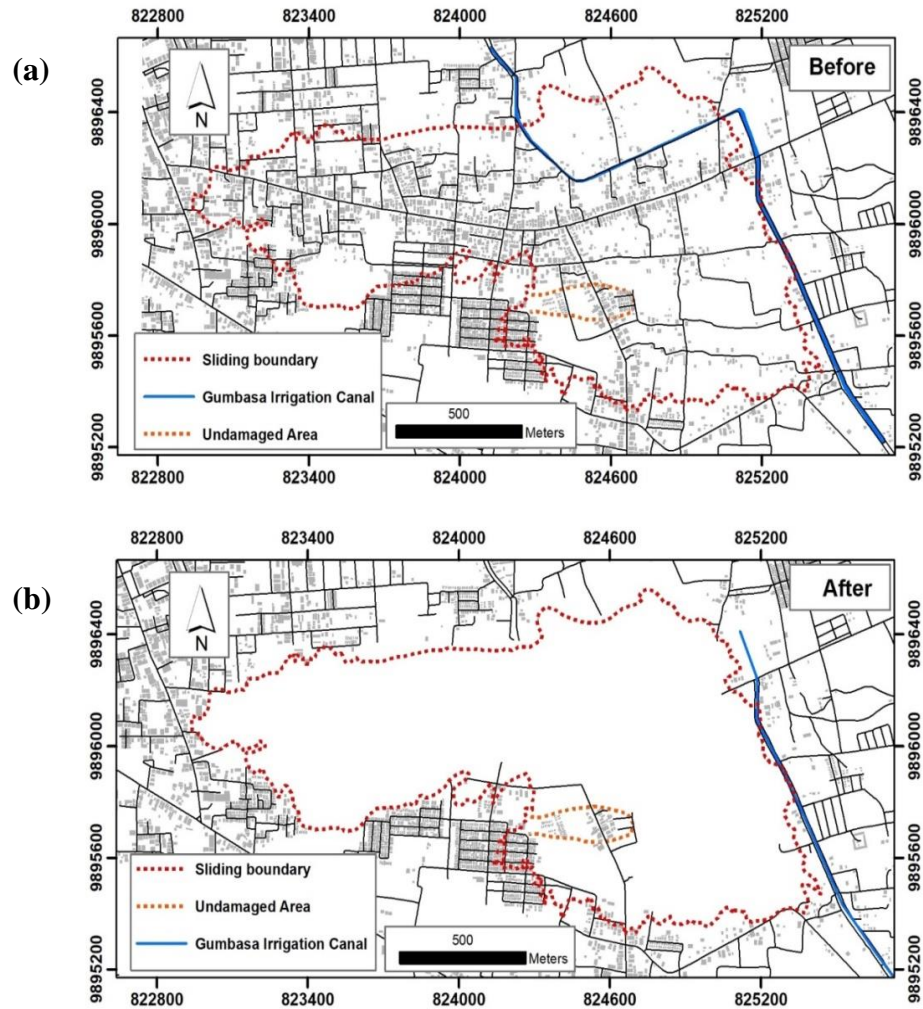
Fig. 7 The site condition before and after the earthquake. **a** Condition before earthquake where Gumbasa irrigation canal passed across the flowslide area. **b** Situation after the earthquake where Gumbasa irrigation canal in the NE portion of the sliding was swept away and an undamaged area was found in the southern part of the sliding area.

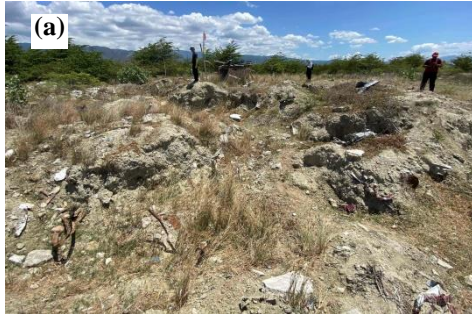
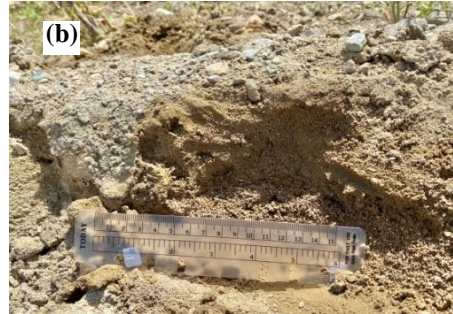
Fig. 8 a. A site with big eruptions of sands during earthquake based on the interviews with Witnesses G and H. The location was near District Office of Petobo (Kantor Kelurahan Petobo). **b, c** Exposed sands as evidences of soil liquefaction.

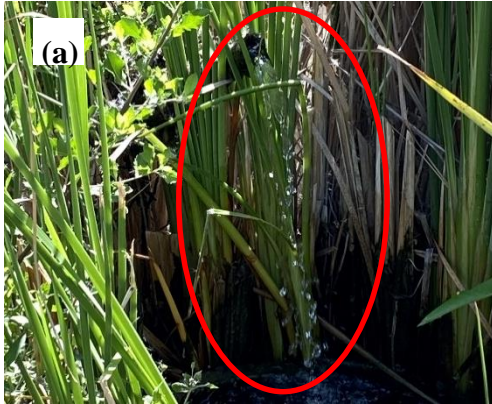
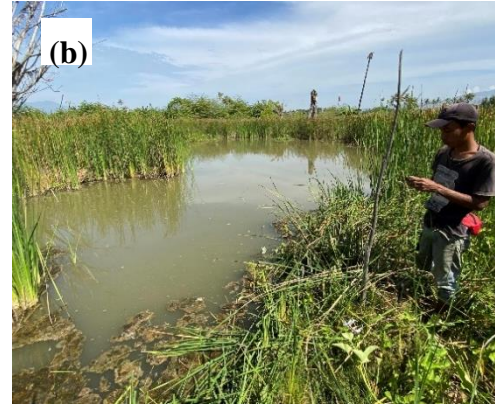
Fig. 11 a The presence of artesian waters in the flowslide area. **b** A swamp with ponded water in the middle part of the sliding area.

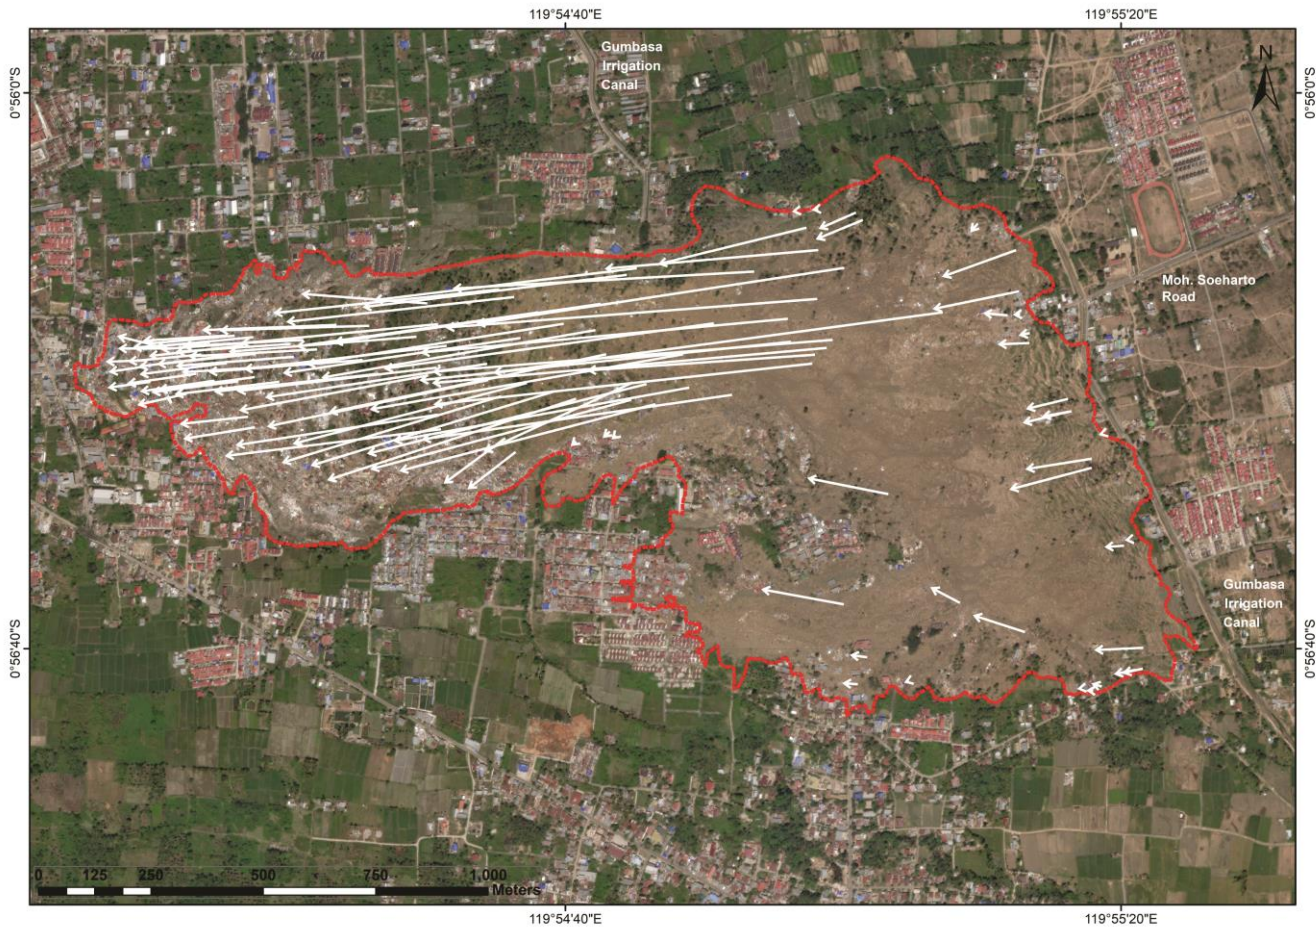
Fig. 12 Displacement vectors of surface objects identified by onsite investigation as well as based on Google Earth satellite images before the after the earthquake. ~~Purple dots are the initial locations and pink dots are the ending positions.~~ The white arrows are the direction of displacements. Base photo is taken from Google Earth satellite image of 2019.05.23

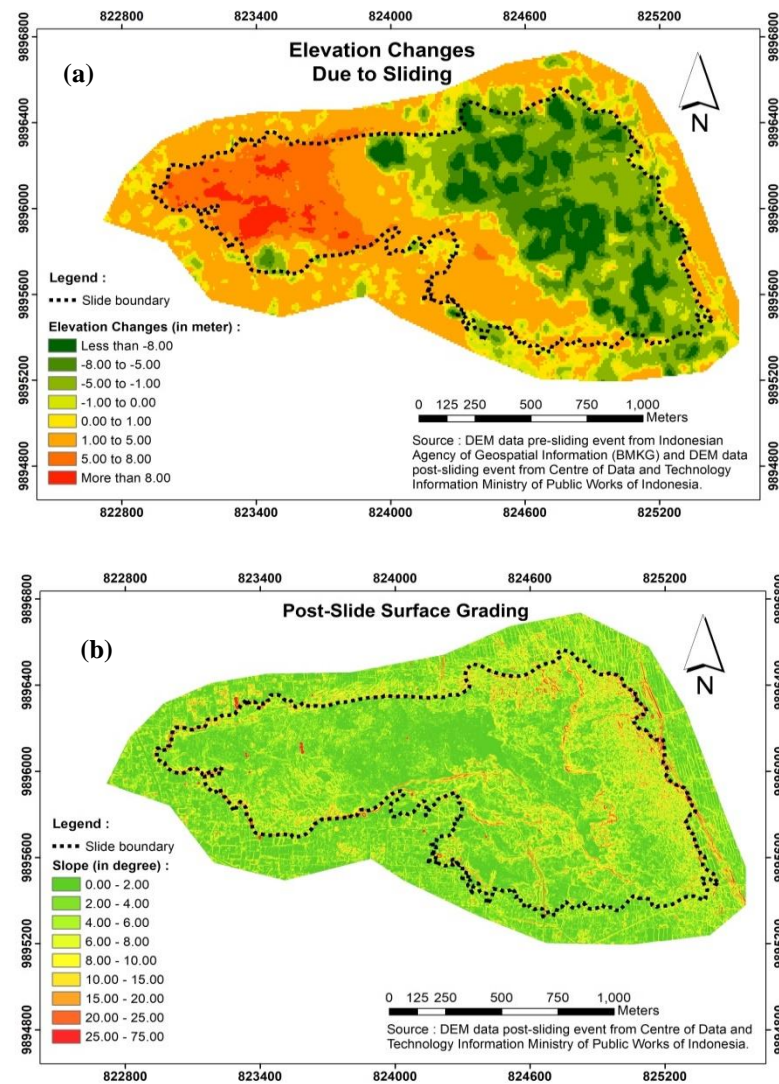
Fig. 13 a The elevation changes due to sliding. **b** The grading of ground surface after the earthquake. The elevation changes varied approximately between -8 m and 8 m. In the eastern part the elevation dropped down more than 8 m (green color) and in the western part raised more than 8 m (red color). Before the earthquake the surface grading in the study area was gentle, with an angle of about 2°. After the earthquake, however, the surface grading changed locally, with an inclination of up to 25° in eastern part. In the middle part the ground surface was generally flat, but then became rougher again to the western part of the flowslide area.

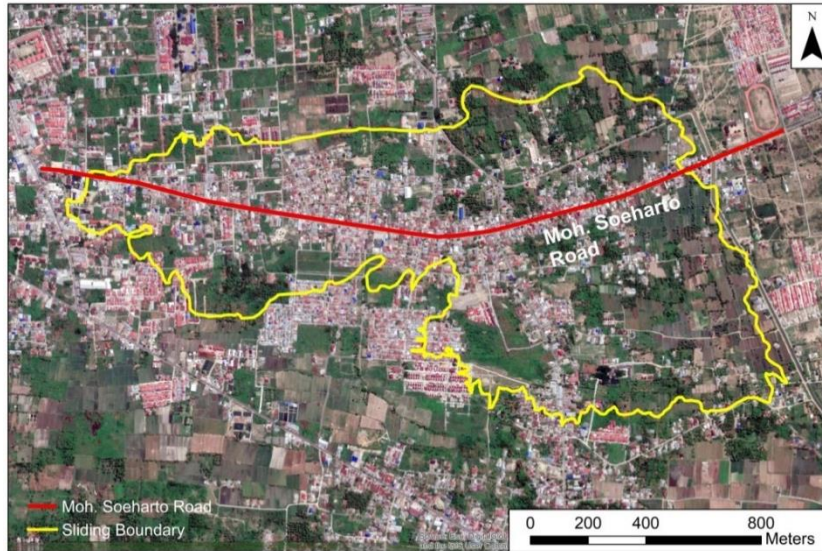
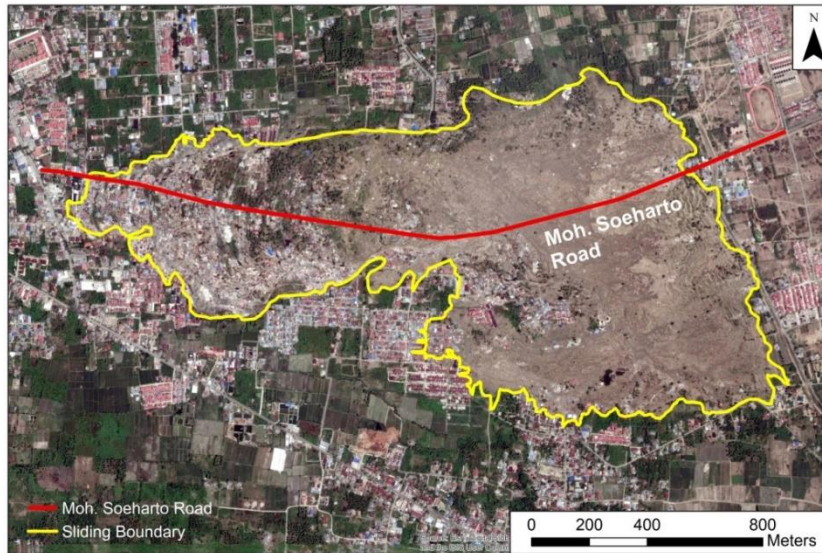
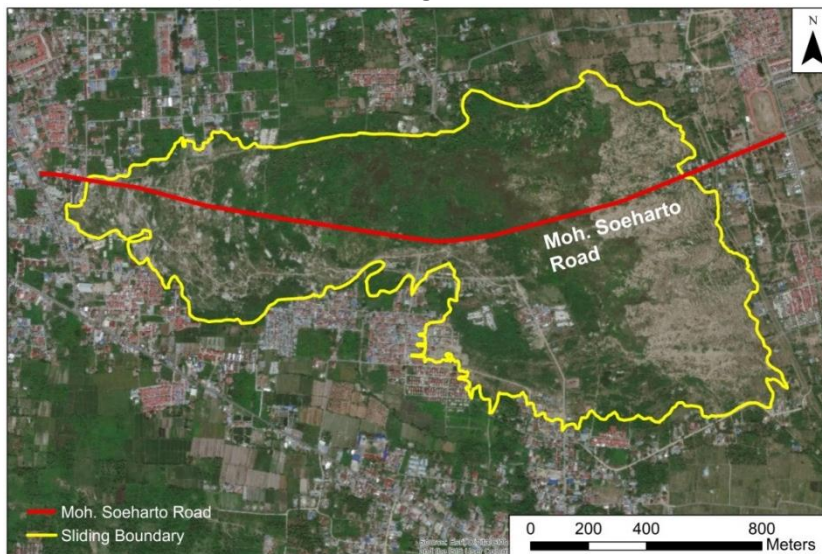
1
2 The earthquake caused land-use changes in Petobo area. Fig. 6 illustrates the land-use
3 changes at different periods. As shown in Fig. 6(a), the eastern and southern parts of the
4 Petobo flowslide area before earthquake were mostly paddy fields, while residential
5 area was densely populated in the western and middle parts. A main road of Moh.
6 Soeharto passed across the flowslide zone from east to west. The earthquake shaking
7 obviously destructed the eastern part of site and swept away everything, such as
8 people, properties and houses, etc., westwards. Fig.6 (b) indicates the area hit by
9 liquefaction flowslide was covered by debris on the surface in brown color. Fig. 6(c)
10 shows the condition of the site one year after the disaster. As can be seen, the area was
11 almost preserved, as confirmed by our team during site investigation, where no
12 reconstruction was noticed and the damaged infrastructures could be observed as an

Fig. 6 Site conditions before and after earthquake are documented at three different times taken from Google Earth. **a** Before the slide on 2018.08.17 the site could be seen with dense population. **b** Four days after the slide on 2018.10.02. **c** Recent image on 2019.11.06.

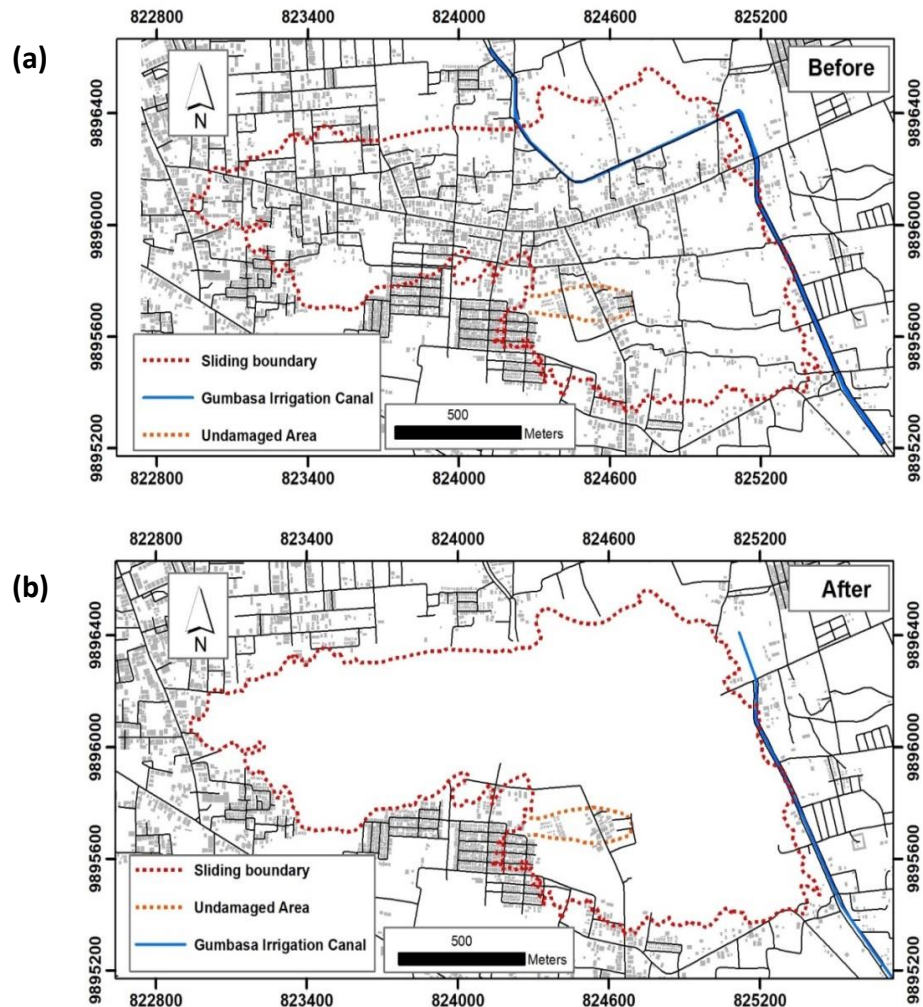
Fig. 7 The site condition before and after the earthquake. **a** Condition before earthquake where Gumbasa irrigation canal passed across the flowslide area. **b** Situation after the earthquake where Gumbasa irrigation canal in the NE portion of the sliding was swept away and an undamaged area was found in the southern part of the sliding area.

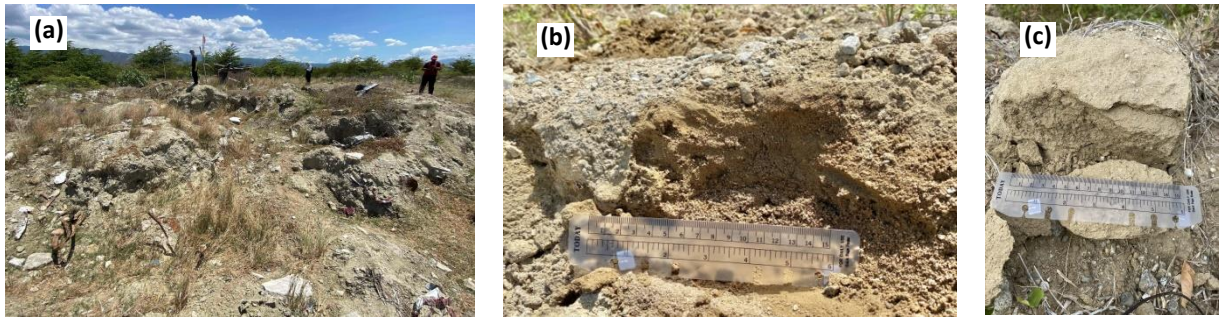
In the middle of the site, our team visited an area where Witness G had indicated big eruptions of sands from the ground during the sliding (Fig. 8). We noticed the ground surface was rugged and piled with sands, suggesting severe liquefaction outflows or eruptions might have occurred during the earthquake shaking. In the southern part, we found an undamaged area (Fig. 7(b)), where houses and people were not hit directly but surrounded by the flowslides.

Fig. 8 a. A site with big eruptions of sands during earthquake based on the interviews with Witnesses G and H. The location was near District Office of Petobo (Kantor Kelurahan Petobo). b, c Exposed sands as evidences of soil liquefaction.

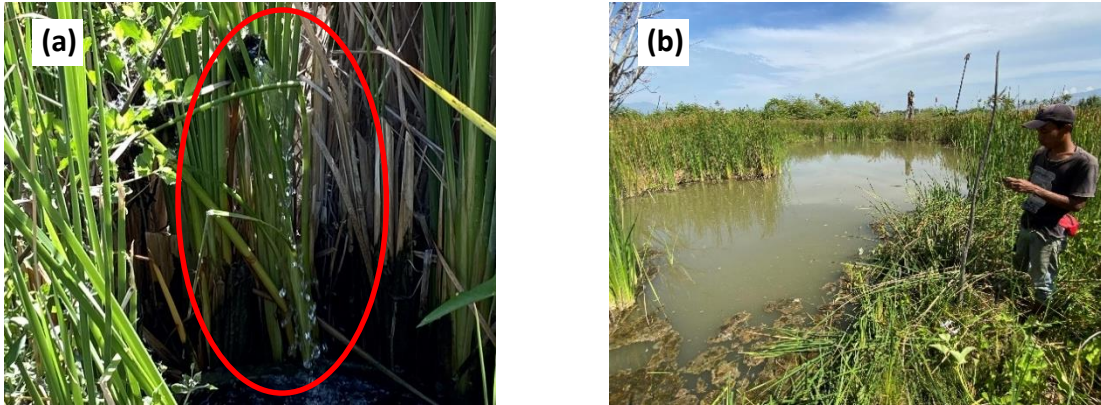
Fig. 11 a The presence of artesian waters in the flowslide area. b A swamp with ponded water in the middle part of the sliding area.

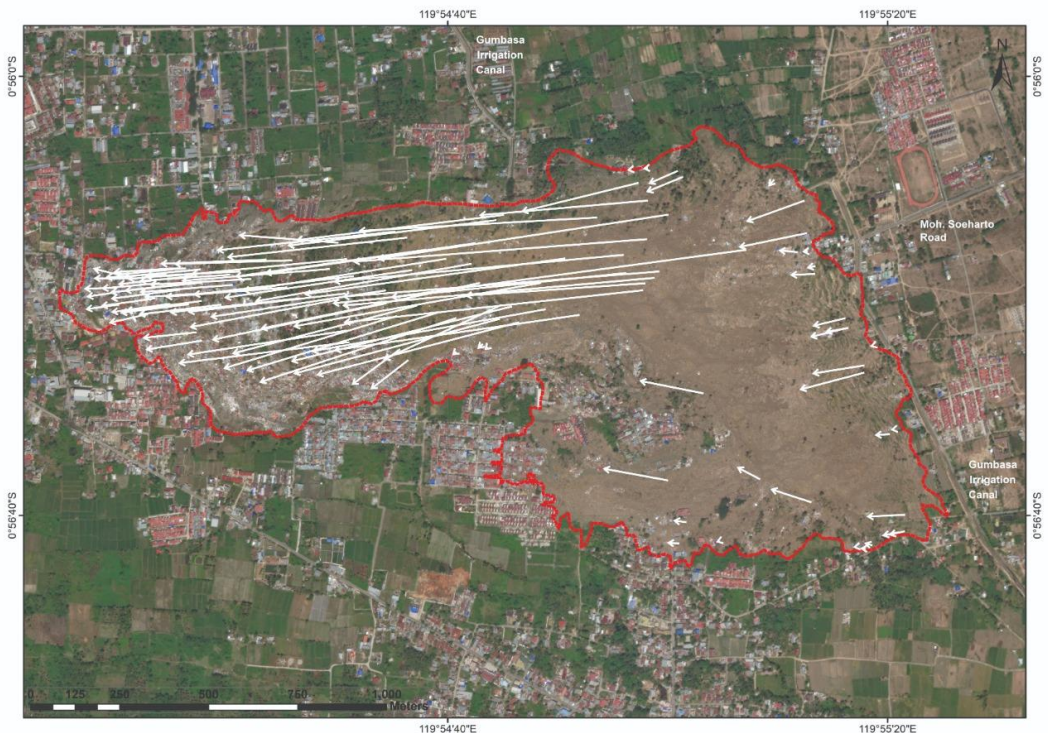
Fig. 12 Displacement vectors of surface objects identified by onsite investigation as well as based on Google Earth satellite images before the after the earthquake. Purple dots are the initial locations and pink dots are the ending positions. The white arrows are the direction of displacements. Base photo is taken from Google Earth satellite image of 2019.05.23.

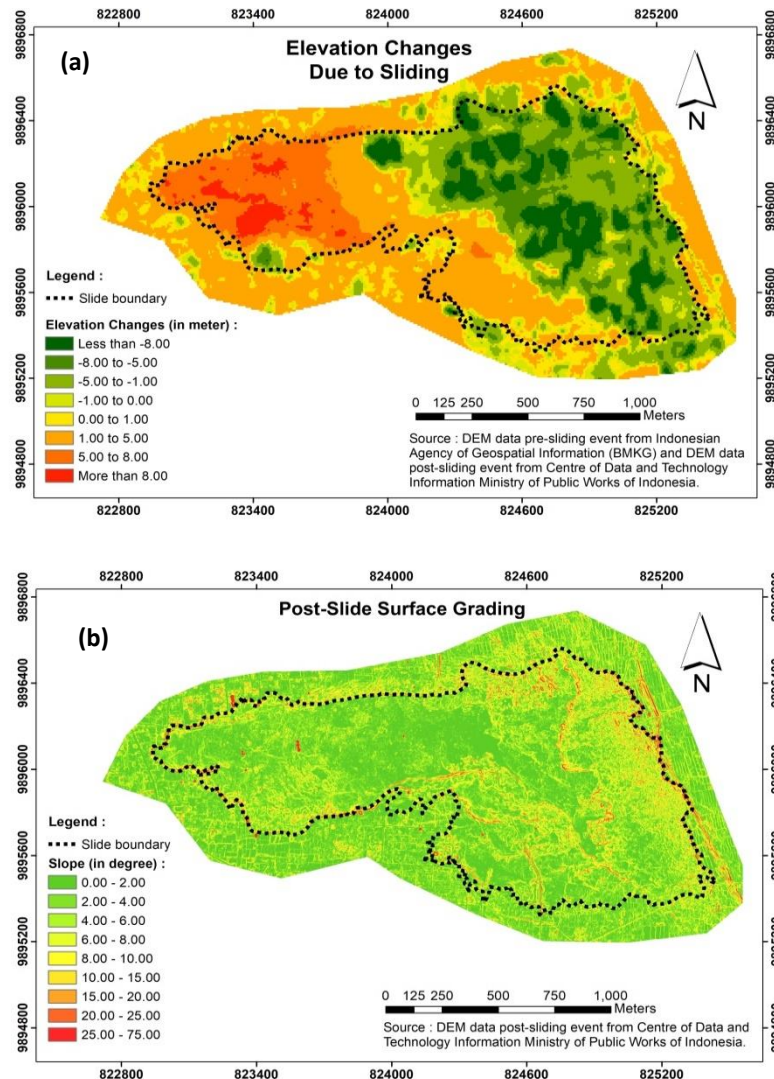
Fig. 13 a The elevation changes due to sliding. b The grading of ground surface after the earthquake. The elevation changes varied approximately between -8 m and 8 m. In the eastern part the elevation dropped down more than 8 m (green color) and in the western part raised

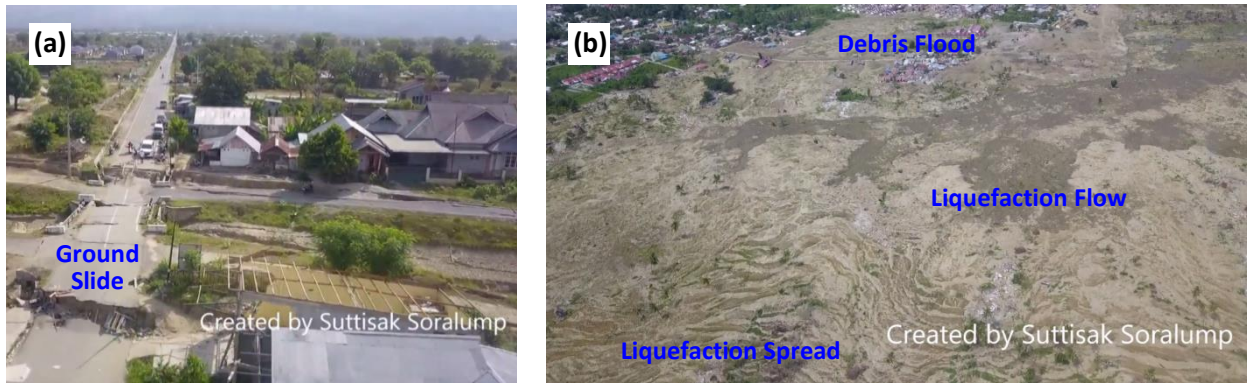
Fig. 18 Morphological features observed from the snapshots of drone videos by Soralump (2018). **a** Photo of the ground slide feature along Moh. Soeharto road to the east boundary of Petobo slide (facing east). **b** Photo of the features of liquefaction spread, liquefaction flow, and debris flood on the south-eastern portion of Petobo slide (facing west).

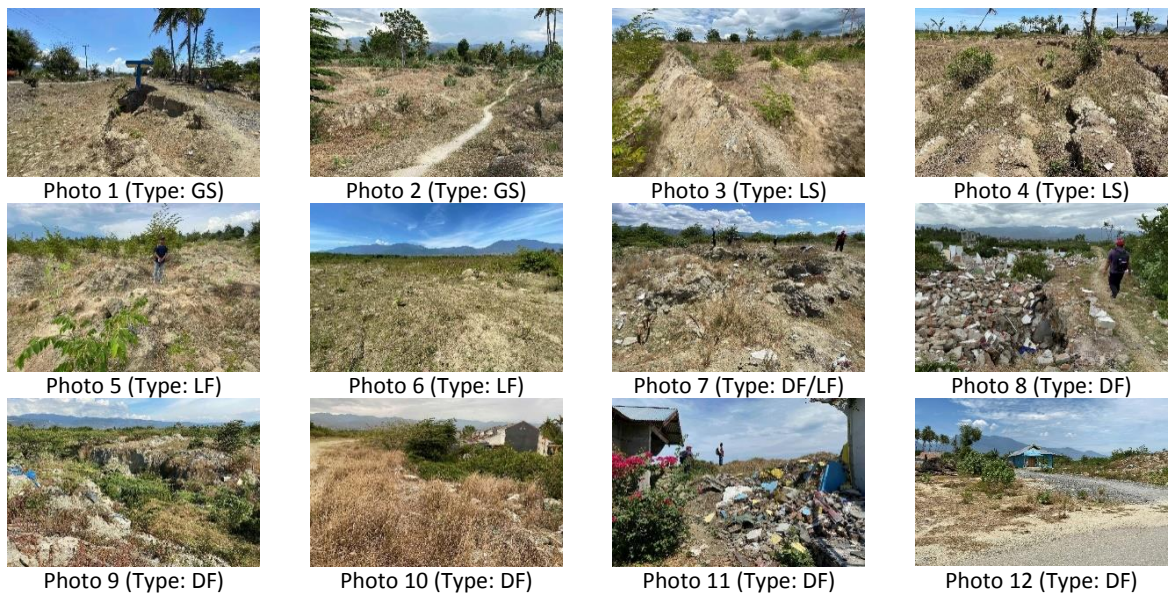
Fig. 20 Photos of associated morphological features identified on Petobo sliding area, with locations indicated on the previous figure of morphological zonation.
