# Onsite Observations of Petobo Liquefaction Area due to 2018.9.28 Palu-Donggala, Indonesia Earthquake

Galih A Prayitno<sup>1,\*</sup>, Muhsiong Chang<sup>2</sup>, Togani C Upomo<sup>3</sup>, Renchung Huang<sup>4</sup>, Rini  
Kusumawardani<sup>5</sup>

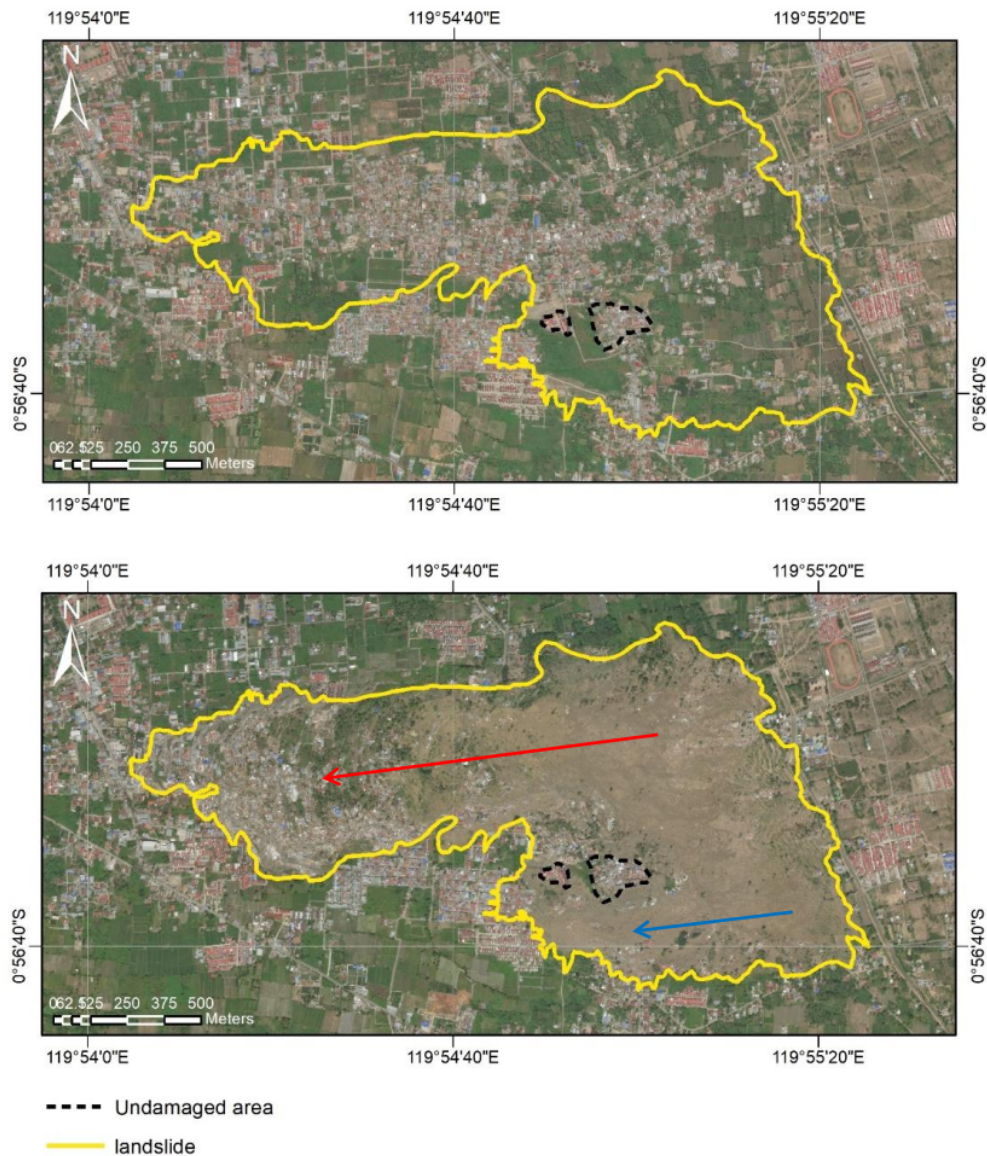
**Fig. 3** Pre-slide and post-slide satellite images of liquefaction-induced landslide in Petobo

Fig. 3 presents the satellite photos captured from Google Earth for the Petobo landslide area in its pre-slide (date picture taken: 18 June 2018) and post-slide (date picture taken: 2 October 2018) time periods. The boundaries of the area affected by landslides are marked with yellow lines. The black dashed lines represent the areas that had not been affected by the landslide, where some houses were not damaged and remained intact.

Approximately 1920 buildings were reported collapsed and affected by the mass movements, with the majority being residential houses (BNPB 2018). Based on the pre-slide image in Fig. 3, the middle and western part of the sliding area were residential with a large number of buildings. Fig. 3 also shown that the eastern portion of the sliding area was primarily paddy fields.

slide in southern part of the area was generally shorter, about 0.5 km or less. In Fig. 3, the red arrow shows general direction of sliding of the northern part, while the blue arrow indicates the direction of sliding of the southern part. Among the landslides triggered by earthquakes, the flow-like long-runout landslides, with large-volume and high-speed, are generally considered most destructive (Huang 2014). The surface grading of the ground before the sliding was very gentle, with an average inclination of 2–3% (Hidayat 2019).

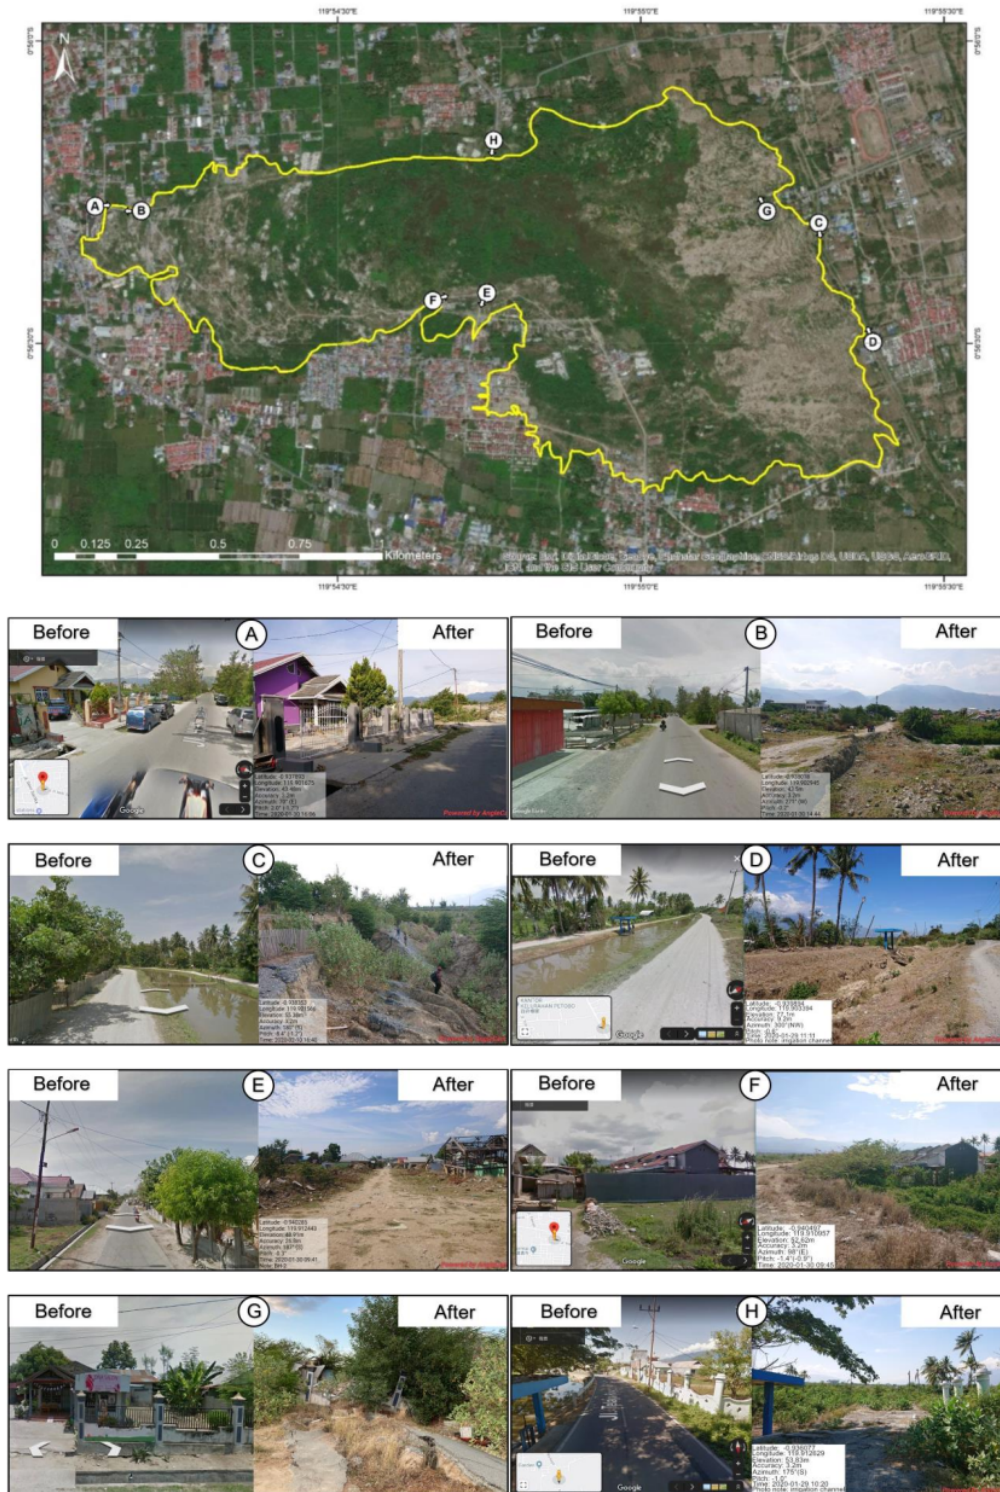
Fig. 4 Location map and photographs of feature before and after earthquake

Figs. 4A and 4B were taken from eastern part of the slide area near the toe. Fig. 4A shows the roads that had been cut off due to the debris. This picture was taken from outside of the boundary line facing to the east direction. It was remarkable that the buildings outside the slide area were merely unaffected. From the opposite side, Fig. 4B was taken facing west direction. It can be seen from the picture that the red building and the road had completely buried by the thick soils deposited after the flow.

The unique feature to the eastern part of Petobo landslide area is the irrigation channel (Gumbasa canal) that bordered the eastern boundary of the site. Figs. 4C and 4D were taken from eastern part of the sliding area. Fig. 4C shows the irrigation channel that had slip away toward downslope direction. Several crack along the irrigation channel in Fig. 4D could be seen and the blue water gate only suffered minor movements. These two pairs of pictures clarified that the water in the irrigation channel had disappeared after the earthquake.

Fig. 4E shows the damage of a road and several building that had already covered by the debris due to the landslide. This road which was originally asphalted has changed into a dust road made by local people after they removed the debris materials. It is one of the access roads used by the local people leading to the landslide area, which is now already covered with vegetation. They also usually bring their livestock (cows and goats) to the landslide area. Fig. 4F shows the ground surface level increased almost as high as half of the building. The houses shown in the photo are no longer inhabited. These two figures were taken in the southern boundary.

Fig. 4G shows a comparison of the pre-slide and post-slide conditions of a house. The fence and the road suffered severe cracks and tilts. Fig. 4H shows a road that lay between the irrigation channel on the left and the Islamic School on the right. The irrigation channel could not be seen with only the blue water gate left in the figure. Some part of the Islamic School buildings in the south had been moved away by the slide further to the west. From the post-slide picture, only portions of the

fence remained in the original place.

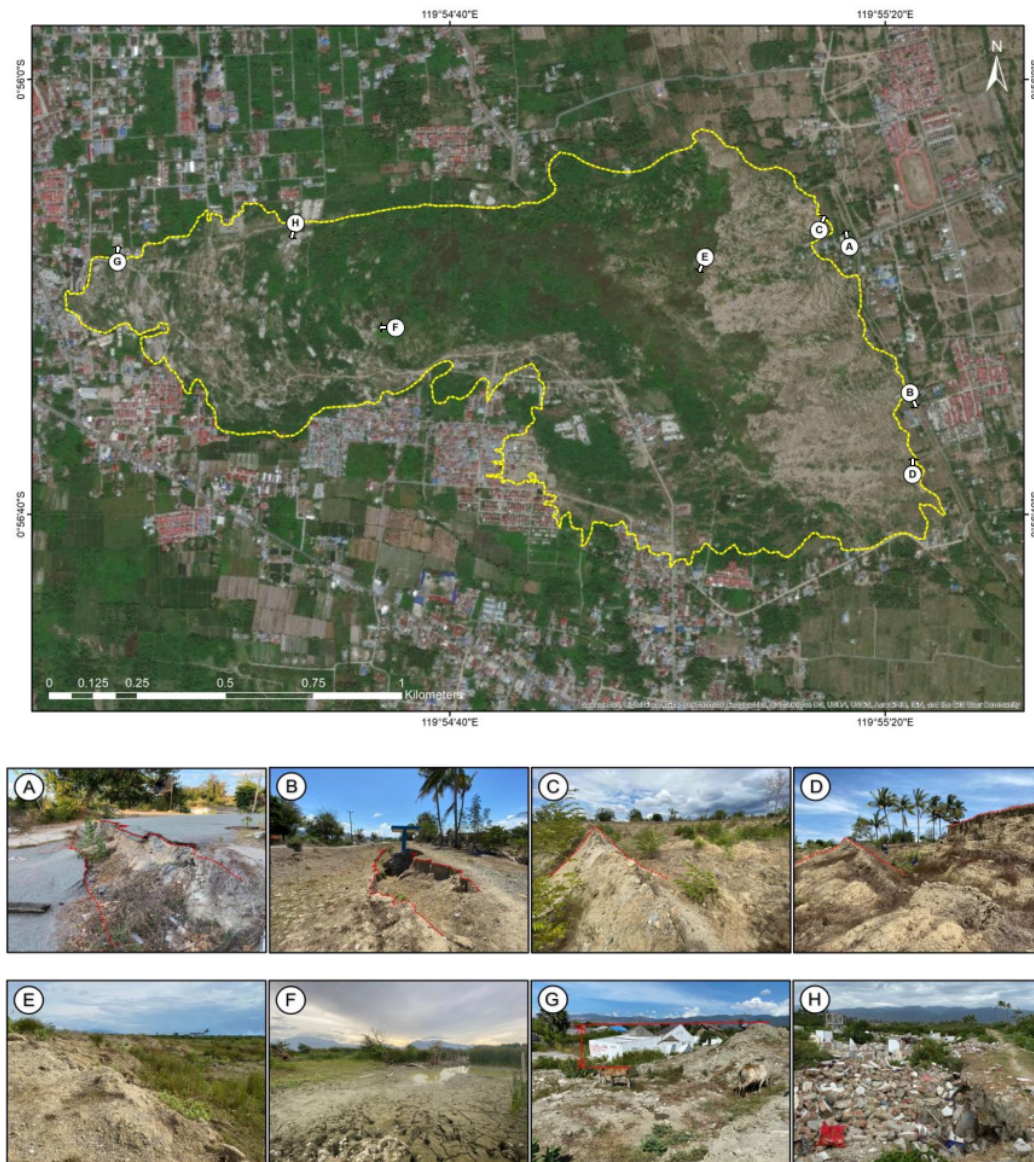
Fig. 5 Morphological features observed at the site

“Ground Slip” is a failure phenomenon caused by slippages in soil materials. Several soil blocks divided by cracks or scraps usually can be observed at the ground surface (Figs. 5A and 5B). Ground slips can be triggered by a sudden increase in ground inertia, such as an earthquake shaking, and/or a drop or loss of a downhill support, such as a slope toe cut. The slip surface practically passes through the intact soil mass which does not liquefy during the ground shaking.

“Lateral Spread” is a failure phenomenon due to cyclic lateral spreading of liquefied soil materials during earthquake shaking. The surface appearance of lateral spreading may include a series of linear fractures or earthen peaks (ridges) with broken and lowered ground sideways (Figs. 5C and 5D). Surface structures can be destroyed, bent, or damaged by cyclic motions and the spreading of liquefied soils. Extruded liquefied sands are found on the ground in areas of cracking and peaking (Fig. 6). Lateral spreads are due to liquefaction of the soil. Due to the cyclical nature of shaking, the liquefied soils move back and forth laterally, leading to a gradual spreading and a decrease in the height of the liquefied mass.

“Liquefaction Flow” is a failure phenomenon due to the monotonic sliding or flowing of fully liquefied earthen materials, which occurs mainly after the earthquake. The ground surface of the liquefaction flows generally uneven and bumpy with extensive exposures of liquefied sands (Figs. 5E and 5F). Structures on the liquefied surface can sink, tilt or flow with sliding over a long distance. Liquefaction flows generally occur in sloping ground in which earthen materials are completely saturated and liquefied due to ground shaking. Due to the gravity and/or additional driving forces from the upper side of the slope, such as by ground slip or lateral spreads, the liquefied soil materials can start flowing downslope right after the ground shaking. The liquefaction flow can be accomplished in stages, depending on the viscosity of the liquefied soil materials, the degree of liquefaction that sliding mass can carry, the geometry of the ground and sliding surface, etc.

ground. Surface manifestations of the debris flow are characterized by the irregular surface of liquefied soil materials and debris, the destroyed existing and transported structures, and the elevated ground surface as opposed to the adjacent areas unaffected by the debris flows, etc. (Figs. 5G and 5H). The causes of debris flow are similar to those of liquefaction flow. When an earthquake is shaking, the soil on the upstream side is completely liquefied, dragged by gravity, and then flowing downward.

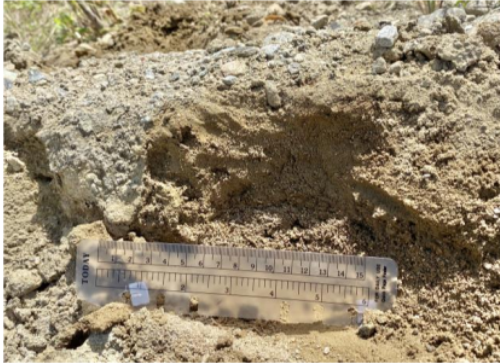
Fig. 6 Extruded sands in areas of lateral spread (LS)
