# Subsurface Study of Flowslide Liquefaction in Petobo, Palu, Indonesia

Togani Cahyadi Upomo, Muhsiong Chang, Rini Kusumawardani,  
Galih Ady Prayitno, Ren-Chung Huang, and Muhammad Hamzah Fansuri

**Abstract** A huge flowslide due to liquefaction occurred at Petobo on September 28, 2018. Many building structures were collapsed, tilted, buried, or moved away up to a distance of 800 m or more. Flowslide occurred at slopes of around  $3^\circ$  and the affected area was approximately 1.64 km<sup>2</sup>. Magnitude and intensity of earthquake shaking, soil and groundwater conditions etc., would have contributed to the phenomena of the flowslide. Drilling, SPT with hammer energy measurements, laboratory testing on grain-size distributions and groundwater monitoring were performed after the incident. This paper discusses subsurface conditions and the assessment of liquefaction susceptibility. The geometry of ground surface was developed based on topographic survey and DTM data. Results show the materials at Petobo site consist primarily of loose silty sands and sandy silts in the middle and the debris flood areas. At the crown, the soils are mostly gravelly sands or sandy gravels. The

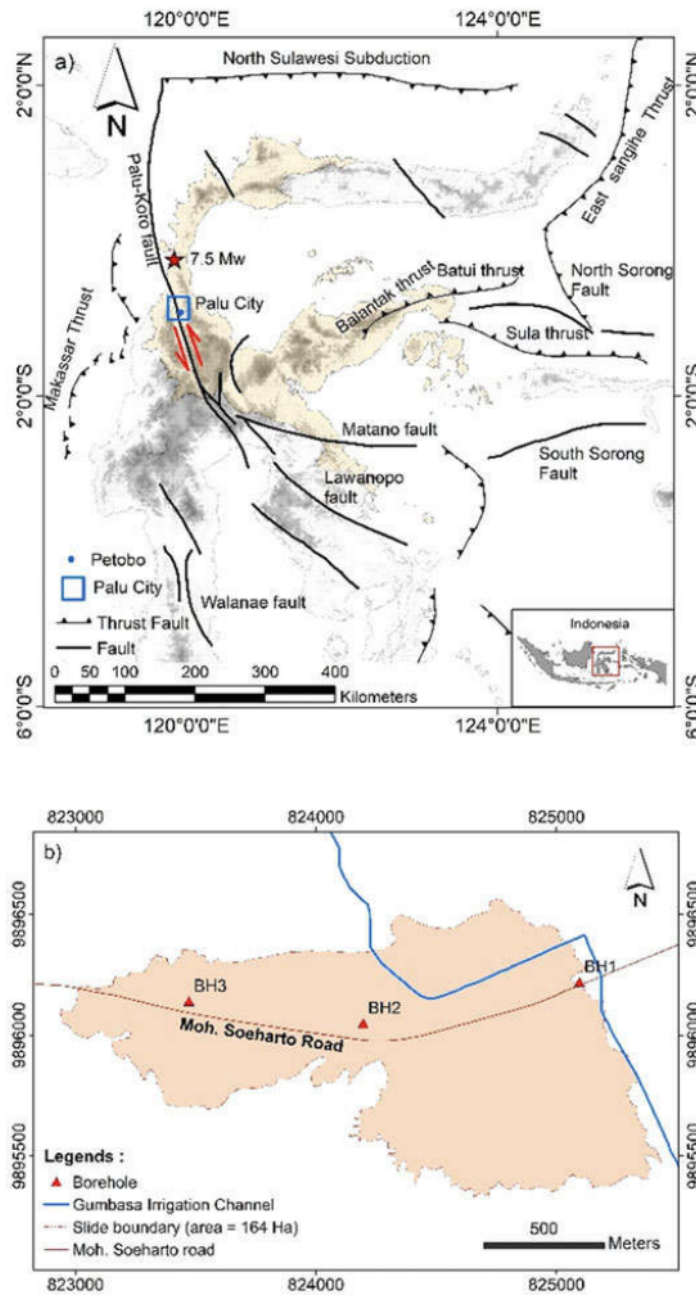
**Fig. 1** a Regional tectonic map in Sulawesi, Indonesia and surrounding taken from [3]. Red star, blue rectangle and blue dot indicate the epicentre of main shock, locations of Palu city and Petobo village, respectively. b Locations of boreholes (BH-1, BH-2, and BH-3) at the Petobo flow slide area

During Palu Donggala earthquake ( $M_w = 7.5$ ) on 28 September 2018, Petobo village, as seen in Fig. 1a, has suffered a dramatic flow slide due to liquefaction [4, 5]. Hundreds of buildings collapsed, tilted, buried, and moved away up to 800 m or more. The flowslide occurred at slopes of around  $3^\circ$ , with affected area of approximately  $1.64 \text{ km}^2$  (Fig. 1b).

For determining subsurface conditions in Petobo, the site characterization activities include three boreholes, SPTs (Standard Penetration Test), and grain-size analyses. Figure 1b shows the study area and borehole locations, which are near the Moh. Soeharto road of the site. SPTs were conducted in the boreholes at a depth interval of 1.5 m. Additionally, grain-size as well as physical indices of soils were tested on the split spoon samples. Groundwater levels were measured weekly subsequently after the drilling.

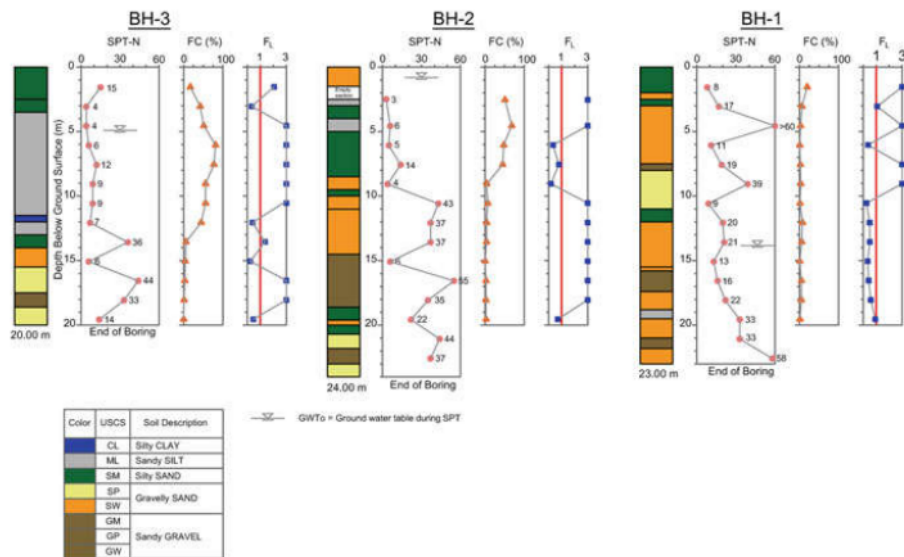
**Fig. 2** SPT blow counts, fine contents and the computed safety factor in the boreholes

The soil layer in BH-1 are dominated by sand and gravel. Loose soils with N values of approximately 8–17 have been found at the top 4 m. Below this level, soils become denser with N values between 7–60. Fines content ranges from 1–20%.

The soil layer in BH-2 consists of silt and sand with fines content range of 40–70% for the top 8.5 m. N values vary from 3–14. The soils below 8.5 m are sand and gravel with N values ranged from 22–55.

At BH-3, debris materials were found at the top 2.5 m. Below the debris materials and down to 13 m deep, soils are dominated by loose to medium dense sand and silt with fines content 42–79%. N values vary from 4–12. The soil stratum below 13 m consists of sand and gravel with N values ranged 6–44.

A comparison of SPT blow counts and fines content shows that fines content appears to have a relationship with the N value. At BH-2 and BH-3 with fines content of > 20%, N values would be less than 10. In contrast, BH-1 has a fines content of < 20% and the N values would be more than 10.

The computed safety factors are shown in Fig. 2. At BH-1, the soils with high liquefaction potential are at 6 and 11–18 m. Soil classifications for these depth

In BH-2, liquefaction is estimated to have occurred at a depth of 6–9 m, with soil classifications of SW and SM. As shown in Fig. 3b, the soils in this depth are almost silt and sand, and below 9 m then become sand and gravel. Based on our surface observations, flow liquefaction occurs in the location near BH-2. The SW and SM layers of the borehole are believed to have liquefied and the depth of about 9 m is speculated as the slip surface of this flowslide.

At BH-3, the safety factor of less than 1 occurs at depths of 12–15 m, with soil types of SM, ML, and SP. Observations on the surface of BH-3 are indicative of transported debris mixed with liquefied soils. By comparison with grading curves as shown in Fig. 3c, most of the soils are susceptible to be liquefied. The debris materials include soils, stones, and construction remains.

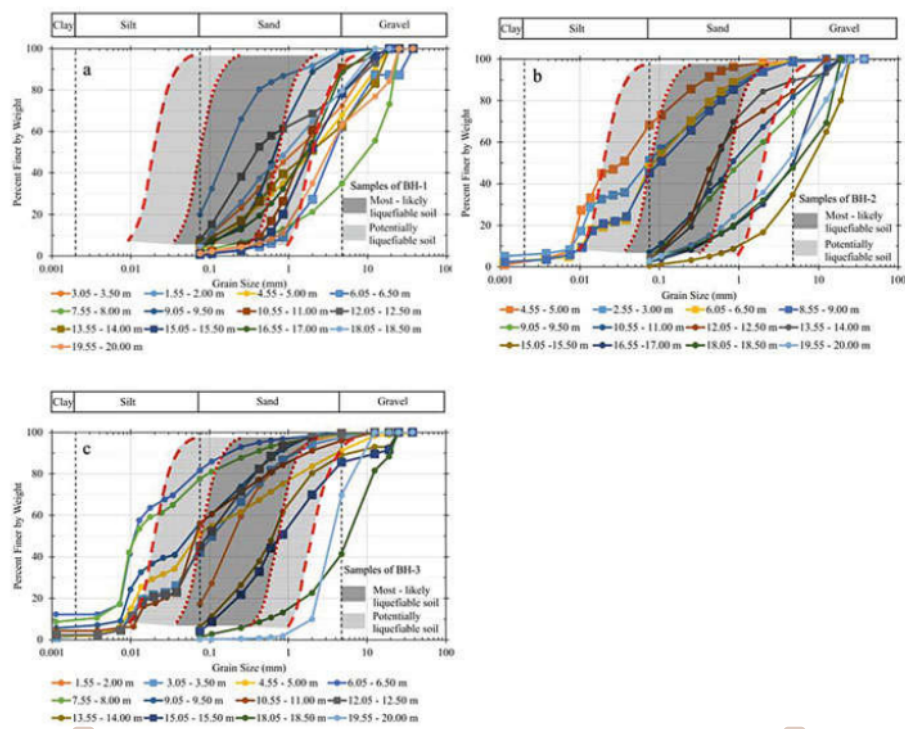
**Fig. 3** Grain-size curves of SPT samples as compared with ranges of most-likely susceptible to liquefaction and potentially susceptible to liquefaction [13]

ranges are SP and SW. The grain-size distributions for samples of BH-1 can be seen in Fig. 3a, indicating the soils in this borehole are almost gravel and sand in size. Our onsite observations in the area around BH-1 did not clearly reveal the symptoms for soil liquefaction. However, numerous cracks and down-dropped ground surface are observable on the surface near to BH-1 area, dividing it into several soil blocks. This phenomenon could be triggered by ground shaking and/or lack of downslope support [14].

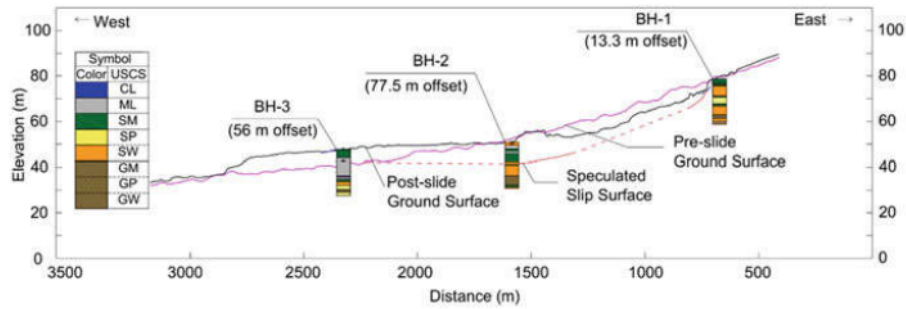
**Fig. 4** Soil profile along Moh. Soeharto road. Bold red line and black line indicate post-slide and pre-slide, respectively

Figure 4 shows the soil profile along Moh. Soeharto road revealed after onsite exploration, as well as a potential slip surface estimated in association with the results of liquefaction assessment. The potential slip surface is speculated to locate with a maximum depth of approximately 13 or 10 m, respectively, below the pre-slide or post-slide ground surface.
