Fifth International Conference on New Developments
in Soil Mechanics and Geotechnical Engineering

Subsurface Study of Flowslide Liquefaction in Petobo, Palu, Indonesia

Togani Cahyadi Upomo, Muhsiung Chang, Rini Kusumawardani,
Galih Ady Prayitno, Ren-Chung Huang, and Muhammad Hamzah Fansuri

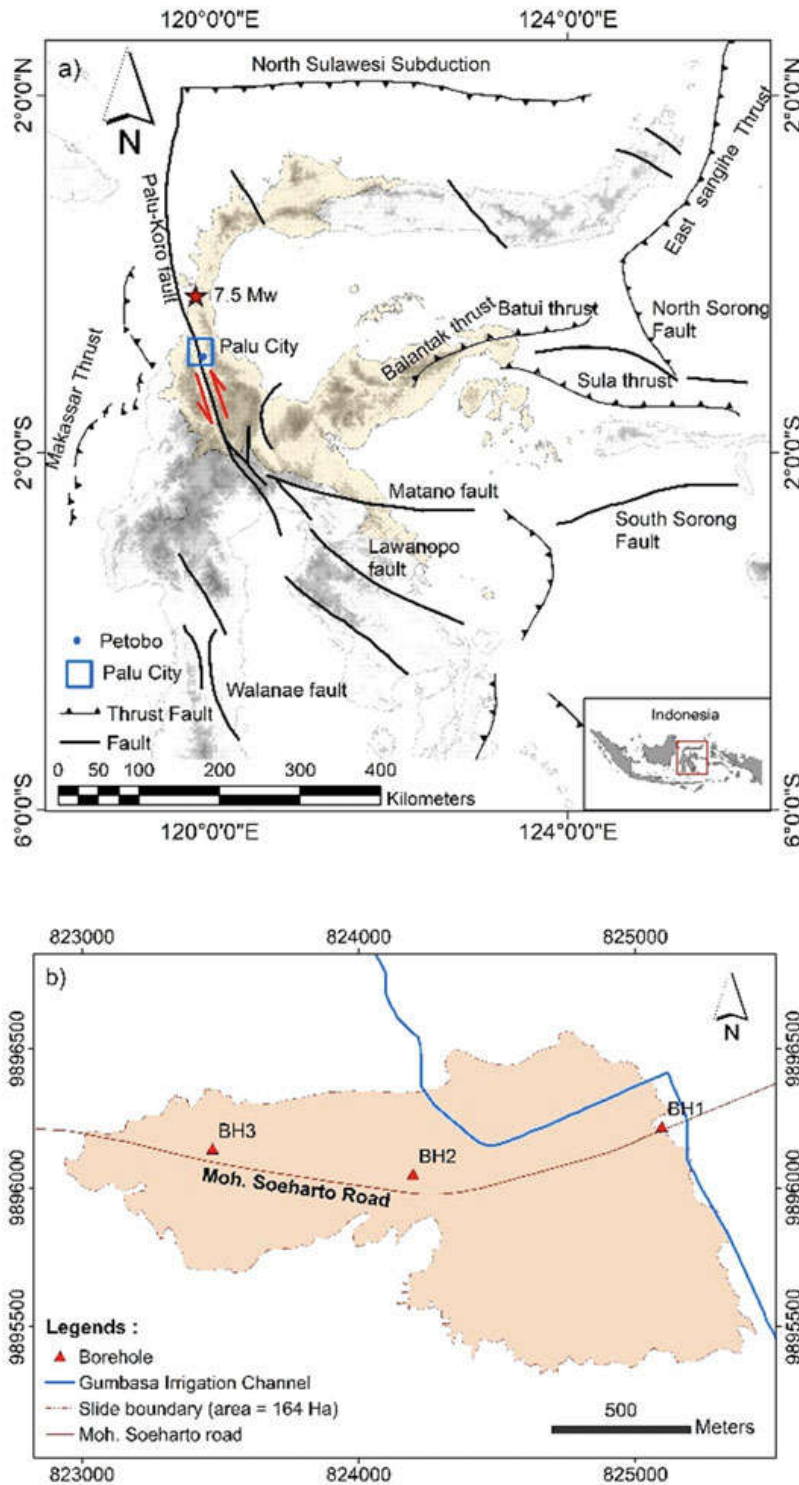
During Palu Donggala earthquake ($M_w = 7.5$) on 28 September 2018, Petobo village, as seen in Fig. 1a, has suffered a dramatic flow slide due to liquefaction [4, 5]. Hundreds of buildings collapsed, tilted, buried, and moved away up to 800 m or more. The flowslide occurred at slopes of around 3° , with affected area of approximately 1.64 km^2 (Fig. 1b).

For determining subsurface conditions in Petobo, the site characterization activities include three boreholes, SPTs (Standard Penetration Test), and grain-size analyses. Figure 1b shows the study area and borehole locations, which are near the Moh. Soeharto road of the site. SPTs were conducted in the boreholes at a depth interval of 1.5 m. Additionally, grain-size as well as physical indices of soils were tested on the split spoon samples. Groundwater levels were measured weekly subsequently after the drilling.

Fig. 1 **a** Regional tectonic map in Sulawesi, Indonesia and surrounding taken from [3]. Red star, blue rectangle and blue dot indicate the epicentre of main shock, locations of Palu city and Petobo village, respectively. **b** Locations of boreholes (BH-1, BH-2, and BH-3) at the Petobo flow slide area

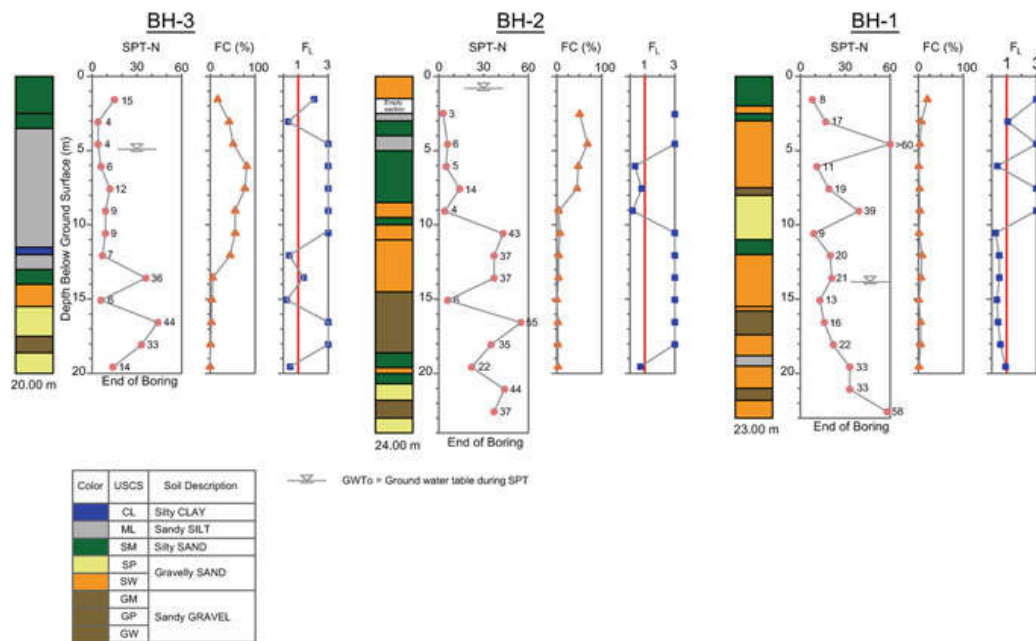
Fig. 2 SPT blow counts, fine contents and the computed safety factor in the boreholes

The soil layer in BH-1 are dominated by sand and gravel. Loose soils with N values of approximately 8–17 have been found at the top 4 m. Below this level, soils become denser with N values between 7–60. Fines content ranges from 1–20%.

The soil layer in BH-2 consists of silt and sand with fines content range of 40–70% for the top 8.5 m. N values vary from 3–14. The soils below 8.5 m are sand and gravel with N values ranged from 22–55.

At BH-3, debris materials were found at the top 2.5 m. Below the debris materials and down to 13 m deep, soils are dominated by loose to medium dense sand and silt with fines content 42–79%. N values vary from 4–12. The soil stratum below 13 m consists of sand and gravel with N values ranged 6–44.

A comparison of SPT blow counts and fines content shows that fines content appears to have a relationship with the N value. At BH-2 and BH-3 with fines content of > 20%, N values would be less than 10. In contrast, BH-1 has a fines content of < 20% and the N values would be more than 10.

The computed safety factors are shown in Fig. 2. At BH-1, the soils with high liquefaction potential are at 6 and 11–18 m. Soil classifications for these depth

In BH-2, liquefaction is estimated to have occurred at a depth of 6–9 m, with soil classifications of SW and SM. As shown in Fig. 3b, the soils in this depth are almost silt and sand, and below 9 m then become sand and gravel. Based on our surface observations, flow liquefaction occurs in the location near BH-2. The SW and SM layers of the borehole are believed to have liquefied and the depth of about 9 m is speculated as the slip surface of this flowslide.

At BH-3, the safety factor of less than 1 occurs at depths of 12–15 m, with soil types of SM, ML, and SP. Observations on the surface of BH-3 are indicative of transported debris mixed with liquefied soils. By comparison with grading curves as shown in Fig. 3c, most of the soils are susceptible to be liquefied. The debris materials include soils, stones, and construction remains.

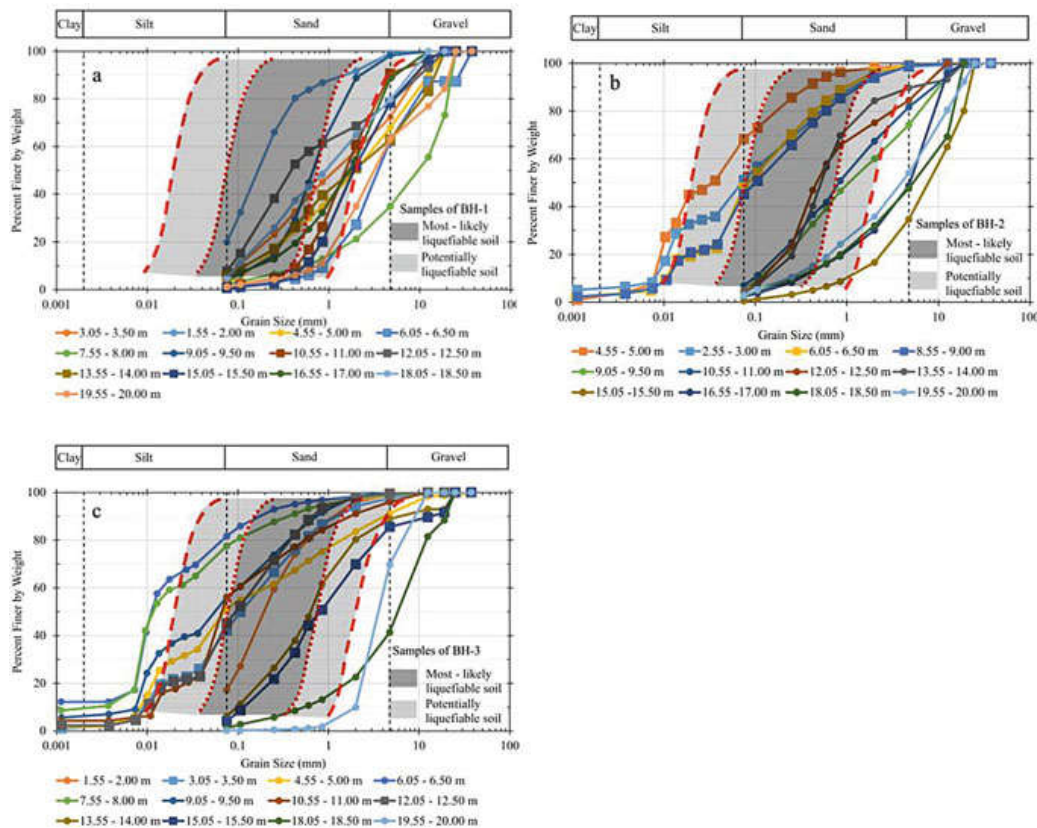
ranges are SP and SW. The grain-size distributions for samples of BH-1 can be seen in Fig. 3a, indicating the soils in this borehole are almost gravel and sand in size. Our onsite observations in the area around BH-1 did not clearly reveal the symptoms for soil liquefaction. However, numerous cracks and down-dropped ground surface are observable on the surface near to BH-1 area, dividing it into several soil blocks. This phenomenon could be triggered by ground shaking and/or lack of downslope support [14].

Fig. 3 Grain-size curves of SPT samples as compared with ranges of most-likely susceptible to liquefaction and potentially susceptible to liquefaction [13]

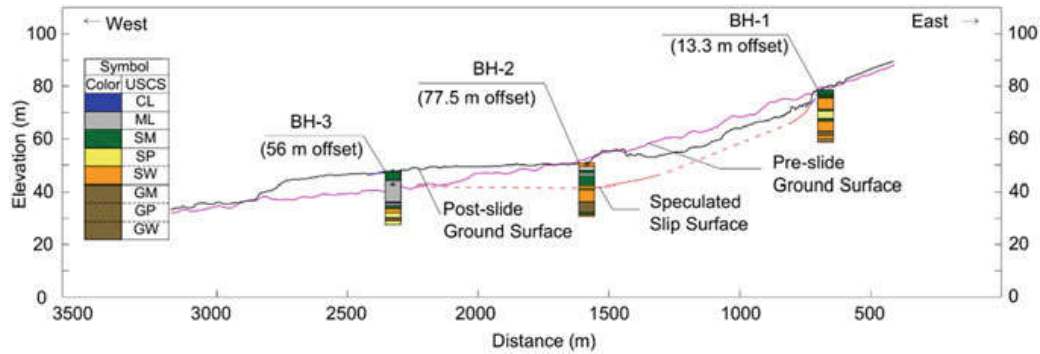
Fig. 4 Soil profile along Moh. Soeharto road. Bold red line and black line indicate post-slide and pre-slide, respectively

Figure 4 shows the soil profile along Moh. Soeharto road revealed after onsite exploration, as well as a potential slip surface estimated in association with the results of liquefaction assessment. The potential slip surface is speculated to locate with a maximum depth of approximately 13 or 10 m, respectively, below the pre-slide or post-slide ground surface.
