A retrospective view on liquefaction-induced flowslide and lessons learned - an example of Petobo failure incident during 2018 Palu-Donggala Indonesia earthquake

M. Chang¹, T.C. Upomo², R. Kusumawardani³, G.A. Prayitno⁴, N.M. Ermansyah⁵, and C.J. Yang⁵

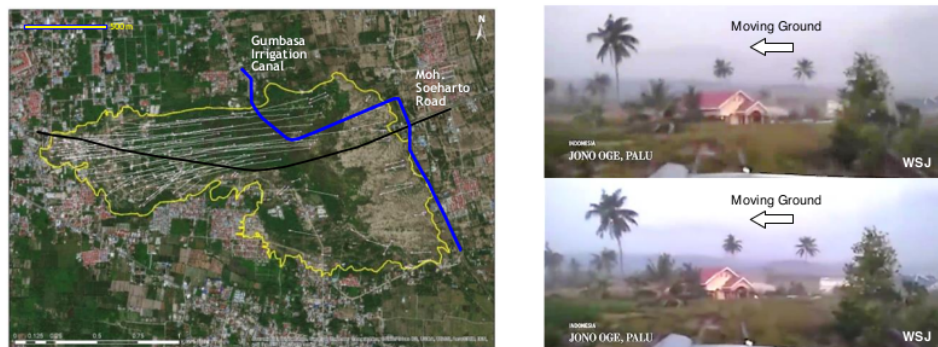
Figure 1. (a) Displacement vectors of the 2018 Petobo slide (left; Kusumawardani et al., 2021). (b) Snapshots of moving ground from the videos taken at Jono Oge (right; WSJ, 2018).

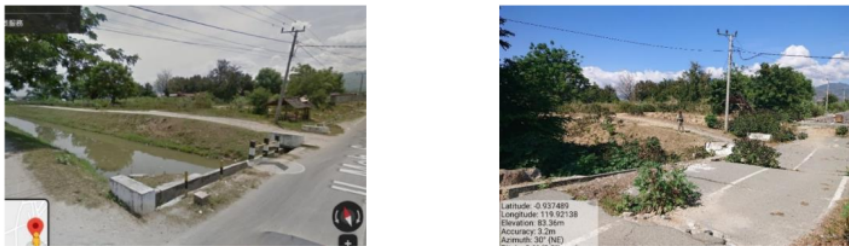
Figure 2. Gumbasa canal at the crest of Petobo slide footprint, before (left) and after (right) the 2018 earthquake (Kusumawardani et al., 2021).

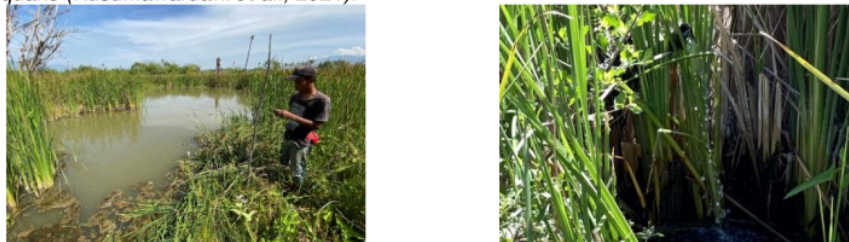
Ample evidences had revealed ponds, springs and sand boils were extensive near the toe and crest of sliding area soon after the failure (GEER, 2019; Kiyota et al., 2020). Based on our site reconnaissance and witness interviews in 02/2020, victims reported water with sands erupted from the ground during the sliding, and then ponded the softened surface after the slide (Kusumawardani et al., 2021). The phenomena might have been due to the originally high groundwater levels of the area and the pore water being squeezed out of the liquefied ground. Local victims also indicated the constantly-full unlined Gumbasa canal and its irrigation system, as well as the extensive wet-paddy fields that were filled with irrigation water, during Feb-May and Aug-Nov of the year (Kusumawardani et al., 2021); suggesting the groundwater levels prior to the 2018 slide should have been very close to the ground surface.

Figure 3. Surface ponding (left) and artesian waters (right) in the middle of Petobo slide footprint during 02/2020 site reconnaissance (Kusumawardani et al., 2021).

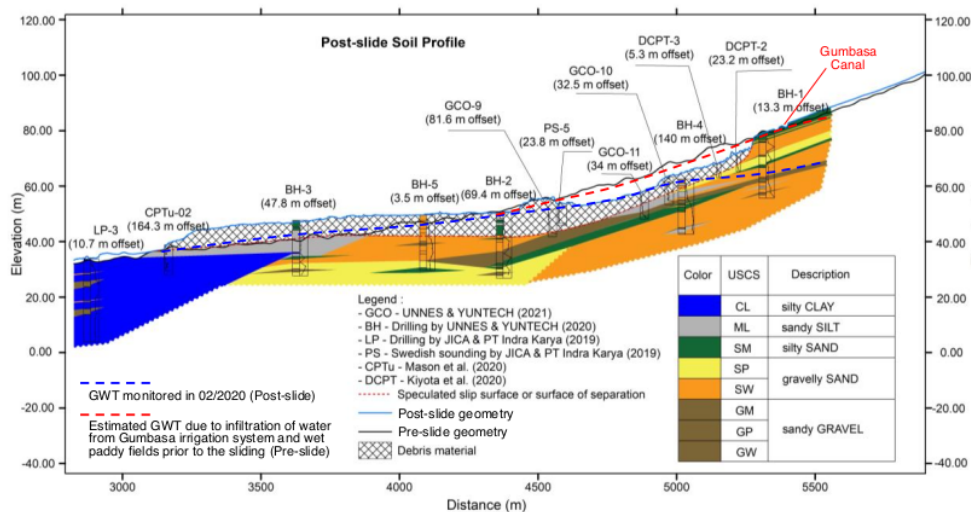
We also carried out subsurface exploration, geo-resistivity surveying, and groundwater monitoring along the EW main road (Moh. Soeharto Rd.; location shown in Figure 1) of the Petobo area, and results are summarized in Figure 4. The post-slide investigations indicated the groundwater level in the upper portion near the sliding crest had substantially dropped by 10~15m, as compared with its pre-slide situation. In the mid-upper portion, the groundwater level was close to its post-slide surface; while in the mid-lower portion, the groundwater level was approximately parallel to the pre-slide geometry.

Figure 4. Post-slide material profile along EW cross-section (Moh. Soeharto Rd.) of Petobo area with monitored / estimated groundwater tables (GWTs), respectively, after / before the 2018 earthquake.

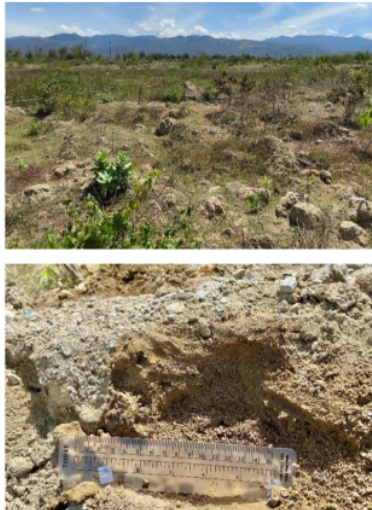
Our site reconnaissance revealed widespread liquefied soils on the surface of upper and middle portions of the sliding area. As shown in Figure 5, the exposed liquefied soils on surface were generally fine to medium sands, with inclusions of some earthen chunks or gravels which might have been carried and drifted by the flowslide. Based on results of borehole logging and geo-resistivity surveying, as shown in Figures 4 & 6, the shallower material profile along the EW cross-section of Petobo area could approximately be divided into three portions. In the upper portion of the sliding area, the earthen materials are generally gravelly sands or sandy gravels. The middle portion consists of mostly silty sands; while the lower portion comprises silty sands, sandy silts and silty clays. Laboratory classification tests, as illustrated in Figure 7, also indicate the grain-size distributions of soils within sliding mass fall in the range of liquefiable zone. It is certain that the in-situ soils are prone to liquefaction.

Figure 5. Wide-spread liquefied soils on the surface of Petobo slide: (up) general view, (down) close view; during 02/2020 site reconnaissance (Kusumawardani et al., 2021).

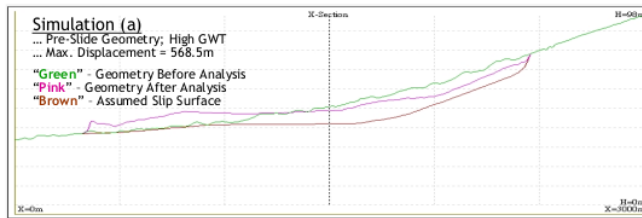
Figure 11 indicates the results of Simulation (a) for the conditions of Petobo slope at the time of 2018 earthquake. The slope was in its pre-slide geometry and the groundwater table was high as due to a constant infiltration of water from Gumbasa irrigation system and wet paddies on upper portion of the slope. As illustrated by the "Red" dashed line of Figure 4, the high groundwater table was expected to be close to the pre-slide surface of the slope. As shown in Figure 11, results of the simulation clearly demonstrate a significant slide by the 2018 shaking, with a total displacement of the slope up to 569m; which is in resemblance to the post-slide slope geometry of the EW cross-section.

As for the details of sliding process of the simulation, the slide initiates at approximately 3 seconds after the shaking start, and then keeps sliding for around 223 seconds (3.72 minutes) before ceasing. Maximum speed during the course of sliding is 18.3 m/s and the average sliding speed is around 7 m/s (25 Km/h). This simulation validates the Petobo slope would be failing and sliding for distance when all of the conditions are met, including liquefiable soils, high groundwater levels, strong shaking, and the inclined ground that provides sufficient driving forces.

Figure 11. Verification of Petobo sliding subjected to 2018.9.28 Palu-Donggala earthquake shaking; Simulation (a) - EW cross-section (Moh. Soeharto Rd.), pre-slide geometry, high groundwater table.

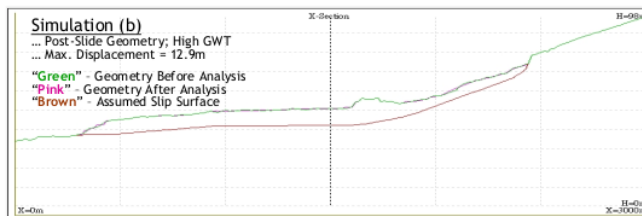
Figure 12 shows the results of Simulation (b), for the case of post-slide geometry of the Petobo slope right after sliding, and then subjected to a second strike of the same earthquake. It would be of interest to know if the post-slide slope geometry, which has become much flatter than its pre-slide one, would still be able to provide sufficient static/driving shears and re-trigger a slide in the slope. The simulation is performed under a condition of high groundwater table since the timing considered is for the “right after pre-slide”, where the groundwater level is close to the post-slide surface.

Results of the simulation apparently show the much flatter post-slide geometry would not be able to restart a significant flowsliding in the slope, even if the groundwater table remains high, the slope mass is still liquefied, and the same earthquake is striking at the slope. Details of the simulation also show a slight movement of the slope is noticed at about 3 seconds after the shaking start. The movements last for 56 seconds (<1 minute) then cease, ending up a total displacement of around 13m, which is very small as compared with the length of slope of more than 2000m.

Figure 12. Verification on the potential of re-initiation of sliding in the failed (flatten) slope subjected to the second striking of the same earthquake; Simulation (b) - EW cross-section (Moh. Soeharto Rd.), post-slide geometry, high groundwater table.

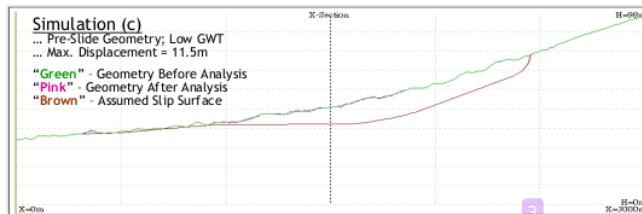
Figure 13 illustrates the results of Simulation (c), an assumed case of low groundwater table prior to the 2018 shaking, as a result of no water infiltration by Gumbasa irrigation system and wet-paddy fields. This simulation would like to focus on the influence of localized-raised groundwater level due to human activities on the potential of soil liquefaction and flowsliding of the slope. As seen in Figure 4, the groundwater table is expected to have raised by 0~15m in the upper portion of the slope, as a result of the irrigation system and wet paddies, prior to the 2018 earthquake. It would be of interest to see If without

The simulation is conducted with a low groundwater condition as observed in the 02/2020 investigation and a pre-slide slope geometry of EW cross-section of Petobo area. The Balaroa EW record of the 2018 earthquake, as mentioned previously, is adopted as the input motion for the simulation. As shown in Figure 13, results of the simulation indicate no major liquefaction or flowsliding in the slope is likely. The computed overall displacement of the slope is around 12m, very small as compared with the slope length. The slope movement occurs within the beginning 20 seconds of the shaking and then no further deformation is noticed. This simulation, associated with [Simulation \(a\)](#), clearly demonstrate the importance of the localized-raised groundwater table, as a result of human activities, would have a detrimental effect on the stability of slopes.

Figure 13. Verification on the potential of sliding of Petobo slope if no infiltration of water from Gumbasa irrigation system and wet paddy fields; Simulation (c) - EW cross-section (Moh. Soeharto Rd.), pre-slide geometry, low groundwater table.
