**9th International Congress on
Environmental Geotechnics**

A retrospective view on liquefaction-induced flowslide and lessons learned - an example of Petobo failure incident during 2018 Palu-Donggala Indonesia earthquake

M. Chang¹, T.C. Upomo², R. Kusumawardani³, G.A. Prayitno⁴, N.M. Ermansyah⁵, and C.J. Yang⁵

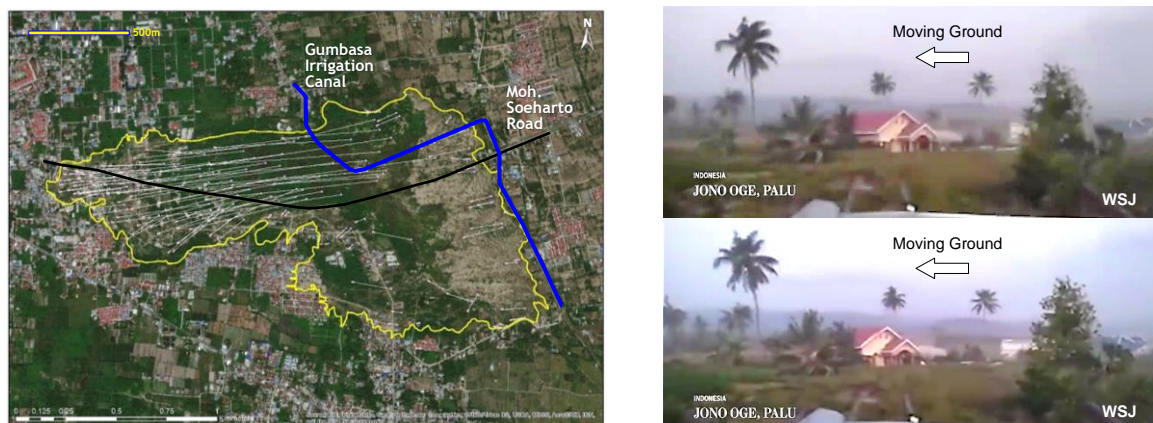
Four major landslides occurred in the areas of Balaroa, Petobo, Jono Oge, and South Sibalaya of Palu valley, with distances approximately 3~30Km south of the bay, or 65~90Km from the epicenter of the earthquake. All of these landslides were triggered by soil liquefaction during the shaking and resulted in long-distance sliding of ground of several hundreds of meters. The Petobo sliding, as shown in Figure 1(a), was the most severe one in terms of its casualty, damage and sliding distance (>1,000m). Figure 1(b) illustrates the moving ground during the course of sliding in Jono Oge area, as indicated by relative movements of the houses and the nearby trees.

Figure 1. (a) Displacement vectors of the 2018 Petobo slide (left; Kusumawardani et al., 2021). (b) Snapshots of moving ground from the videos taken at Jono Oge (right; WSJ, 2018).

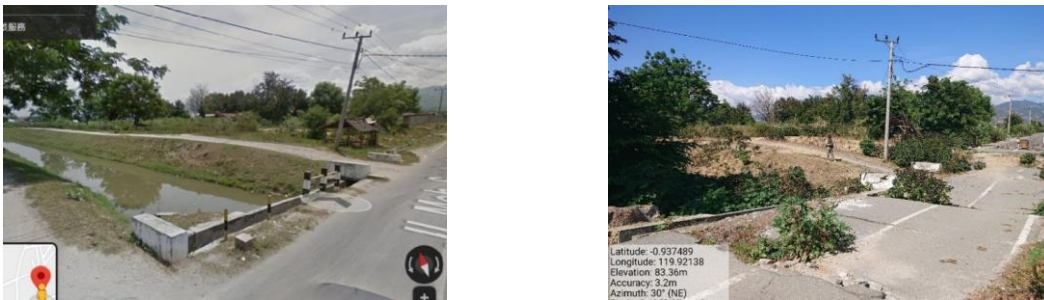
These findings would suggest a close relationship of the landslides with the unlined Gumbasa canal and the widespread wet paddy fields. Constant infiltrations of water through the unlined irrigation system and wet paddies would probably have had saturated the ground and hence raised the local groundwater table of the site. In addition, the mildly sloping surface that provided static (driving) shears would probably have had triggered the movement once the ground was liquefied by the shaking. While these arguments seem to be plausible, more precise verifications would be warranted to assure the causes and mechanism of the sliding; and hence the associated results will be addressed below.

Figure 2. Gumbasa canal at the crest of Petobo slide footprint, before (left) and after (right) the 2018 earthquake (Kusumawardani et al., 2021).

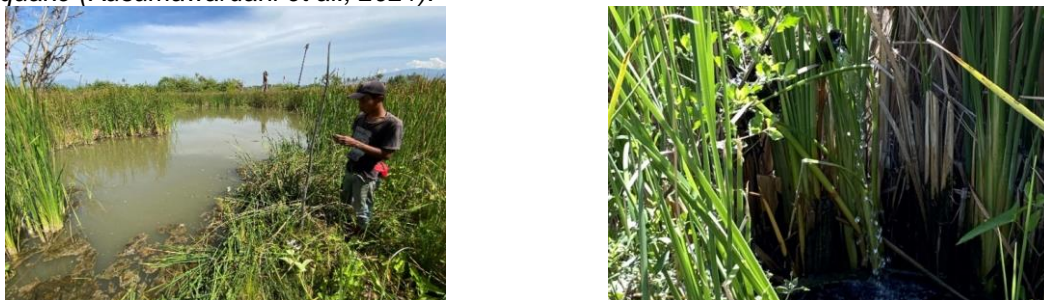
Ample evidences had revealed ponds, springs and sand boils were extensive near the toe and crest of sliding area soon after the failure (GEER, 2019; Kiyota et al., 2020). Based on our site reconnaissance and witness interviews in 02/2020, victims reported water with sands erupted from the ground during the sliding, and then ponded the softened surface after the slide (Kusumawardani et al., 2021). The phenomena might have been due to the originally high groundwater levels of the area and the pore water being squeezed out of the liquefied ground. Local victims also indicated the constantly-full unlined Gumbasa canal and its irrigation system, as well as the extensive wet-paddy fields that were filled with irrigation water, during Feb-May and Aug-Nov of the year (Kusumawardani et al., 2021); suggesting the groundwater levels prior to the 2018 slide should have been very close to the ground surface.

Figure 3. Surface ponding (left) and artesian waters (right) in the middle of Petobo slide footprint during 02/2020 site reconnaissance (Kusumawardani et al., 2021).

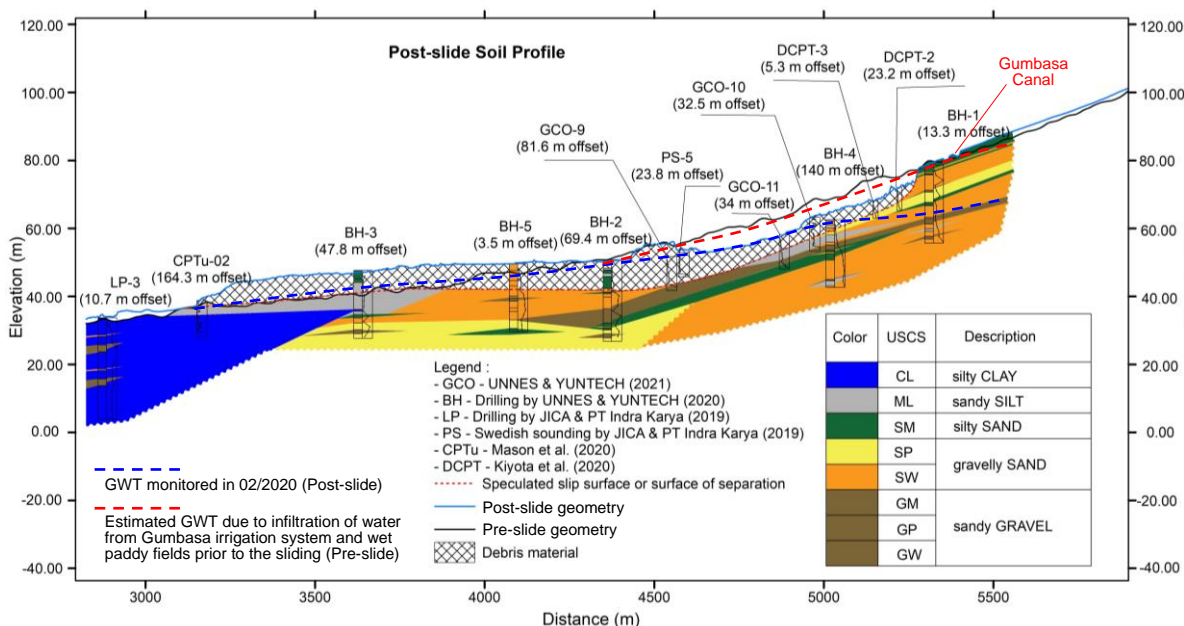
We also carried out subsurface exploration, geo-resistivity surveying, and groundwater monitoring along the EW main road (Moh. Soeharto Rd.; location shown in Figure 1) of the Petobo area, and results are summarized in Figure 4. The post-slide investigations indicated the groundwater level in the upper portion near the sliding crest had substantially dropped by 10~15m, as compared with its pre-slide situation. In the mid-upper portion, the groundwater level was close to its post-slide surface; while in the mid-lower portion, the groundwater level was approximately parallel to the pre-slide geometry.

Figure 4. Post-slide material profile along EW cross-section (Moh. Soeharto Rd.) of Petobo area with monitored / estimated groundwater tables (GWTs), respectively, after / before the 2018 earthquake.

In accordance, the evidences observed soon after the failure by other parties, as well as the additional information obtained during our investigation of 02/2022 suggest the original groundwater table in the upper portion of slide footprint had been substantially raised prior to the earthquake shaking, as shown by “Blue” and “Red” dashed lines in Figure 4, which appeared to be the results of constant infiltration of water by Gumbasa irrigation system and wet paddy fields of the area.

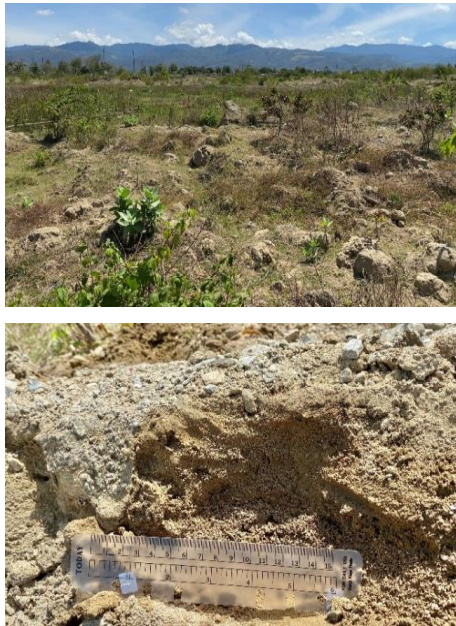
Our site reconnaissance revealed widespread liquefied soils on the surface of upper and middle portions of the sliding area. As shown in Figure 5, the exposed liquefied soils on surface were generally fine to medium sands, with inclusions of some earthen chunks or gravels which might have been carried and drifted by the flowslide. Based on results of borehole logging and geo-resistivity surveying, as shown in Figures 4 & 6, the shallower material profile along the EW cross-section of Petobo area could approximately be divided into three portions. In the upper portion of the sliding area, the earthen materials are generally gravelly sands or sandy gravels. The middle portion consists of mostly silty sands; while the lower portion comprises silty sands, sandy silts and silty clays. Laboratory classification tests, as illustrated in Figure 7, also indicate the grain-size distributions of soils within sliding mass fall in the range of liquefiable zone. It is certain that the in-situ soils are prone to liquefaction.

Figure 5. Wide-spread liquefied soils on the surface of Petobo slide: (up) general view, (down) close view; during 02/2020 site reconnaissance (Kusumawardani et al., 2021).

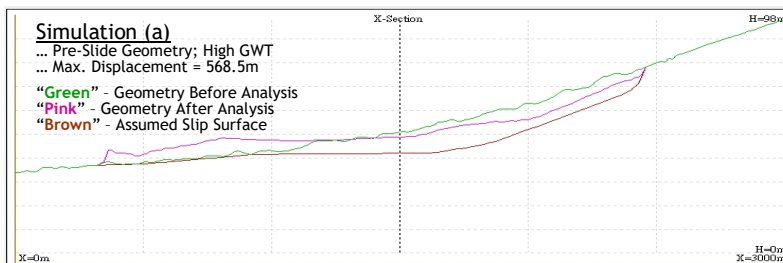
Figure 11 indicates the results of Simulation (a) for the conditions of Petobo slope at the time of 2018 earthquake. The slope was in its pre-slide geometry and the groundwater table was high as due to a constant infiltration of water from Gumbasa irrigation system and wet paddies on upper portion of the slope. As illustrated by the "Red" dashed line of Figure 4, the high groundwater table was expected to be close to the pre-slide surface of the slope. As shown in Figure 11, results of the simulation clearly demonstrate a significant slide by the 2018 shaking, with a total displacement of the slope up to 569m; which is in resemblance to the post-slide slope geometry of the EW cross-section.

As for the details of sliding process of the simulation, the slide initiates at approximately 3 seconds after the shaking start, and then keeps sliding for around 223 seconds (3.72 minutes) before ceasing. Maximum speed during the course of sliding is 18.3 m/s and the average sliding speed is around 7 m/s (25 Km/h). This simulation validates the Petobo slope would be failing and sliding for distance when all of the conditions are met, including liquefiable soils, high groundwater levels, strong shaking, and the inclined ground that provides sufficient driving forces.

Figure 11. Verification of Petobo sliding subjected to 2018.9.28 Palu-Donggala earthquake shaking; Simulation (a) - EW cross-section (Moh. Soeharto Rd.), pre-slide geometry, high groundwater table.

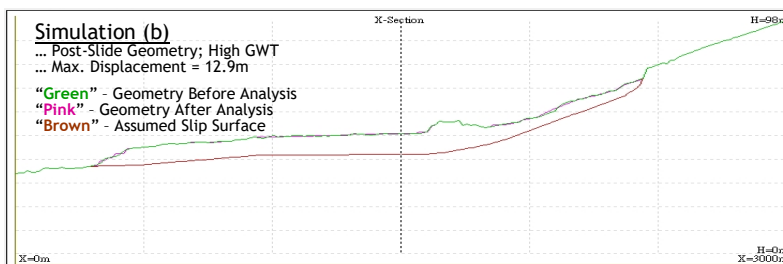
Figure 12 shows the results of Simulation (b), for the case of post-slide geometry of the Petobo slope right after sliding, and then subjected to a second strike of the same earthquake. It would be of interest to know if the post-slide slope geometry, which has become much flatter than its pre-slide one, would still be able to provide sufficient static/driving shears and re-trigger a slide in the slope. The simulation is performed under a condition of high groundwater table since the timing considered is for the “right after pre-slide”, where the groundwater level is close to the post-slide surface.

Results of the simulation apparently show the much flatter post-slide geometry would not be able to restart a significant flowsliding in the slope, even if the groundwater table remains high, the slope mass is still liquefied, and the same earthquake is striking at the slope. Details of the simulation also show a slight movement of the slope is noticed at about 3 seconds after the shaking start. The movements last for 56 seconds (<1 minute) then cease, ending up a total displacement of around 13m, which is very small as compared with the length of slope of more than 2000m.

Although the entire slope appears to be “stable”, a small amount of the computed displacement within one minute indicates the post-slide slope right after the first strike of earthquake would still be in a quasi-state, given the facts that the groundwater table remains high and the slope mass is still liquefied. The reason why the slide in slope is not re-triggered would probably be due to the geometry of the post-slide surface which is much less inclined than the pre-slide slope. If the slope surface becomes steeper, a significant flowsliding would then be anticipated. This simulation demonstrates the importance of ground inclination, which provides static/driving shears, in triggering a long-distance slide of liquefied slopes.

Figure 12. Verification on the potential of re-initiation of sliding in the failed (flatten) slope subjected to the second striking of the same earthquake; Simulation (b) - EW cross-section (Moh. Soeharto Rd.), post-slide geometry, high groundwater table.

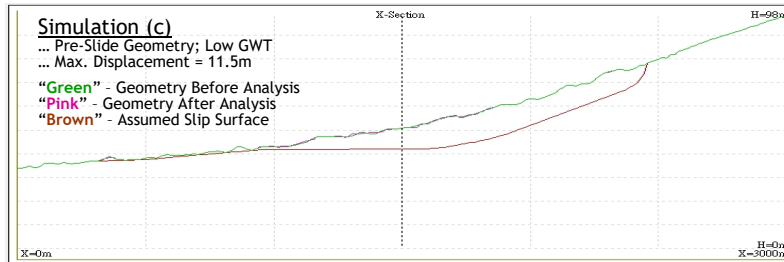
Figure 13 illustrates the results of Simulation (c), an assumed case of low groundwater table prior to the 2018 shaking, as a result of no water infiltration by Gumbasa irrigation system and wet-paddy fields. This simulation would like to focus on the influence of localized-raised groundwater level due to human activities on the potential of soil liquefaction and flowsliding of the slope. As seen in Figure 4, the groundwater table is expected to have raised by 0~15m in the upper portion of the slope, as a result of the irrigation system and wet paddies, prior to the 2018 earthquake. It would be of interest to see If without

rise in groundwater table the Petobo slope would still be experiencing the flowslide as it was during the 2018 shaking.

The simulation is conducted with a low groundwater condition as observed in the 02/2020 investigation and a pre-slide slope geometry of EW cross-section of Petobo area. The Balaroa EW record of the 2018 earthquake, as mentioned previously, is adopted as the input motion for the simulation. As shown in Figure 13, results of the simulation indicate no major liquefaction or flowsliding in the slope is likely. The computed overall displacement of the slope is around 12m, very small as compared with the slope length. The slope movement occurs within the beginning 20 seconds of the shaking and then no further deformation is noticed. This simulation, associated with [Simulation \(a\)](#), clearly demonstrate the importance of the localized-raised groundwater table, as a result of human activities, would have a detrimental effect on the stability of slopes.

Figure 13. Verification on the potential of sliding of Petobo slope if no infiltration of water from Gumbasa irrigation system and wet paddy fields; Simulation (c) - EW cross-section (Moh. Soeharto Rd.), pre-slide geometry, low groundwater table.

- The primary lesson that we could learn from the 2018 incidents of liquefaction-induced flowsliding in Palu, Indonesia, would probably the avoidance of human activities in raising the local groundwater table, in areas that are prone to strong seismic shaking, covered with large extent of liquefiable soils, and inclined on the ground surface.
