An Overview Study of Flowslide Liquefaction in Petobo, Palu, Indonesia

Togani Cahyadi Upomo^{1,2}, Muhsiang Chang³, Rini Kusumawardani², Galih Ady Prayitno³, Ren-Chung Huang³, Muhammad Hamzah Fansuri⁴

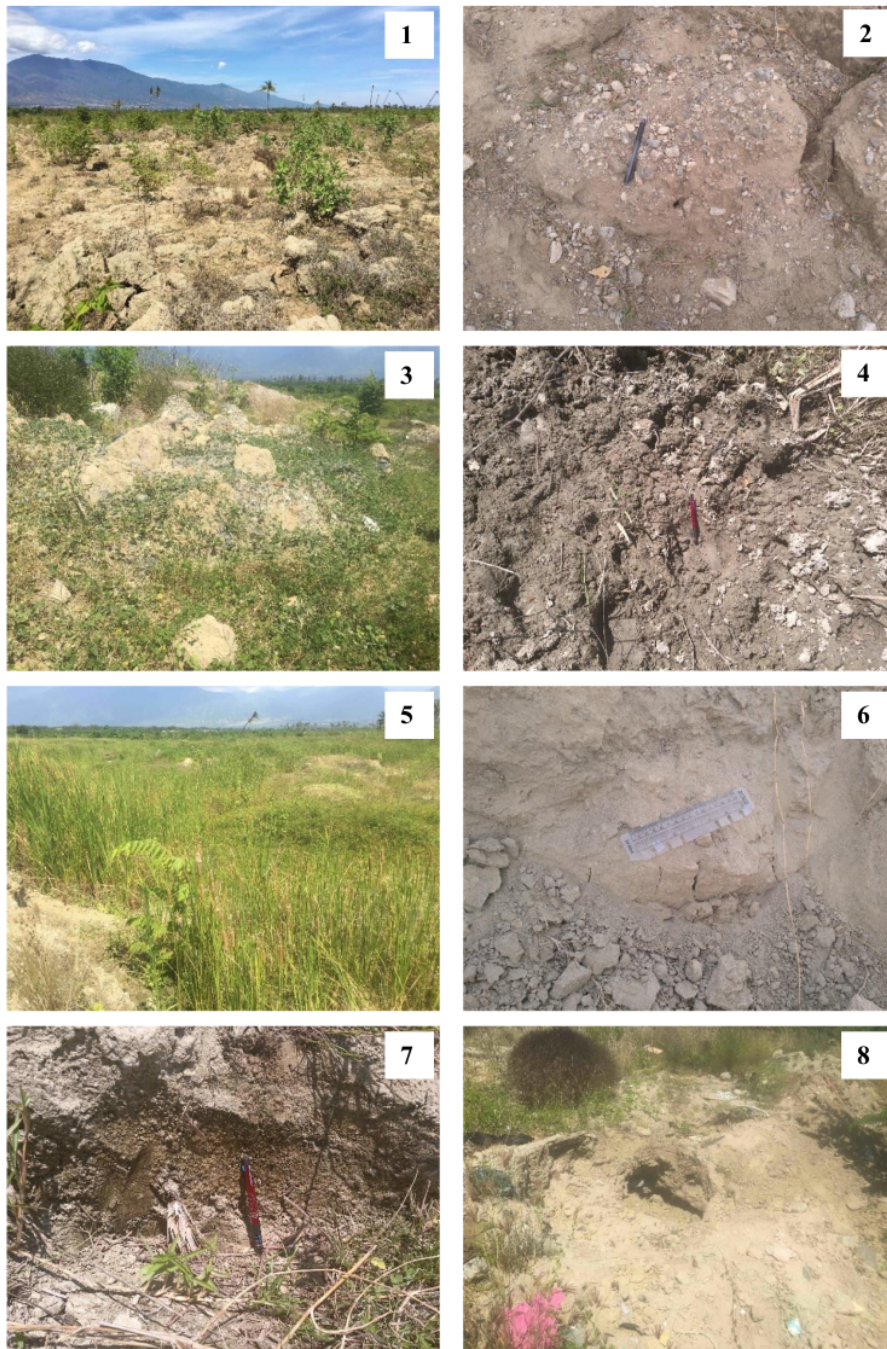
In Palu city, [14] indicated the sand, silt and clay of Formation Qap are at various depths between 1-7.2 m. [15] investigated using portable dynamic cone penetration tests in Petobo area. They found that the converted SPT-N values are lower than 10 at the site with depths less than 6.5 m, indicating the sandy soils should be loose to very loose. Based on our surface mapping, the sandy soils of the site are generally loose to medium dense. Figure 5 shows the photographs of onsite soils taken in Petobo area, with locations indicated in Figure 4.

Figure 5. Soil conditions in Petobo slide area

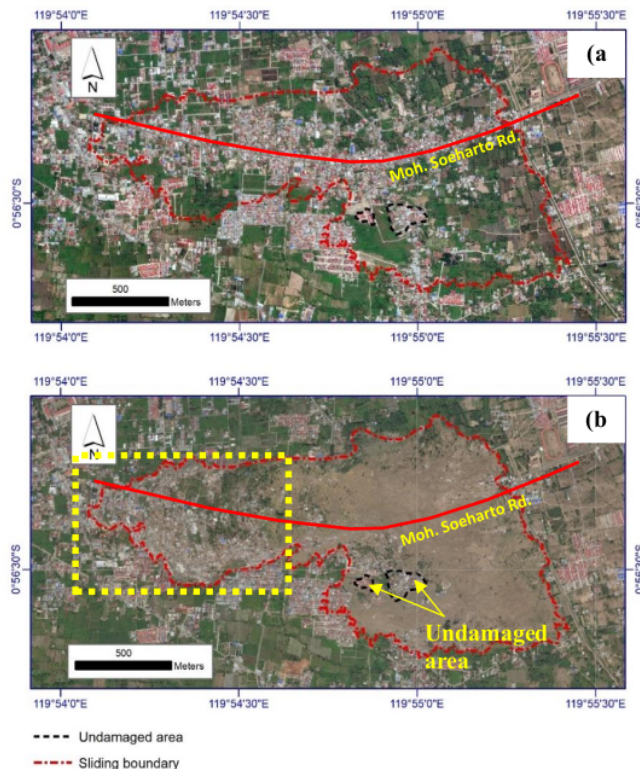
The pre-sliding satellite image, as shown in Figure 7(a), was taken from Digitalglobe on 18 June 2018 with a resolution of 30 cm. Figure 7(b) shows the post-sliding satellite image, also from Digitalglobe, taken on 2 October 2018 with the same resolution, which was acquired in 4 days after the event. Figure 7(a) shows the houses used to be densely populated along Moh. Soeharto road prior to the slide. While in Figure 7(b), the houses were disappeared and displaced after the slide, with deposition debris found on the west part of the area (yellow rectangle). Some unaffected residential houses, however, could be seen in the southern part of the site (Figure 7(b)).

Figure 7. Comparison of satellite images from Digitalglobe: (a) before sliding on 18 June 2018 and (b) after sliding on 2 October 2018

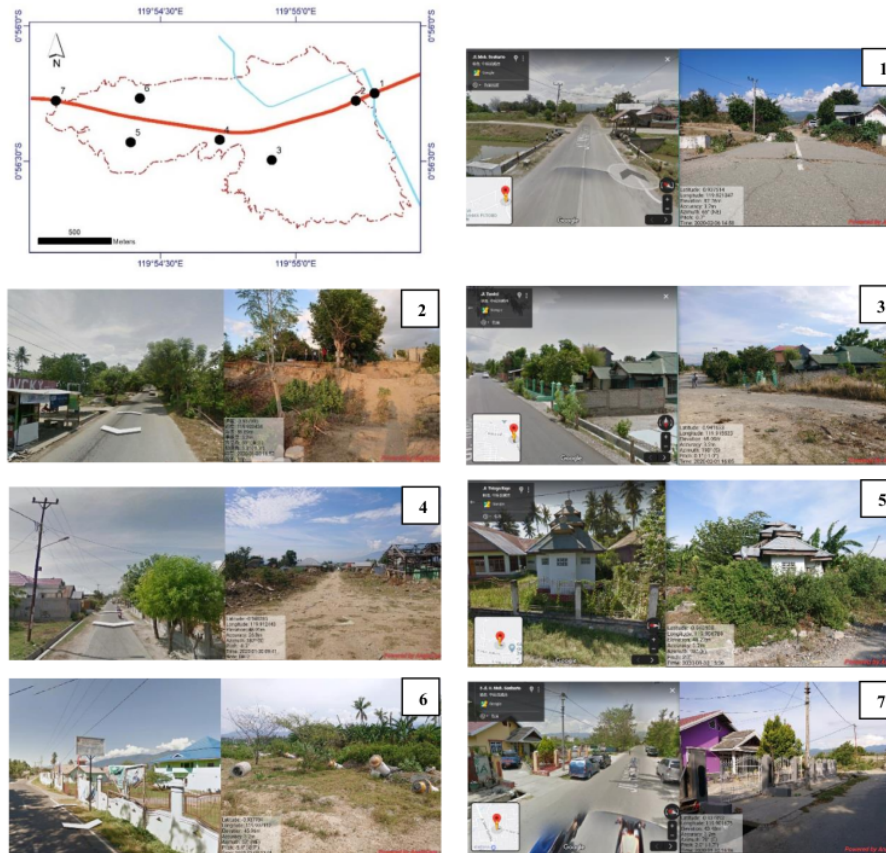
Figure 8. Comparison of onsite images before and after sliding.

Locations 1 and 2 are in the area of the headscarp, adjacent to the Gumbasa irrigation canal on the eastern part of the sliding boundary. As seen, surface cracking and ground slipping are clearly visible. Locations 3 and 4 are in the southern part of the area, where the residential buildings had been hit by the debris flow (a mixture of construction materials and soils). Locations 5 and 6 are close to the lower-middle part of the area where the mosque and school fence had been encountered and ripped away by the debris flow. Location 7 is at the toe boundary of the slide, and the houses in this area were relatively intact and unaffected by the sliding.

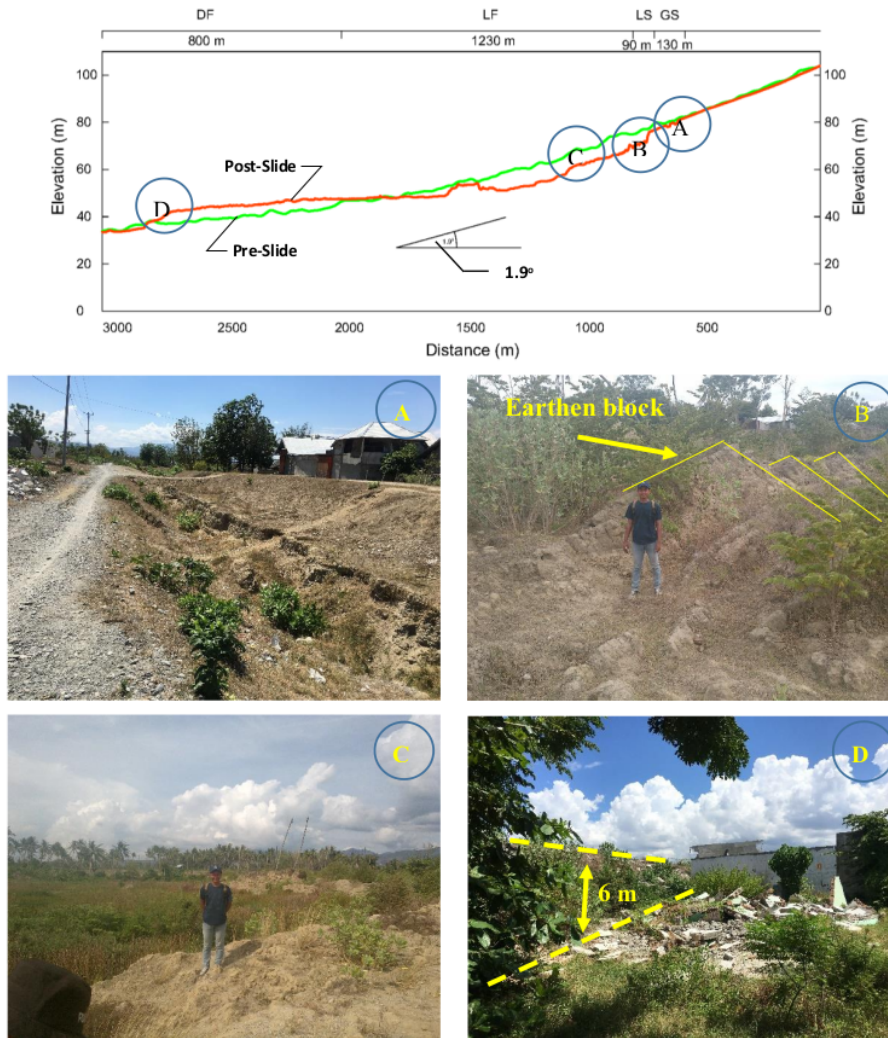
Figure 9 indicates the changes in elevation before and after sliding for the cross section along Moh. Soeharto road, as well as some photos showing morphological features observed at the site. To the east or beyond headscarp, the elevation change was negligible. In the middle portion, however, the elevation dropped around 10 m, while the west portion of the sliding area the elevation mounted about 6 m. Figure 10 presents a 3D view of sliding with arrows showing the direction of movement at several locations of the sliding mass. Generally, the ground had moved from east to west, resulted in significant losses of soil materials on the eastern part that were transported and deposited on the western portion of the sliding area.

Figure 9. Before and after sliding profiles along Moh. Soeharto Road and morphological features observed at the site

- (a) Ground Slip – Scarps or cracks can be seen on the ground's surface, as shown in Figure 9(A), dividing the ground into many earthen blocks. The area is found adjacent Gumbasa canal to the western border of the sliding zone.

- (b) Lateral Spread – As shown in Figure 9(B), surface ground phenomenons of lateral spread may consist of a series of sequential cracks or earthen ridges with damaged and lowered ground on the side. The cyclic motions and spreading of liquefied soils may result in the destruction, tilting, or distortion (elongation) of structures on the ground. The width of the lateral spreading zone along the Moh. Soeharto road segment is approximately 90 meters. The lateral spread zone is adjacent to the ground slip zone to the west.

- (c) Liquefaction Flow – As shown in Figure 9(C), during earthquake shaking, pore water pressures would be built up to a limit such that soils would lose their strengths. Ground becomes a muddy flow. Houses and features on the ground would be sinking, tilting or moving for a large distance. The significant proportion of the zone of liquefaction flow is distributed in the middle part of the sliding area.

- (d) Debris Flow – As shown in Figure 9(D), earthen materials of liquefaction flow mixed with construction debris ride over the existing ground. The existing ground elevation would be mounted. The debris flow zone is situated in the western portion of the slide. The debris deposit could reach around 6 m in height above the existing ground, and the length of transported debris flow could be as large as 700 m.

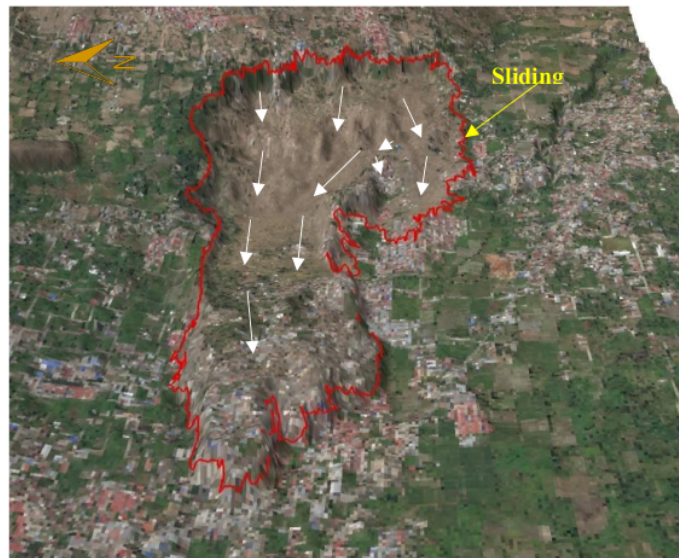
Figure 10. Post-slide 3D topography of Petobo area with arrows showing directions of movement.

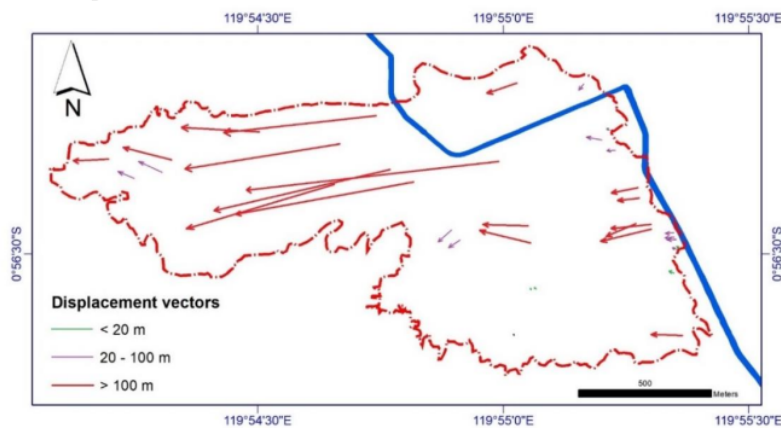
Vectors of displacement were measured by several ways including manually tracking the objects in satellite photos before and after sliding, information provided by witnesses, and measurements of on-site objects with reference to pre-slide positions from Google street view. Displacement vectors in Figure 11 are divided into three categories, with the magnitude of displacement of more than 100 m, 20-100 m and less than 20 m. As can be seen, the area with displacement of less than 20 m occurred mainly along the crown and toe boundaries; while significant displacements of more than 100 m were observed in the large middle portion of site.

Figure 11. Displacement vectors of sliding in Petobo area.
