An Overview Study of Flowslide Liquefaction in Petobo, Palu, Indonesia

Togani Cahyadi Upomo^{1,2}, Muhsiong Chang³, Rini Kusumawardani², Galih Ady Prayitno³, Ren-Chung Huang³, Muhammad Hamzah Fansuri⁴

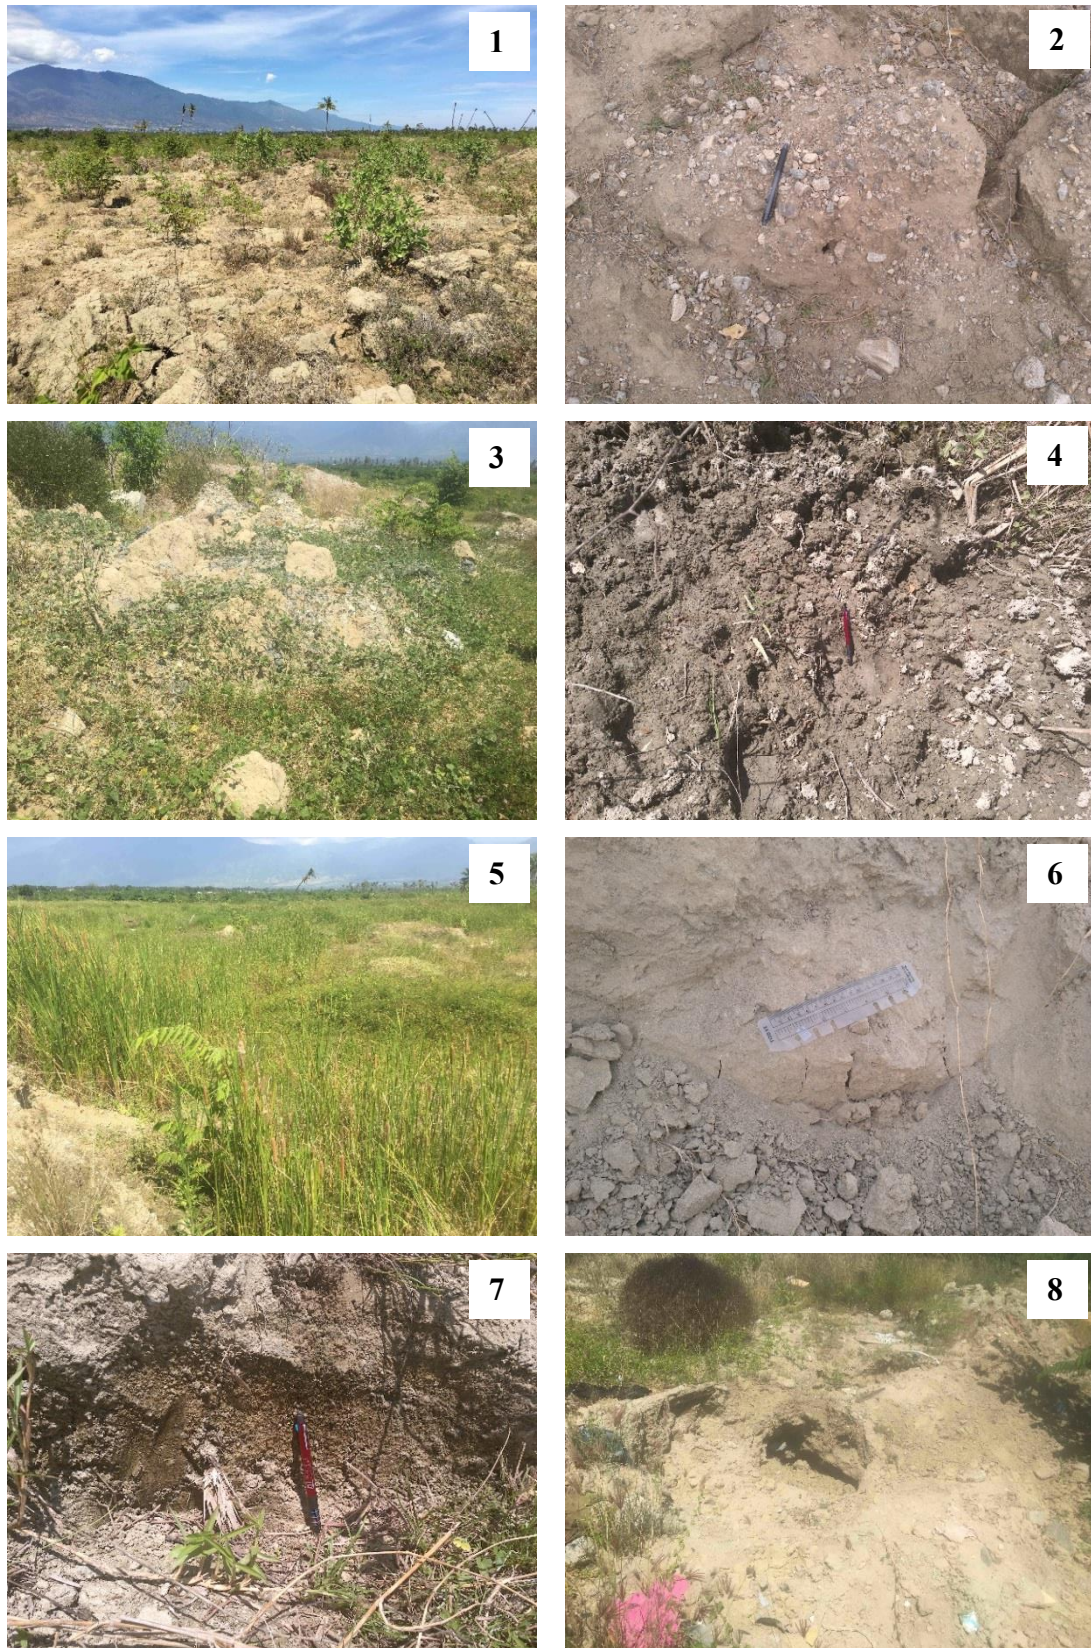
In Palu city, [14] indicated the sand, silt and clay of Formation Qap are at various depths between 1-7.2 m. [15] investigated using portable dynamic cone penetration tests in Petobo area. They found that the converted SPT-N values are lower than 10 at the site with depths less than 6.5 m, indicating the sandy soils should be loose to very loose. Based on our surface mapping, the sandy soils of the site are generally loose to medium dense. Figure 5 shows the photographs of onsite soils taken in Petobo area, with locations indicated in Figure 4.

Figure 5. Soil conditions in Petobo slide area

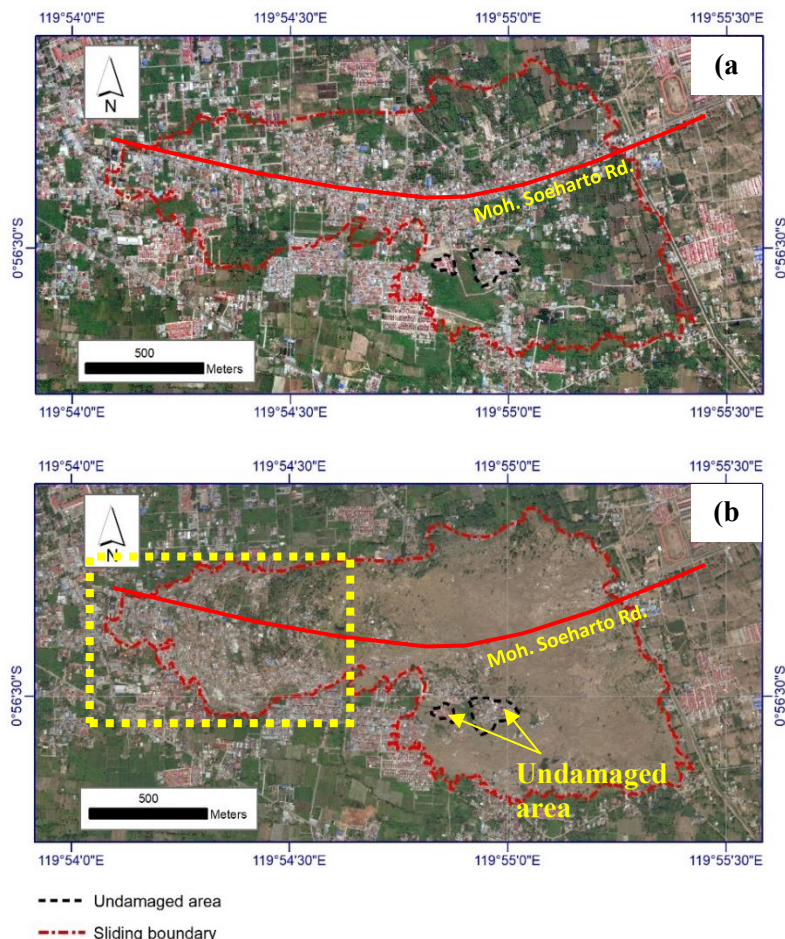
The pre-sliding satellite image, as shown in Figure 7(a), was taken from Digitalglobe on 18 June 2018 with a resolution of 30 cm. Figure 7(b) shows the post-sliding satellite image, also from Digitalglobe, taken on 2 October 2018 with the same resolution, which was acquired in 4 days after the event. Figure 7(a) shows the houses used to be densely populated along Moh. Soeharto road prior to the slide. While in Figure 7(b), the houses were disappeared and displaced after the slide, with deposition debris found on the west part of the area (yellow rectangle). Some unaffected residential houses, however, could be seen in the southern part of the site (Figure 7(b)).

Figure 7. Comparison of satellite images from Digitalglobe: (a) before sliding on 18 June 2018 and (b) after sliding on 2 October 2018

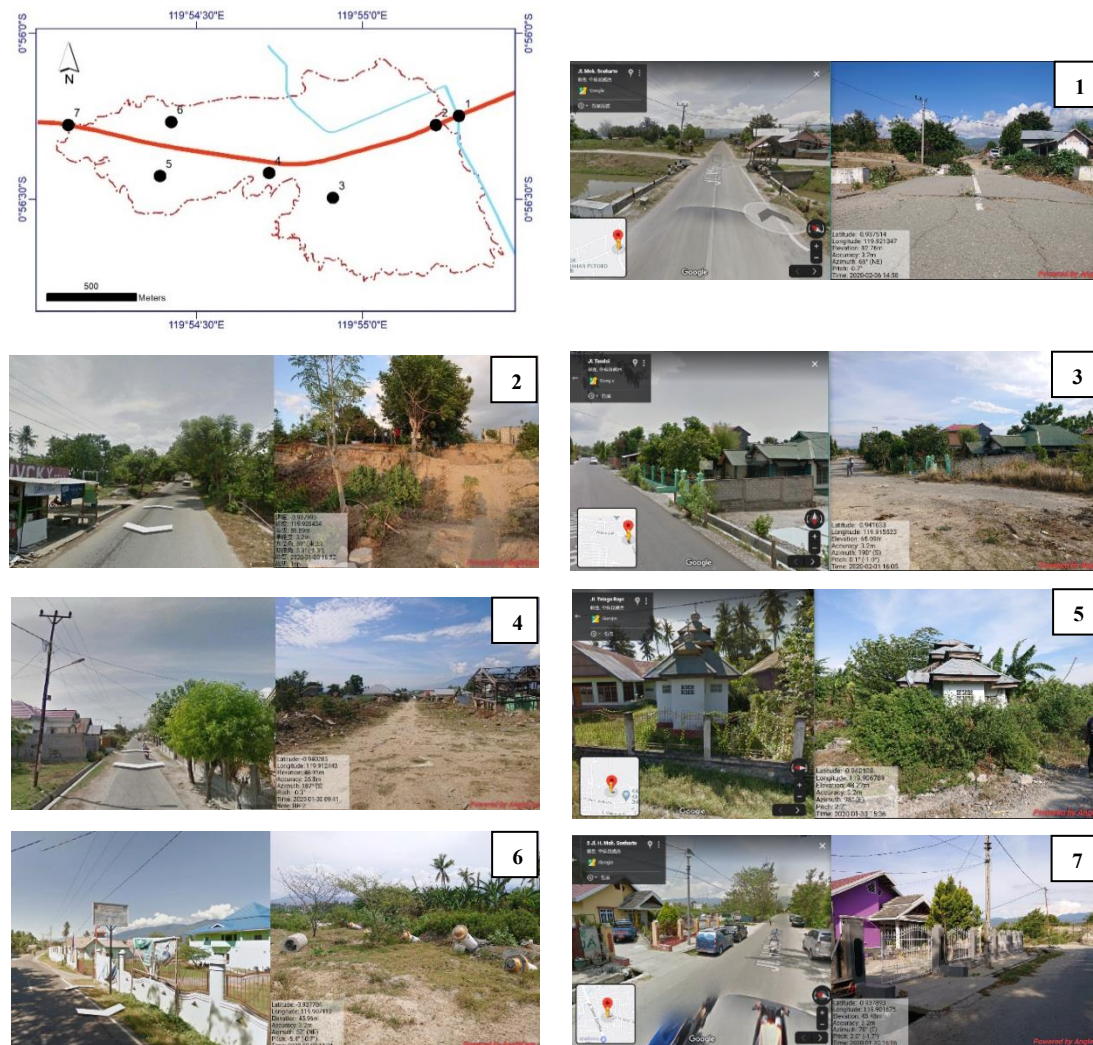
Figure 8. Comparison of onsite images before and after sliding.

Locations 1 and 2 are in the area of the headscarp, adjacent to the Gumbasa irrigation canal on the eastern part of the sliding boundary. As seen, surface cracking and ground slipping are clearly visible. Locations 3 and 4 are in the southern part of the area, where the residential buildings had been hit by the debris flow (a mixture of construction materials and soils). Locations 5 and 6 are close to the lower-middle part of the area where the mosque and school fence had been encountered and ripped away by the debris flow. Location 7 is at the toe boundary of the slide, and the houses in this area were relatively intact and unaffected by the sliding.

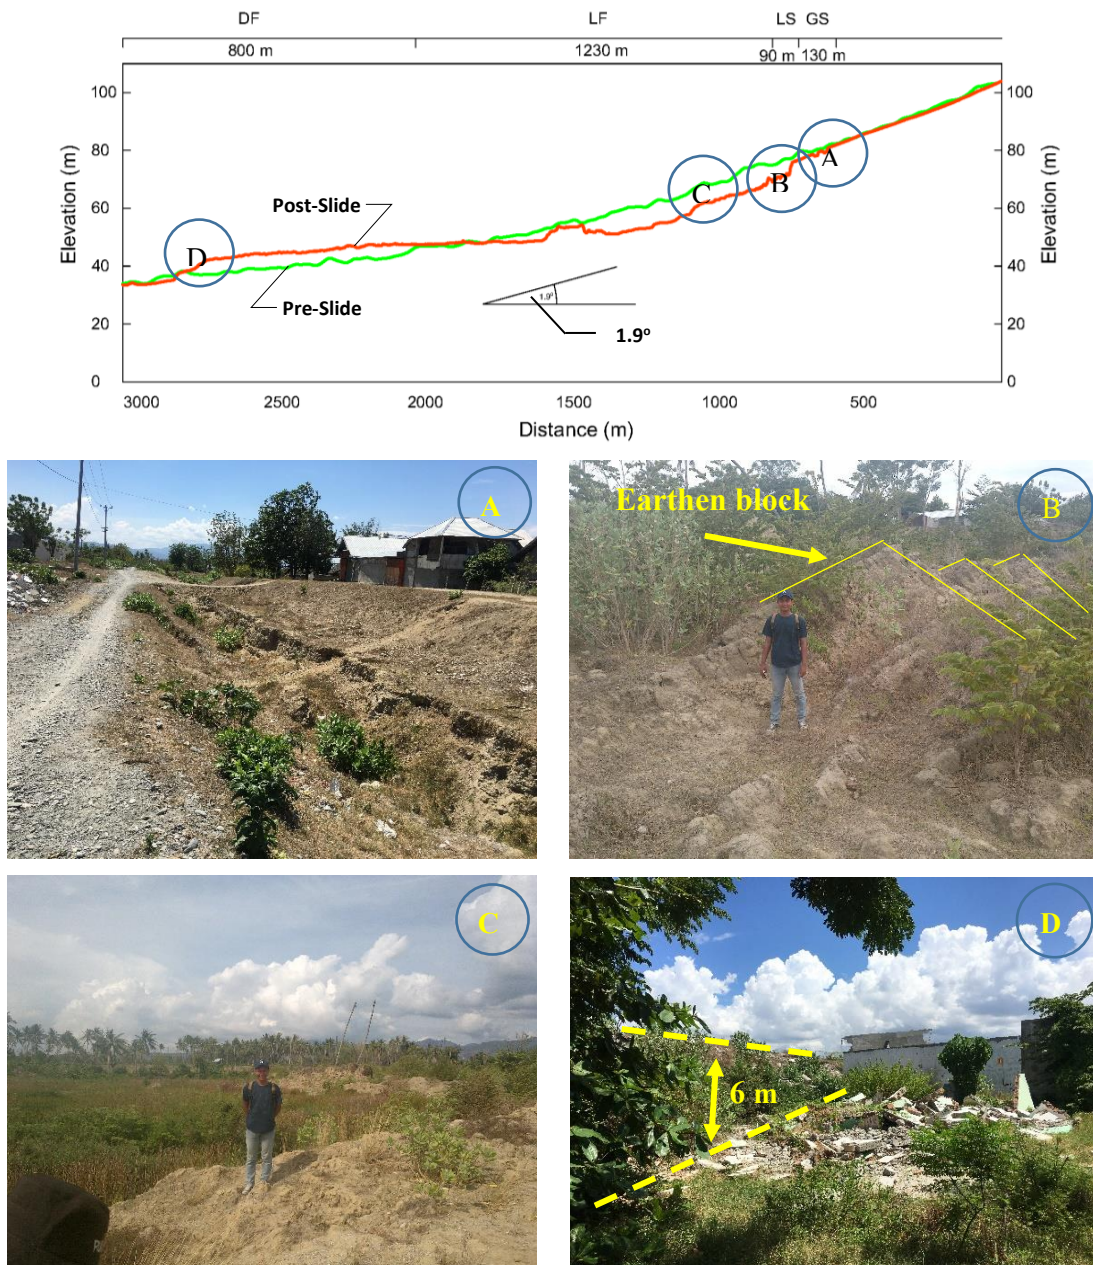
Figure 9 indicates the changes in elevation before and after sliding for the cross section along Moh. Soeharto road, as well as some photos showing morphological features observed at the site. To the east or beyond headscarp, the elevation change was negligible. In the middle portion, however, the elevation dropped around 10 m, while the west portion of the sliding area the elevation mounted about 6 m. Figure 10 presents a 3D view of sliding with arrows showing the direction of movement at several locations of the sliding mass. Generally, the ground had moved from east to west, resulted in significant losses of soil materials on the eastern part that were transported and deposited on the western portion of the sliding area.

Figure 9. Before and after sliding profiles along Moh. Soeharto Road and morphological features observed at the site

- (a) Ground Slip – Scarps or cracks can be seen on the ground's surface, as shown in Figure 9(A), dividing the ground into many earthen blocks. The area is found adjacent Gumbasa canal to the western border of the sliding zone.

- (b) Lateral Spread – As shown in Figure 9(B), surface ground phenomena of lateral spread may consist of a series of sequential cracks or earthen ridges with damaged and lowered ground on the side. The cyclic motions and spreading of liquefied soils may result in the destruction, tilting, or distortion (elongation) of structures on the ground. The width of the lateral spreading zone along the Moh. Soeharto road segment is approximately 90 meters. The lateral spread zone is adjacent to the ground slip zone to the west.

- (c) Liquefaction Flow – As shown in Figure 9(C), during earthquake shaking, pore water pressures would be built up to a limit such that soils would lose their strengths. Ground becomes a muddy flow. Houses and features on the ground would be sinking, tilting or moving for a large distance. The significant proportion of the zone of liquefaction flow is distributed in the middle part of the sliding area.

- (d) Debris Flow – As shown in Figure 9(D), earthen materials of liquefaction flow mixed with construction debris ride over the existing ground. The existing ground elevation would be mounted. The debris flow zone is situated in the western portion of the slide. The debris deposit could reach around 6 m in height above the existing ground, and the length of transported debris flow could be as large as 700 m.

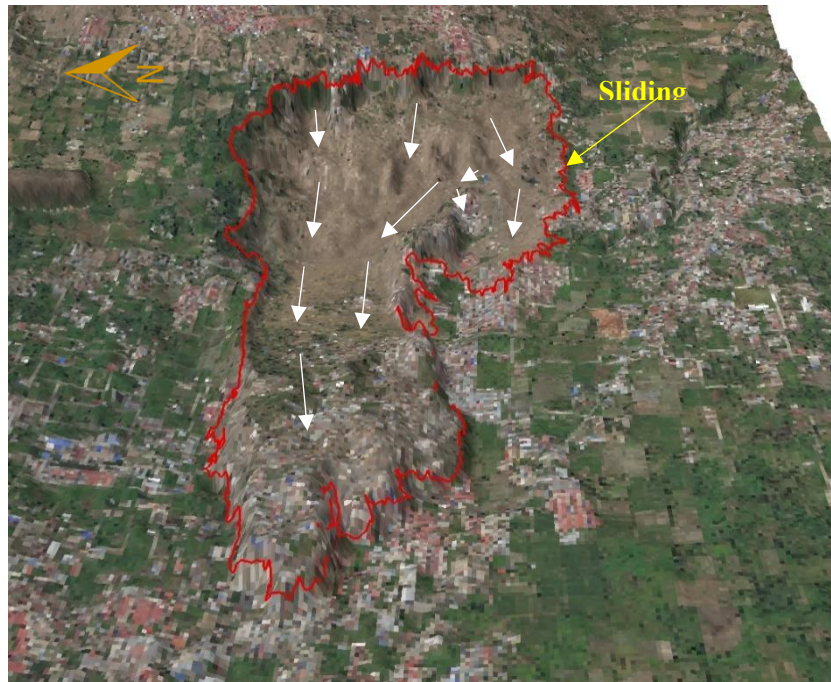
Figure 10. Post-slide 3D topography of Petobo area with arrows showing directions of movement.

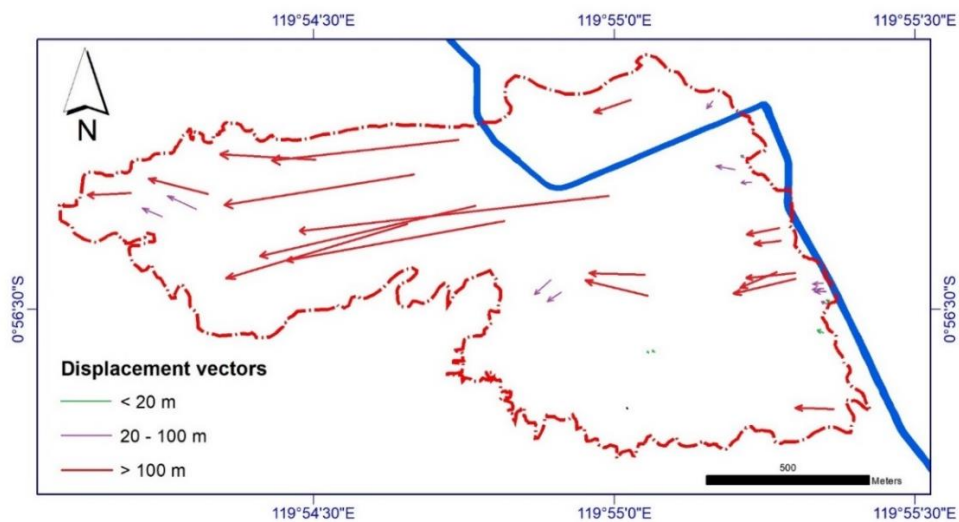
Vectors of displacement were measured by several ways including manually tracking the objects in satellite photos before and after sliding, information provided by witnesses, and measurements of on-site objects with reference to pre-slide positions from Google street view. Displacement vectors in Figure 11 are divided into three categories, with the magnitude of displacement of more than 100 m, 20-100 m and less than 20 m. As can be seen, the area with displacement of less than 20 m occurred mainly along the crown and toe boundaries; while significant displacements of more than 100 m were observed in the large middle portion of site.

Figure 11. Displacement vectors of sliding in Petobo area.
