**PAVEMENT EVALUATION OF MARGOREJO ROAD  
KARANGMALANG DISTRICT SRAGEN REGENCY BASED ON  
DYNAMIC CONE PENETROMETER TEST**

Margorejo road, Karangmalang district is one of the roads that has status as a district road in Sragen regency. The condition of the pavement on Margorejo road is bad, with the traffic volume and load of vehicles passing Margorejo road can be said as low, because it is only 228.8 vehicles/hour. In the next few years, a sports building will

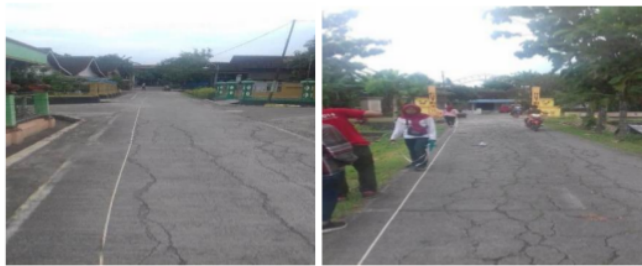
**Figure 3. Vertical Cracking (a) and Crocodile Skin Cracking (b)**

One of the factors that causes damage to Margorejo road's pavement is it doesn't have a base and subbase layer. Without a base and subbase layer, fine particles from the subgrade course will rise to the surface course, and the ground water will gather on the surface course, which will quickly reduce the life and strength of the pavement structure. The existing pavement data of Margorejo road can be seen in Table 3. below :

2. With a small vehicle load, the author's hypothesis about the cause of the damage to the pavement of Margorejo road is the poor composition of the layer. Without a base and a subbase course, thus soft particles from the subgrade course will go up to surface course, which will quickly reduce the life and strength of the pavement structure. In addition, the poor drainage in Margorejo road is also one of the causes.

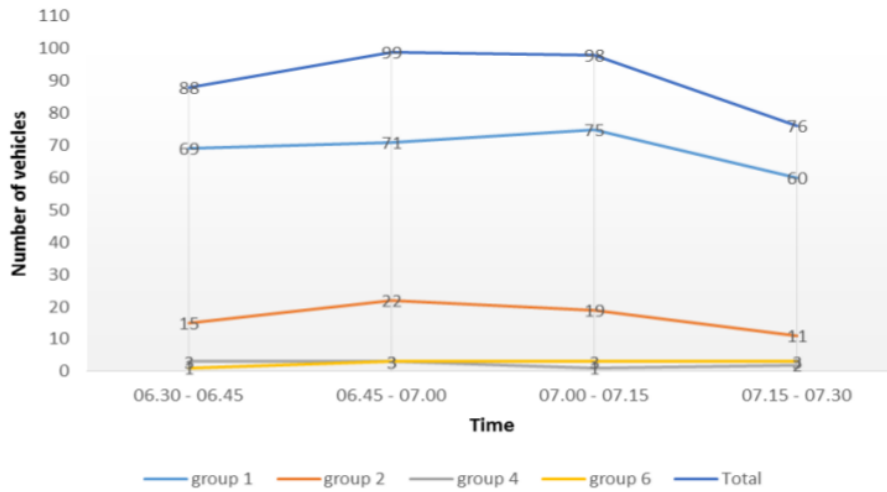
Peak traffic hour data for Margorejo Road is obtained by conducting traffic surveys for 40 consecutive hours which include weekdays and weekends. Peak hour traffic data is the highest traffic flow data from 40 hours of traffic data stated in pcu / hour. Peak traffic hour of Margorejo road is 228.8 vehicles / hour. Data of peak traffic hour on Margorejo road can be seen in figure below.

Figure 4: Peak Traffic Hour Chart.
