3D model and morphometry of the Beringin watershed as an effort for flash flood disaster risk reduction in Semarang

Abstract. The Beringin watershed is one of the watersheds (DAS) located in Semarang, Central Java, Indonesia. During 2010 – 2017 in this watershed area, there have been 8 flood disasters, the last two of which changed from an inundation flood to a flash flood type. The objective of this research is to investigate the characteristics of the rivers or the morphology of the watershed by 1) creating a three-dimensional spatial model of the Beringin watershed and describing its physical profiles and shapes, 2) arranging a satellite imagery map of the settlement at risk of flash flood disaster surrounding the watershed, 3) mapping the morphometric of the watershed, which consists of the landslide potential, the narrowing of river bodies and calculating the peak discharge in order to get the trigger factor of the flash flood, and 4) mapping the vulnerability of the Beringin watershed to minimize the flash flood disaster risk. The research method conducted was a combination of qualitative and quantitative approaches. Clearly, that the output of this research will contribute

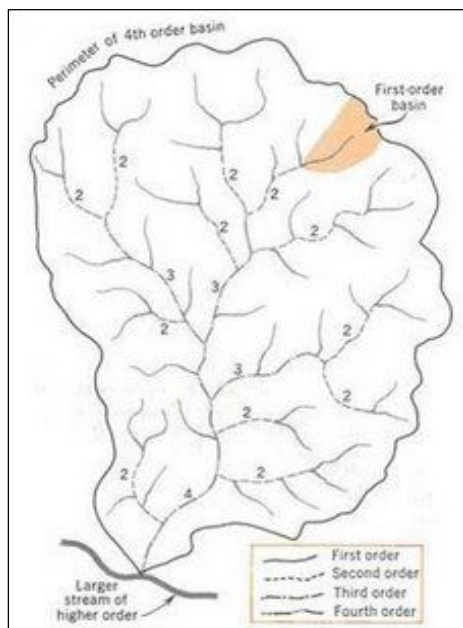
Fig. 1. The determination of river order using the strahler method (Strahler, 1975)

The river order is the serial number of each river segment to its main river. The Strahler method is the most widely used method to determine the river order. Strahler's 1st order rivers are the tributaries that are located at the far end and considered as the first fountain of the tributaries. The river segment which is a result of a meeting of rivers at the same order is a 2nd order river, and the river segment as the result of the meeting of two rivers of different orders will be categorized as the higher order. Other methods of determining the river orders are Horton, Shreve, and Scheidegger methods.

The Beringin watershed is a large watershed with many first-order rivers and its largest river order is 6. In this research, the river orders are determined based on Strahler's method. The largest river order in the Beringin watershed is 5. The circumference or perimeter of the Beringin watershed is 117.67 each. The drainage density or Dd found in the Beringin watershed are 3.93 and 2.08 mile/ mile². The slant of the watershed is 0.13. For the form factor of the watershed, the Beringin watershed is 0.3184 or takes a shape of a leaf.

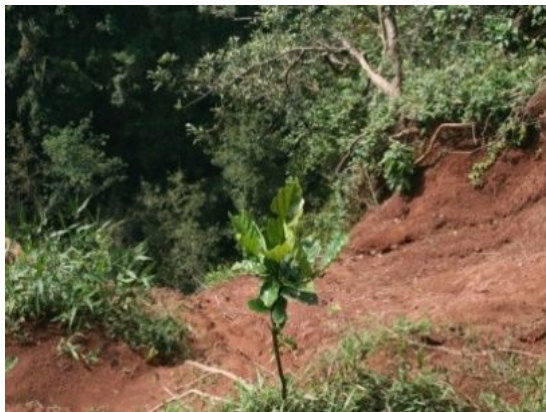
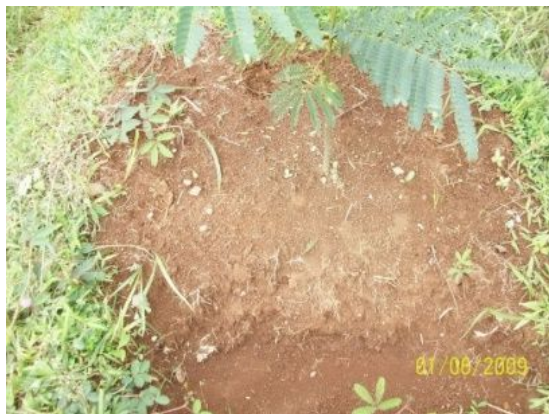
Fig. 2. Landslide events encountered during the field observation

The landslide in the Beringin Watershed mostly occurs on steep slopes (>300). There are thin weathered layers on the top, but the bottom is a thick hill (>2m). There is a natural drainage channel due to the trench

erosion from the top of the hill to the bottom. There is an impermeable layer at the bottom of the weathered layer.
