Determination of Corrosion Rate of Artificial Bone Made of Metal at Different pH Conditions using X-Ray Radiography

To cite this article: Sutikno *et al* 2018 *J. Phys.: Conf. Ser.* **983** 012041

Determination of corrosion rate of artificial bone made of metal at different pH conditions using x-ray radiography

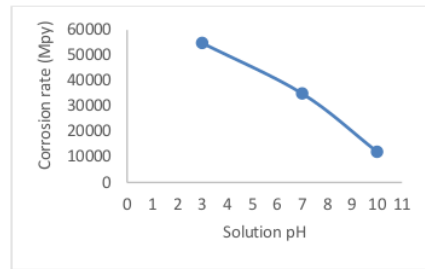
Figure 7. Corrosion rate versus solution pH.

Based on Table 1, as acidity increases, the corrosion rate increases as well. The largest corrosion is founded in the pH 3 (acid condition). In Figure 7, the highest corrosion rate is achieved at solution pH 3, while the lowest corrosion rate is achieved at solution pH 10. In this process, bone plate metal experiencing reduction reaction, while oxygen experiencing oxidation. The higher acidity level the higher ion concentration in HCl. Ion H^+ plays role as reductor and ion Cl^- as passive layer (Cr_2O_3) and metal bonding destroyer, so that the amount of ions increase will spur corrosion reaction. The aeration effects will accelerate the corrosion rate, where oxygen around the material surface will be removed when dipped in solution. The dissolved oxygen in HCl increase will improve cathodic reaction. A correlation between data in Table 1 and Graph in Figure 7 is confirmed.

arch area and straight area. On the arch, the residual stress produced by deformation process leads to the elements in the arch are instable so that the atoms will discharge electrons. The corrosion is initiated by the formed passive layer destroy, so electron in Fe transforms to Fe^{2-} ion. Except it, in the arch area higher energy exist than the surrounding area due to bonding force between archs. This energy causes Fe is easier to discharge electron and it will change it into ion. The corrosion in sample B is greater than that of samples A and C. The method used in this analysis is the mass loss method. The corrosion testing result is tabulated in Table 1 and shown graphically in Figure 7.

Table 1. Corrosion rate of bone plate at different pH.
