# Assessment of Petobo Flowslide Induced by Soil Liquefaction during 2018 Palu– Donggala Indonesian Earthquake

# Assessment of Petobo Flowslide Induced by Soil Liquefaction during 2018 Palu–Donggala Indonesian Earthquake

**Abstract:** This paper presents the results of the subsurface investigation and liquefaction assessment of the Petobo flowslide, induced by soil liquefaction during the Mw 7.5 Palu–Donggala earthquake of Indonesia on 28 September 2018. The investigations, including drilling, standard penetration tests, electrical resistivity imaging survey, dynamic probing, groundwater table monitoring, etc., were conducted along the main road that passes through the middle of the flowslide area. Liquefaction assessments and flowslide simulations were carried out with three assumed scenarios. Scenario 1 describes the condition if the flowslide were to be retriggered at the cease of sliding due to the same earthquake striking the site. Scenarios 2 and 3 attempt to examine the influence of locally raised groundwater levels due to the infiltration of the Gumbasa irrigation system and widespread paddy fields of the site as a result of soil liquefaction and the flowslide. Subsurface

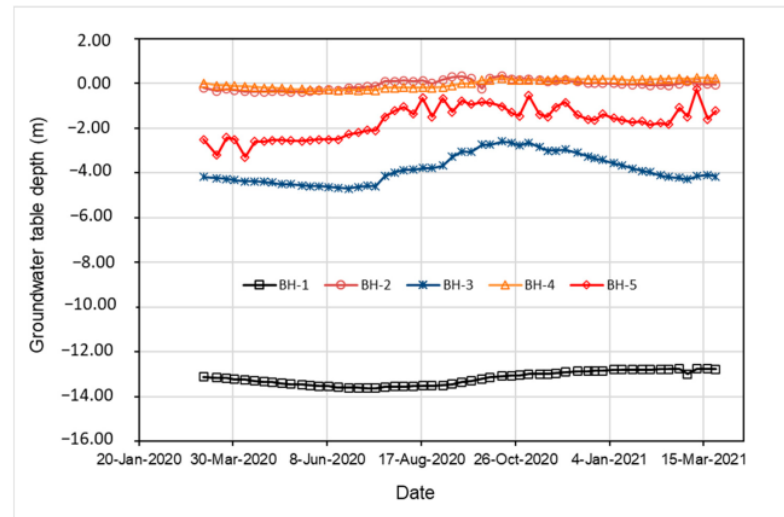
**Figure 5.** Results of groundwater measurement at Petobo site after the 2018 incident.

BH-4 and BH-2 are situated at the eastern and middle portions, respectively, of the sliding area (Figure 2). The results of the monitoring show that the groundwater levels are very close to the post-slide ground surface, which was evidenced through the onsite reconnaissance by Kusumawardani et al. [8], showing that ponds and wetlands are often found in these areas. By comparison with its pre-slide geometry, the current elevation at BH-4 (in the eastern portion) is approximately 6 m below the pre-slide level, while the current elevation at BH-2 (in the middle portion) is about the same as its pre-slide level.

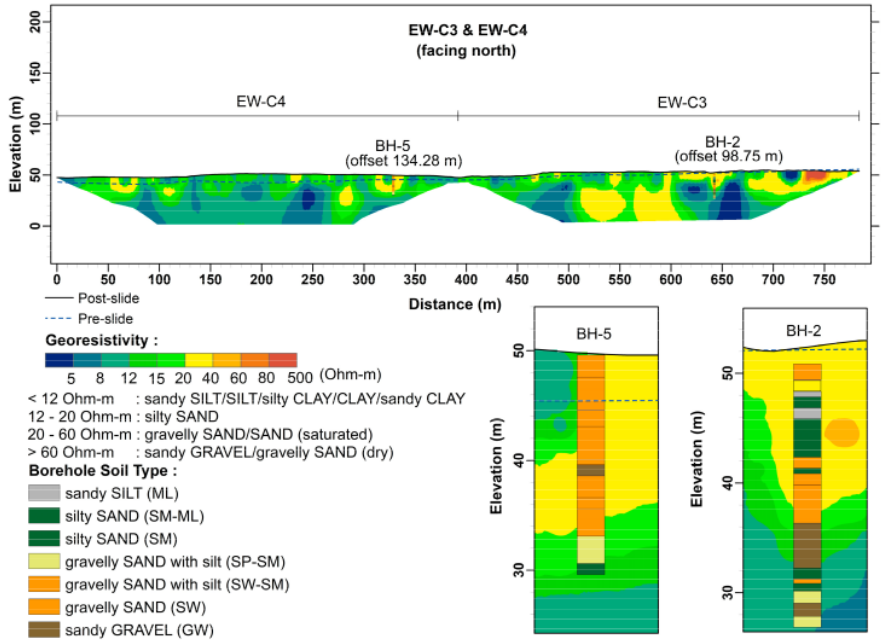
Figure 7. ERI profiles of EW-C3 and EW-C4 with comparison of borehole logs at BH-2 and BH-5.

Figure 7 shows the resistivity profiles EW-C3 and EW-C4, with boreholes BH-2 and BH-5, respectively. According to Kusumawardani et al. [8], Profile EW-C3 sits along the

junction of the liquefaction flow zone (LF-3) and debris flood zone (DF-1a), while profile EW-C4 is on the debris flood zone (DF-2). From the associated profiles, it can be seen that the horizontal offsets of BH-2 and BH-5 are approximately 99 m and 134 m, respectively. In profile EW-C3, high and moderate–high resistivity values, corresponding to gravelly sands or sandy gravels, are found to the east portion of the profile, probably due to a mixture of the onsite construction debris with the upstream liquefied soils. Profile EW-C4 and the middle portion of profile EW-C3 consist of moderate–low to low resistivity values, indicating that the surface materials of these profiles are most likely silty sands or sandy silts as a result of the liquefied debris from upstream.

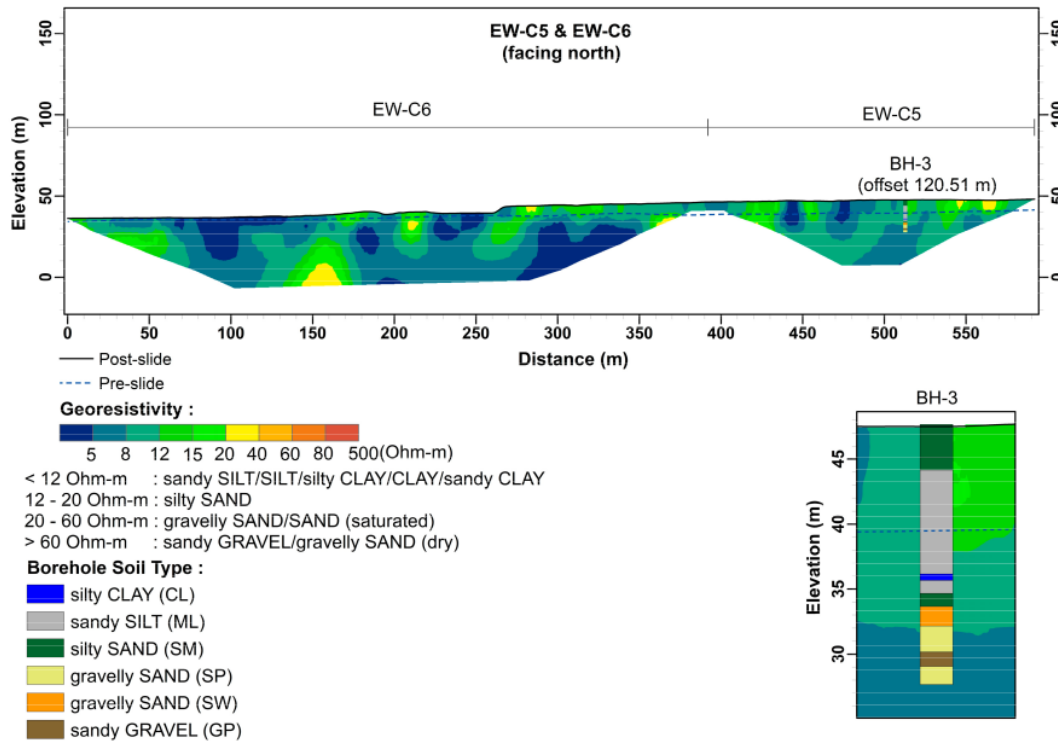
Figure 8. ERI profiles of ERI at EW-C5 and EW-C6 with comparison of borehole log at BH-3.

Figure 8 shows the resistivity profiles of EW-C5 and EW-C6 and the associated borehole BH-3. The horizontal offset of BH-3 to profile EW-C5 is approximately 121 m. Based on Kusumawardani et al. [8], these profiles sit in the debris flood zone (DF-2). The surficial deposit of these profiles comprise silty sand, sandy silt or silty clay, with moderate–low to low resistivity. As in profile EW-4, the deposited materials of these areas are most likely the transported debris from the liquefied upstream site.

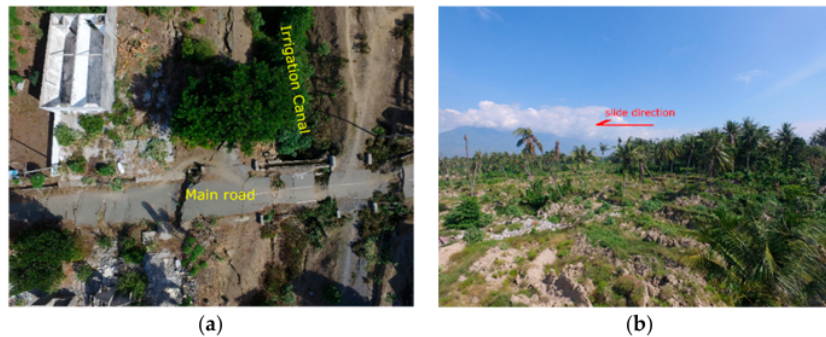
**Figure 9.** Photos showing GS and LS morphological features observed at Petobo sliding area: (a) ground slide (GS), (b) liquefaction spread (LS).

The borehole BH-1 results indicate that the top soil layers with a thickness of 10 m or more would generally not liquefy and only the soils below would have a computed factor of safety against liquefaction ( $F_L$ ) of less than unity, for all of the analysis scenarios assessed. In view of the studies by Ishihara [48] and Dobry [49], the 10-m-thick non-liquefied upper layer at this location would likely prevent the influence of the underneath liquefied soils and hence the effect on the ground surface. The onsite observations by Kusumawardani et al. [8] confirm that the ground surface in the neighborhood of BH-1 consisted of a series of cracks with no phenomena of soil liquefaction, which was classified as the ground slide (GS) zone, as shown in Figure 9a.

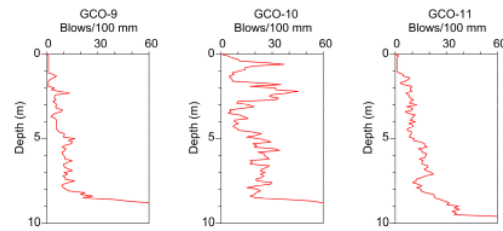
Figure 10. Results of GCO probing at Petobo site.

Figure 10 shows the results of GCO probing, located on the eastern portion of the road (Figure 2). The results indicate that the firm in situ layers are generally situated at a depth of 8–10 m below the post-slide ground. With the aid of other probings, i.e., the SPT-N profiles of boreholes current study [12], DCPT blowcounts [7], and Swedish soundings [12], as well as the ERI profiles of onsite materials discussed above, these results enable the establishment of an approximate boundary that delineates the junction between the relatively disturbed/loose sliding mass and the relatively undisturbed/firm in situ ground. Moreover, as will be discussed shortly, the liquefaction assessment results would be able to further verify whether the speculated boundary is the potential slip surface of the 2018 Petobo slide.

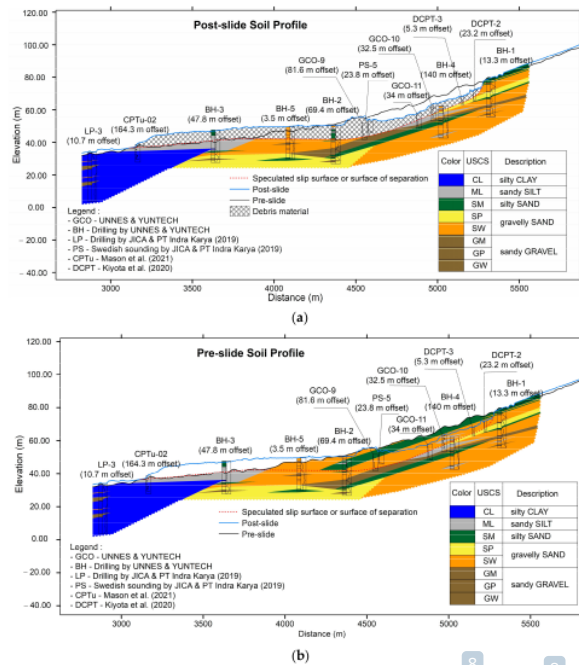
Figure 11. Interpretation of material stratification profile along Moh. Soeharto road in Petobo sliding area: (a) post-slide surface geometry and (b) pre-slide surface geometry.

The results of the subsurface investigation are summarized and interpreted in Figure 11. Figure 11a shows the material stratification with the post-slide slope geometry of the site. Based upon the speculated boundary of the sliding mass and in situ ground, the figure approximately outlines the plausible mass of the 2018 sliding, including a major portion of the slip surface within the in situ ground and a small portion near the toe on the top of the ground surface, i.e., the surface of separation.

Figure 11b illustrates the material profile with the pre-slide slope geometry of the site. Since site investigations were performed after sliding, some of the boreholes were drilled at locations with ground elevations lower than their pre-slide levels. To reconstruct the pre-slide material profile, the missing data between the pre-slide and post-slide geometries were amended using the adjacent materials of the same boreholes, or the average data of materials at approximately the same elevations as the nearby boreholes. The amended pre-slide material profile indicates that soil layers are generally parallel to the ground in the crest and middle portions of the site. The soil materials presented in this area, in descending order, are more or less like silty SAND, gravelly SAND, sandy GRAVEL, etc. In the toe portion of the site, however, relatively thick layers of sandy SILT and silty CLAY are found.

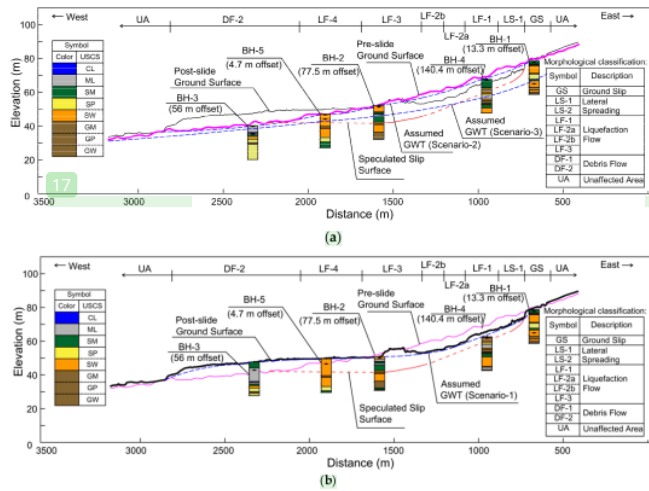
**Figure 12.** Interpretation of the assumed GWT condition, material stratification, and speculated slip surface in the profile along Moh. Soeharto road in Petobo sliding area: (a) post-slide surface geometry and (b) pre-slide surface geometry.

The results of liquefaction assessment associated with the liquefied zones identified for each of the boreholes are synthesized. A speculated slip surface connecting the liquefied zones of boreholes can therefore be delineated and is shown in Figure 12. It is noted that the speculated slip surface of the 2018 Petobo flowslide, based on the liquefaction assessment herein, is in good agreement with the speculated boundary of the sliding mass and in situ ground, as discussed previously through the results of probing and sounding during site investigation (Figure 11). It is also noted that the speculated slip surface as identified through the liquefaction assessment of scenario 1 (post-slide geometry and high GWT) is almost the same as that defined by the liquefaction assessment of scenario 2 (pre-slide geometry and high GWT). In accordance, the speculated slip surface is determined to generally pass through the weak interfaces of material layers and presents

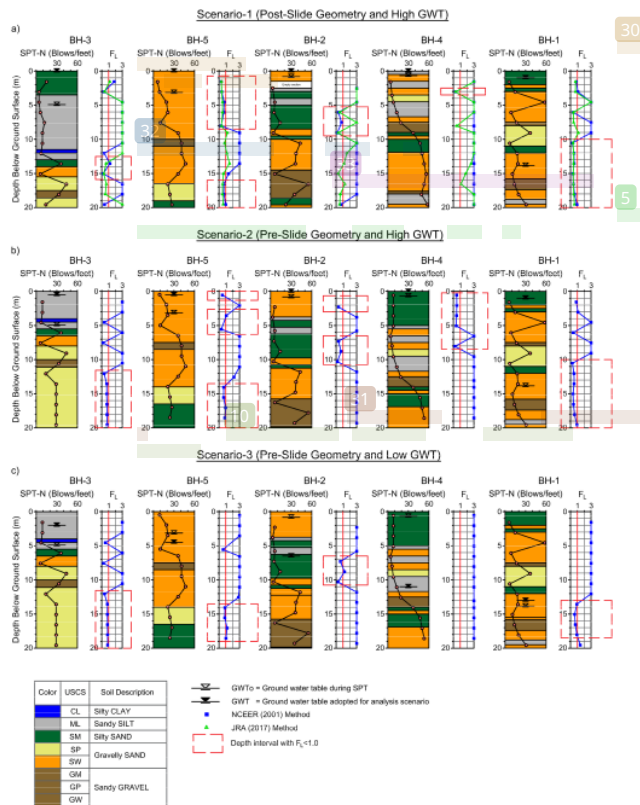
**Figure 13.** Results of soil liquefaction analysis: (a) scenario 1 (post-slide and high GWT), (b) scenario 2 (pre-slide and high GWT), and (c) scenario 3 (pre-slide and low GWT).

Figure 13 shows the results of liquefaction assessment for the three analysis scenarios. Both Seed/NCEER [33] and JRA [34] methods were adopted in the assessment for scenario 1. The results show general consistency between the methods, with only minor differences in the assessed factor of safety against liquefaction ( $F_L$ ). The differences might have been due to the fact that the Seed/NCEER method does not consider gravels to be a liquefiable soil type. In view of its general acceptance and extensive usage worldwide, the Seed/NCEER [33] method is the major tool used for the assessment of liquefaction in this study.

The borehole BH-4 results show that soil liquefaction is identified at a depth of around 3 m in the post-slide profile of scenario 1 and a zone from the surface to approximately 9 m deep in the pre-slide profile of scenario 2. Due to variations in pre-slide and post-slide ground surfaces, the elevations of liquefied depth in the profiles of scenarios 1 and 2 are nearly the same, indicating that the depth of liquefaction (i.e., the sliding surface) at this location was approximately 9 m below the pre-slide ground surface. For scenario 3, however, no liquefaction was found within the first 20 m of the pre-slide ground, implying that the drop in groundwater level as a result of the termination of surface water infiltration (i.e., the Gumbasa irrigation system and onsite paddy fields) significantly prevented soil liquefaction at this location.

The borehole BH-2 results denote that the zones of soil liquefaction were found at a depth of around 5–10 m in the post-slide geometry of scenario 1 or around 6–11 m in the pre-slide geometry of scenarios 2 and 3. In terms of elevations, the liquefied depths of these analysis scenarios were about the same, indicating that the depth of liquefaction (i.e., sliding surface) at this location was around 11 m below the pre-slide ground surface. It is important to note, however, that the liquefaction zone is also identified in scenario 3, under the conditions of a pre-slide slope and low groundwater table, suggesting that soil liquefaction would be triggered at this location even if the influence of surface water infiltration was prohibited and the groundwater table was dropped to a minimum level.

The borehole BH-3 results of liquefaction assessment are shown in Figure 13, with sparse depths of liquefaction found at 12 m and 15 m in the post-slide profile of scenario 1, or at 5 m and 8 m in the pre-slide profile of scenarios 2 and 3. Due to a relatively thick layer of silts and clays at this borehole location, the assessment indicates that soil layers in the upper 10 m are generally capable of resisting soil liquefaction caused by the earthquake. Despite a lower zone of liquefaction being identified at a depth of below 19 m in the post-slide profile of scenario 1 or below 12 m in the pre-slide profile of scenarios 2 and 3, the upper non-liquefied layers of approximately 4 m or more in thickness would likely provide buffers and prevent the influence of lower liquefied zones on the ground surface, as suggested by Ishihara [48] and Dobry [49].

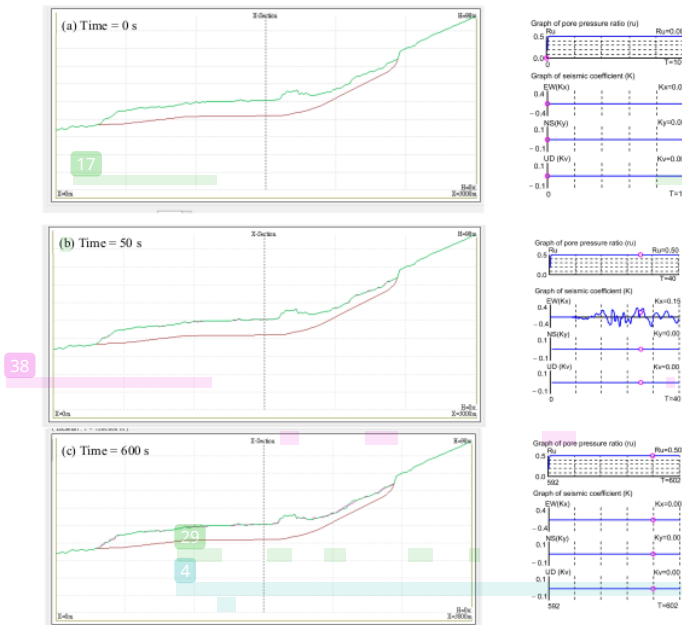
**Figure 14.** Results of LS-Rapid simulation for scenario 1 (post-slide geometry and high GWT). (Note: “green” and “pink” lines represent the slope geometries before and after computations, respectively; and “red” line is the assumed slip surface.)

The results of flowslide simulation for scenario 1 in various computation stages are presented in Figure 14, in which the green and pink lines represent the initial post-slide ground surface (i.e., before computation) and the configuration of the sliding mass in progress, respectively. The results indicate that at second strike of the same earthquake on the failed Petobo site would cause minor deformations of the slope, till the end of computation of 600 s. The computed total displacement and maximum speed of the sliding mass are shown in Figure 17. The results imply that the initial strike of the earthquake that triggered the 2018 flowslide has resulted in a stabilized (post-slide) slope geometry, which would prevent a re-initiation of the flowslide of the failed slope by a second strike of the same earthquake.

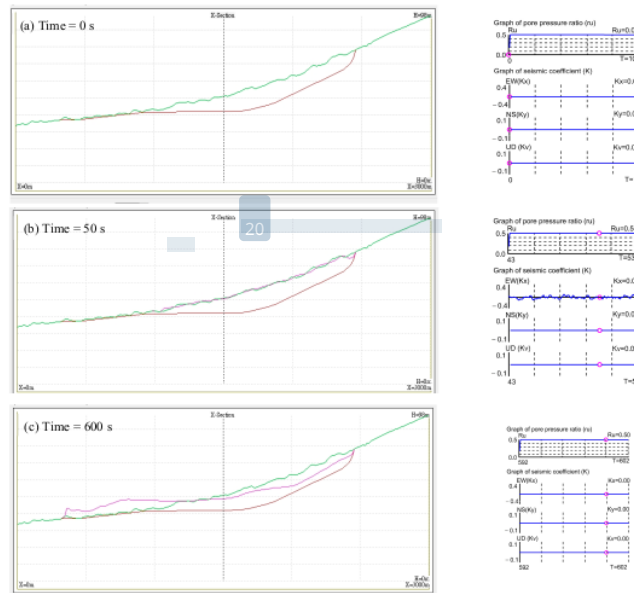
**Figure 15.** Results of LS-Rapid simulation for scenario 2 (pre-slide geometry and high GWT). (Note: “green” and “pink” lines represent the slope geometries before and after computations, respectively; and “red” line is the assumed slip surface.)

The results of flowslide simulation for scenario 2 are illustrated in Figure 15, with various stages of sliding computation. scenario 2 is assumed for the case of the Petobo site when subjected to the 2018 earthquake shaking. The Petobo site had pre-slide geometry and a raised groundwater table as a result of the constant ground infiltration of the Gumbasa irrigation system and onsite paddy fields. The computed displacement and speed of the sliding mass are shown in Figure 17. As illustrated in Figures 15 and 17, the flowslide started at approximately the same time as the initiation of earthquake shaking. The sliding speed reached a maximum value of approximately 15 m/s at a computation time of 163 s, then gradually decreased and ceased at a computation time of 240 s. The maximum displacement was 581.7 m. The computed final configuration of the sliding mass is comparable to the observed post-slide geometry, as indicated by the green line in Figure 14, in terms of the

shape and sliding distance, implying that the simulation of scenario 2 would result in a significant flowslide that resembles the 2018 Petobo slide.

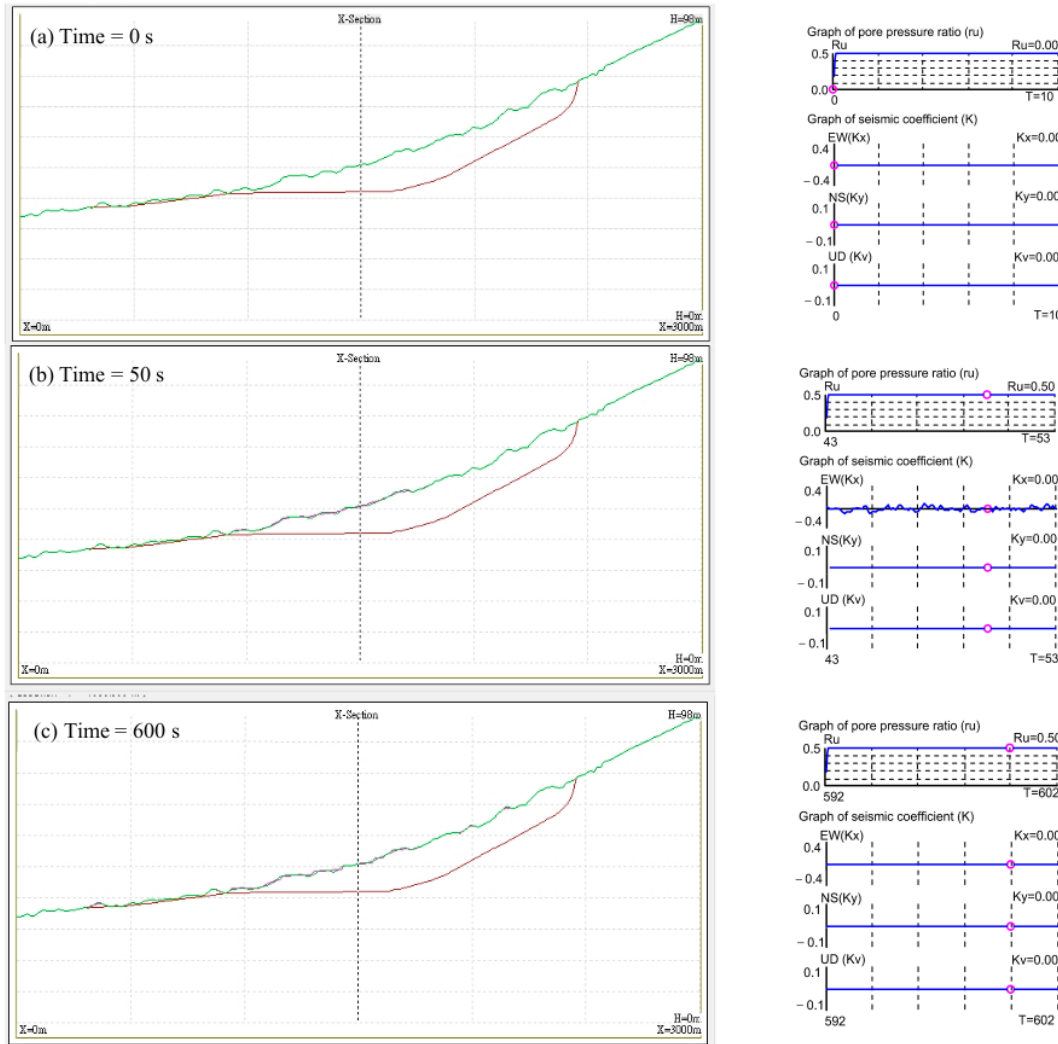
**Figure 16.** Results of LS-Rapid simulation for scenario 3 (pre-slide geometry and low GWT). (Note: “green” and “pink” lines represent the slope geometries before and after computations, respectively; and “red” line is the assumed slip surface.)

The results of scenario 3 are presented in Figures 16 and 17. This scenario was used to examine the likelihood of the 2018 Petobo flowslide in the case of no infiltration of surface water (from irrigation system and wet paddy fields) and a low groundwater table of the site. As shown, the Petobo slope would not initiate a flowslide after the 2018 earthquake shaking if the deposit was desiccated and the groundwater level was low, even if some liquefiable zones were identified at depth in the middle portion of the site (i.e., BH-2). The results indicate that the slope stopped moving at a computation time of 45 s after earthquake shaking, and the maximum displacement of the slope was only about 1 m.
