Assessment of Petobo Flowslide Induced by Soil Liquefaction during 2018 Palu–Donggala Indonesian Earthquake

Article

Togani Cahyadi Upomo [1,2,*], Muhsiung Chang [3], Rini Kusumawardani [2], Galih Ady Prayitno [3], Chih-Ping Kuo [3] and Untoro Nugroho [2]

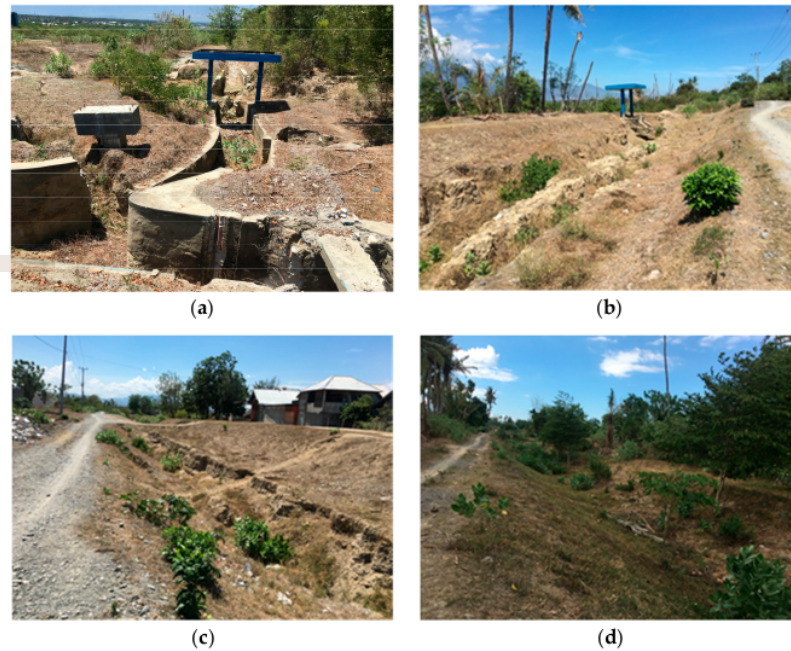
Along the crown (east boundary) of the sliding area, the Gumbasa irrigation canal runs from south to north, making a sharp turn to the west, going through the NE portion of the area, and then existing at the north sliding boundary.

Figure 3. The Gumbasa irrigation canal after slide (**a–d**). The point of view of photo location can be seen in Figure 2.

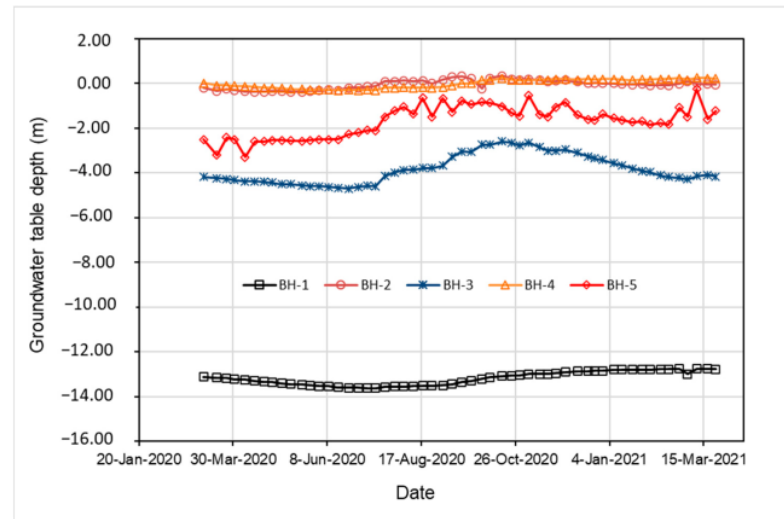
Figure 5 and Table 2 show the results of groundwater monitoring for a period of one year. BH-1 is located beyond the crest and to the east boundary of the sliding footprint (Figure 2). The results indicate that the groundwater level was less influenced by the seasonal effect due to rainfall. However, the depth of the groundwater at this location is significantly lower ($\cong -13$ m deep) than at the time of the earthquake, in view of its proximity to the Gumbasa canal and the nearby wet paddy fields which were constantly full of water prior to the sliding [8].

Figure 5. Results of groundwater measurement at Petobo site after the 2018 incident.

BH-4 and BH-2 are situated at the eastern and middle portions, respectively, of the sliding area (Figure 2). The results of the monitoring show that the groundwater levels are very close to the post-slide ground surface, which was evidenced through the onsite reconnaissance by Kusumawardani et al. [8], showing that ponds and wetlands are often found in these areas. By comparison with its pre-slide geometry, the current elevation at BH-4 (in the eastern portion) is approximately 6 m below the pre-slide level, while the current elevation at BH-2 (in the middle portion) is about the same as its pre-slide level.

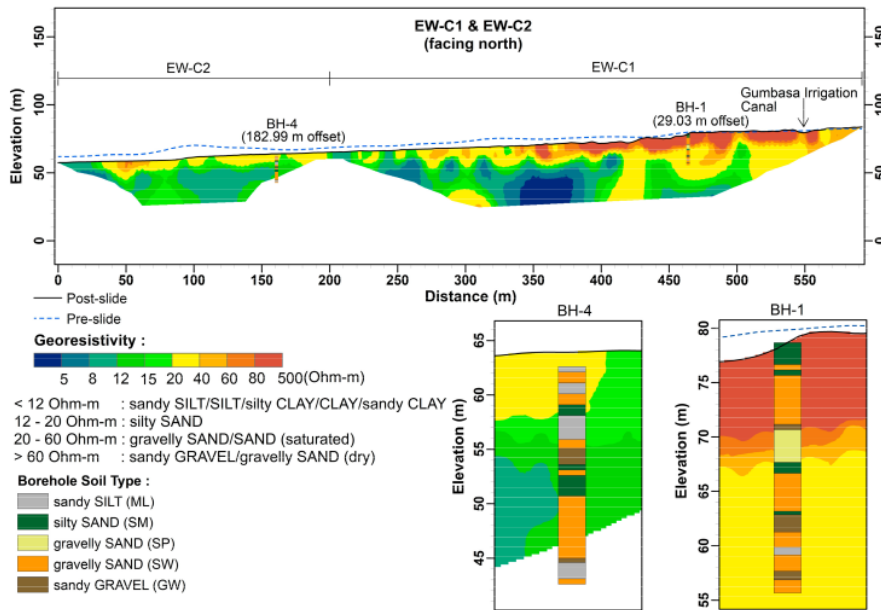
**Figure 6.** ERI profiles of EW-C1 and EW-C2 with comparison of borehole logs at BH-1 and BH-4.

Figure 6 shows the resistivity profiles of EW-C1 and EW-C2, with the boreholes BH-1 and BH-4, respectively. Profile EW-C1 was measured on the ground slide zone (GS) and the liquefaction spread zone (LS-1), as identified by Kusumawardani et al. [8]. Profile EW-C2, a continuation of EW-C1, was measured in the liquefaction flow zone (LF-1). From the profiles, it can be seen that the horizontal offsets of BH-1 and BH-4 are around 29 m and 183 m, respectively. The high resistivity values (>60 Ohm-m) as found in profile EW-C1 correspond to layers of dry sands and gravels. Considering the number of cracks visible on the GS and LS surfaces, as indicated by Kusumawardani et al. [8] and later in Figure 9, this profile clearly presents some disruptions and fractures at a shallower depth of the ground, ground which had been desiccated for a long time since the sliding. Further to the west, profile EW-C2 shows that the shallow ground of the LF zone is covered with gravelly and silty sands of moderate–low to moderate–high resistivity. The surficial layers of the profile are indicative of the liquefied materials that were transported from the upstream side, with relatively uniform distribution and less disruptions across the site.

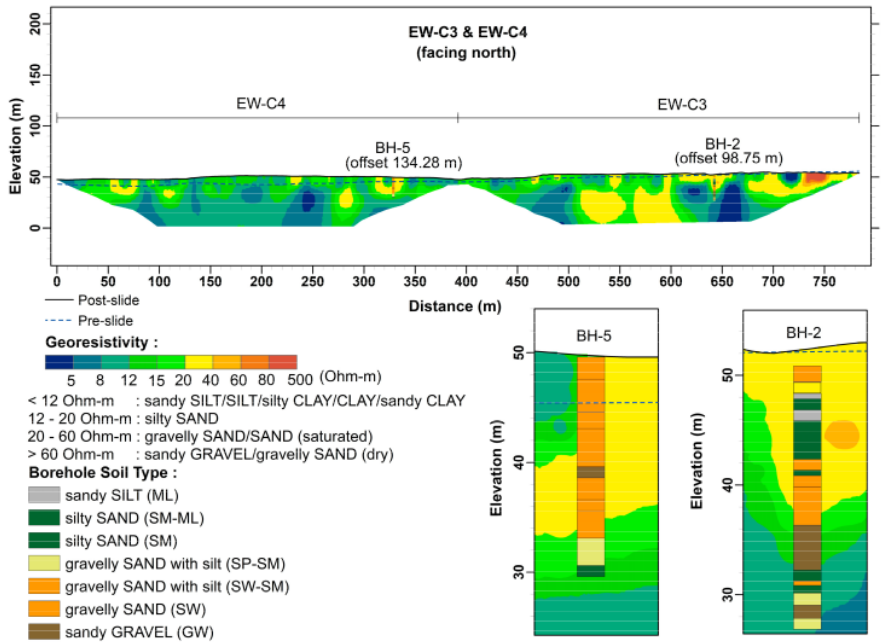
Figure 7. ERI profiles of EW-C3 and EW-C4 with comparison of borehole logs at BH-2 and BH-5.

junction of the liquefaction flow zone (LF-3) and debris flood zone (DF-1a), while profile EW-C4 is on the debris flood zone (DF-2). From the associated profiles, it can be seen that the horizontal offsets of BH-2 and BH-5 are approximately 99 m and 134 m, respectively. In profile EW-C3, high and moderate–high resistivity values, corresponding to gravelly sands or sandy gravels, are found to the east portion of the profile, probably due to a mixture of the onsite construction debris with the upstream liquefied soils. Profile EW-C4 and the middle portion of profile EW-C3 consist of moderate–low to low resistivity values, indicating that the surface materials of these profiles are most likely silty sands or sandy silts as a result of the liquefied debris from upstream.

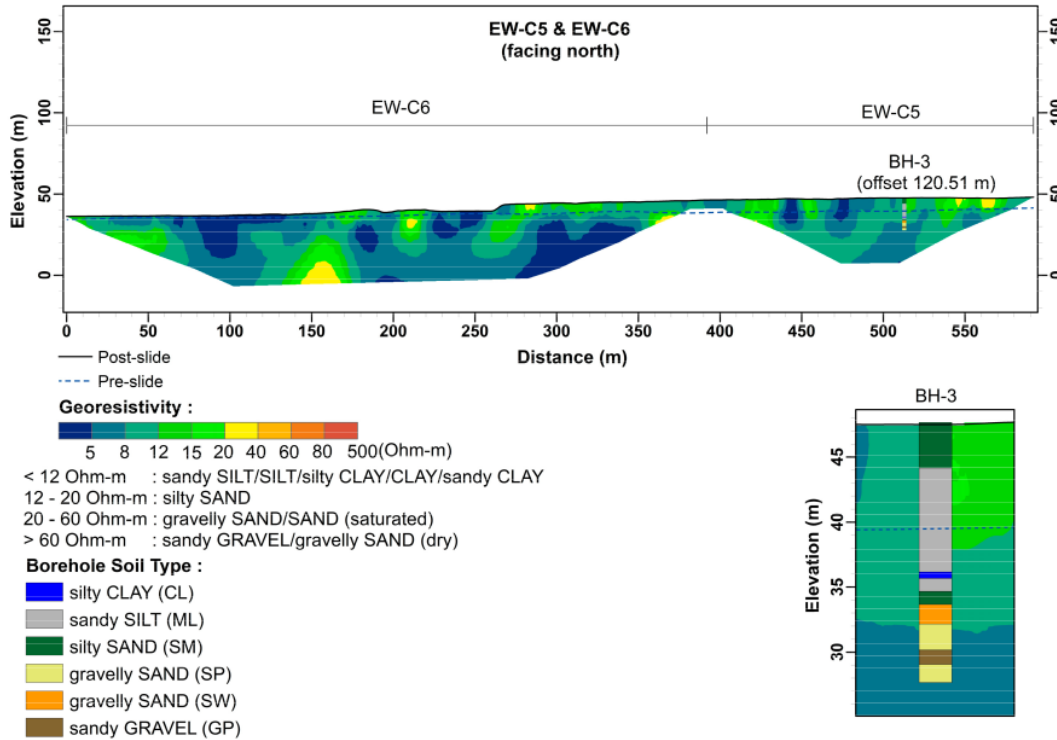
Figure 8. ERI profiles of ERI at EW-C5 and EW-C6 with comparison of borehole log at BH-3.

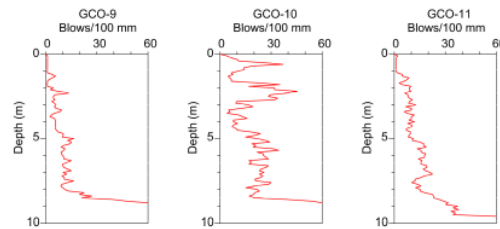
Figure 10 shows the results of GCO probing, located on the eastern portion of the road (Figure 2). The results indicate that the firm in situ layers are generally situated at a depth of 8~10 m below the post-slide ground. With the aid of other probings, i.e., the SPT-N profiles of boreholes current study [12], DCPT blowcounts [7], and Swedish soundings [12], as well as the ERI profiles of onsite materials discussed above, these results enable the establishment of an approximate boundary that delineates the junction between the relatively disturbed/loose sliding mass and the relatively undisturbed/firm in situ ground. Moreover, as will be discussed shortly, the liquefaction assessment results would be able to further verify whether the speculated boundary is the potential slip surface of the 2018 Petobo slide.

Figure 10. Results of GCO probing at Petobo site.

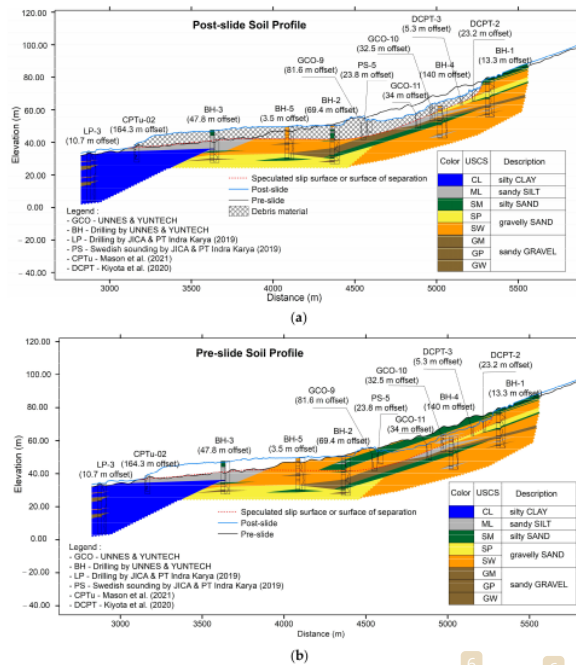
The results of the subsurface investigation are summarized and interpreted in Figure 11. Figure 11a shows the material stratification with the post-slide slope geometry of the site. Based upon the speculated boundary of the sliding mass and in situ ground, the figure approximately outlines the plausible mass of the 2018 sliding, including a major portion of the slip surface within the in situ ground and a small portion near the toe on the top of the ground surface, i.e., the surface of separation.

Figure 11b illustrates the material profile with the pre-slide slope geometry of the site. Since site investigations were performed after sliding, some of the boreholes were drilled at locations with ground elevations lower than their pre-slide levels. To reconstruct the pre-slide material profile, the missing data between the pre-slide and post-slide geometries were amended using the adjacent materials of the same boreholes, or the average data of materials at approximately the same elevations as the nearby boreholes. The amended pre-slide material profile indicates that soil layers are generally parallel to the ground in the crest and middle portions of the site. The soil materials presented in this area, in descending order, are more or less like silty SAND, gravelly SAND, sandy GRAVEL, etc. In the toe portion of the site, however, relatively thick layers of sandy SILT and silty CLAY are found.

Figure 11. Interpretation of material stratification profile along Moh. Soeharto road in Petobo sliding area: (**a**) post-slide surface geometry and (**b**) pre-slide surface geometry.

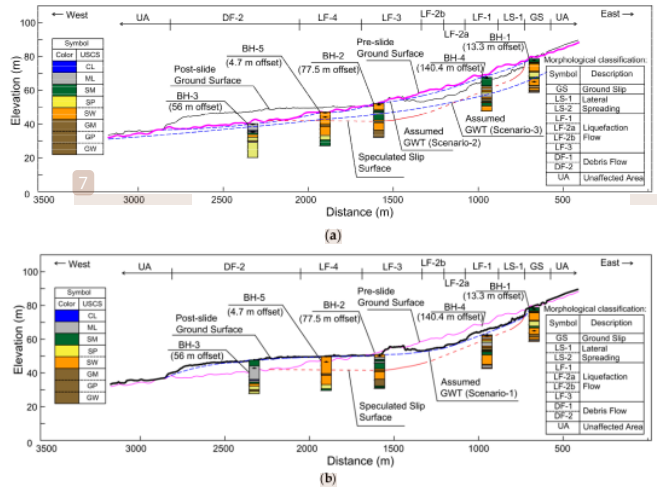
Figure 12. Interpretation of the assumed GWT condition, material stratification, and speculated slip surface in the profile along Moh. Soeharto road in Petobo sliding area: (**a**) post-slide surface geometry and (**b**) pre-slide surface geometry.

The results of liquefaction assessment associated with the liquefied zones identified for each of the boreholes are synthesized. A speculated slip surface connecting the liquefied zones of boreholes can therefore be delineated and is shown in Figure 12. It is noted that the speculated slip surface of the 2018 Petobo flowslide, based on the liquefaction assessment herein, is in good agreement with the speculated boundary of the sliding mass and in situ ground, as discussed previously through the results of probing and sounding during site investigation (Figure 11). It is also noted that the speculated slip surface as identified through the liquefaction assessment of scenario 1 (post-slide geometry and high GWT) is almost the same as that defined by the liquefaction assessment of scenario 2 (pre-slide geometry and high GWT). In accordance, the speculated slip surface is determined to generally pass through the weak interfaces of material layers and presents

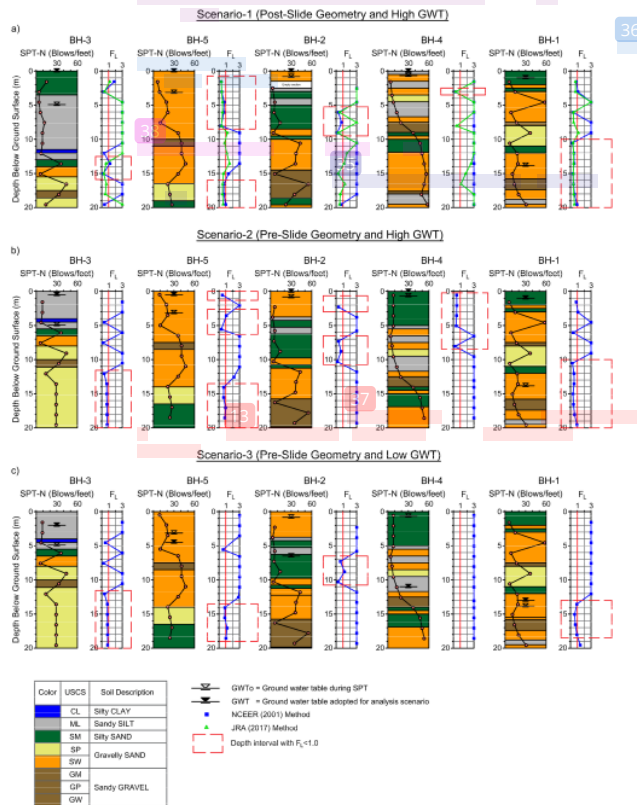
Figure 13 shows the results of liquefaction assessment for the three analysis scenarios. Both Seed/NCEER [33] and JRA [34] methods were adopted in the assessment for scenario 1. The results show general consistency between the methods, with only minor differences in the assessed factor of safety against liquefaction (F_L). The differences might have been due to the fact that the Seed/NCEER method does not consider gravels to be a liquefiable soil type. In view of its general acceptance and extensive usage worldwide, the Seed/NCEER [33] method is the major tool used for the assessment of liquefaction in this study.

The borehole BH-1 results indicate that the top soil layers with a thickness of 10 m or more would generally not liquefy and only the soils below would have a computed factor of safety against liquefaction (F_L) of less than unity, for all of the analysis scenarios assessed. In view of the studies by Ishihara [48] and Dobry [49], the 10-m-thick non-liquefied upper layer at this location would likely prevent the influence of the underneath liquefied soils and hence the effect on the ground surface. The onsite observations by Kusumawardani et al. [8] confirm that the ground surface in the neighborhood of BH-1 consisted of a series of cracks with no phenomena of soil liquefaction, which was classified as the ground slide (GS) zone, as shown in Figure 9a.

Figure 13. Results of soil liquefaction analysis: (**a**) scenario 1 (post-slide and high GWT), (**b**) scenario 2 (pre-slide and high GWT), and (**c**) scenario 3 (pre-slide and low GWT).

The borehole BH-4 results show that soil liquefaction is identified at a depth of around 3 m in the post-slide profile of scenario 1 and a zone from the surface to approximately 9 m deep in the pre-slide profile of scenario 2. Due to variations in pre-slide and post-slide ground surfaces, the elevations of liquefied depth in the profiles of scenarios 1 and 2 are nearly the same, indicating that the depth of liquefaction (i.e., the sliding surface) at this location was approximately 9 m below the pre-slide ground surface. For scenario 3, however, no liquefaction was found within the first 20 m of the pre-slide ground, implying that the drop in groundwater level as a result of the termination of surface water infiltration (i.e., the Gumbasa irrigation system and onsite paddy fields) significantly prevented soil liquefaction at this location.

The borehole BH-2 results denote that the zones of soil liquefaction were found at a depth of around 5~10 m in the post-slide geometry of scenario 1 or around 6~11 m in the pre-slide geometry of scenarios 2 and 3. In terms of elevations, the liquefied depths of these analysis scenarios were about the same, indicating that the depth of liquefaction (i.e., sliding surface) at this location was around 11 m below the pre-slide ground surface. It is important to note, however, that the liquefaction zone is also identified in scenario 3, under the conditions of a pre-slide slope and low groundwater table, suggesting that soil liquefaction would be triggered at this location even if the influence of surface water infiltration was prohibited and the groundwater table was dropped to a minimum level.

The borehole BH-3 results of liquefaction assessment are shown in Figure 13, with sparse depths of liquefaction found at 12 m and 15 m in the post-slide profile of scenario 1, or at 5 m and 8 m in the pre-slide profile of scenarios 2 and 3. Due to a relatively thick layer of silts and clays at this borehole location, the assessment indicates that soil layers in the upper 10 m are generally capable of resisting soil liquefaction caused by the earthquake. Despite a lower zone of liquefaction being identified at a depth of below 19 m in the post-slide profile of scenario 1 or below 12 m in the pre-slide profile of scenarios 2 and 3, the upper non-liquefied layers of approximately 4 m or more in thickness would likely provide buffers and prevent the influence of lower liquefied zones on the ground surface, as suggested by Ishihara [48] and Dobry [49].

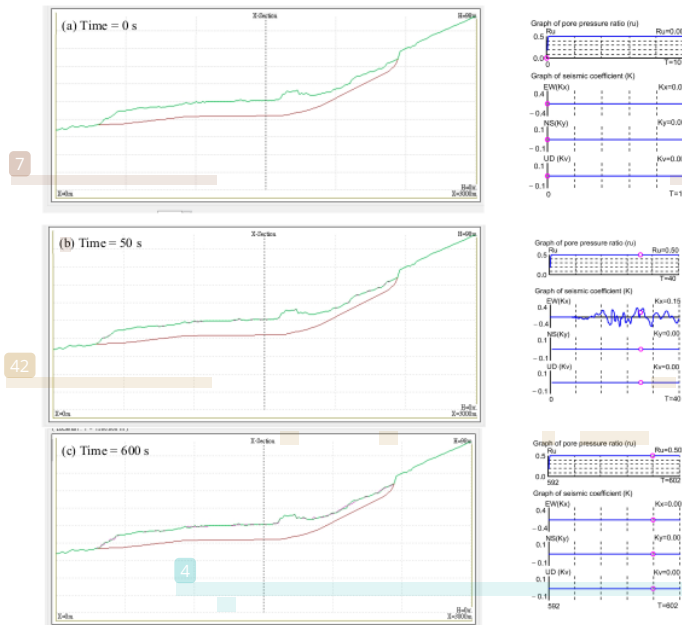
The results of flowslide simulation for scenario 1 in various computation stages are presented in Figure 14, in which the green and pink lines represent the initial post-slide ground surface (i.e., before computation) and the configuration of the sliding mass in progress, respectively. The results indicate that at second strike of the same earthquake on the failed Petobo site would cause minor deformations of the slope, till the end of computation of 600 s. The computed total displacement and maximum speed of the sliding mass are shown in Figure 17. The results imply that the initial strike of the earthquake that triggered the 2018 flowslide has resulted in a stabilized (post-slide) slope geometry, which would prevent a re-initiation of the flowslide of the failed slope by a second strike of the same earthquake.

Figure 14. Results of LS-Rapid simulation for scenario 1 (post-slide geometry and high GWT). (Note: "green" and "pink" lines represent the slope geometries before and after computations, respectively; and "red" line is the assumed slip surface.).

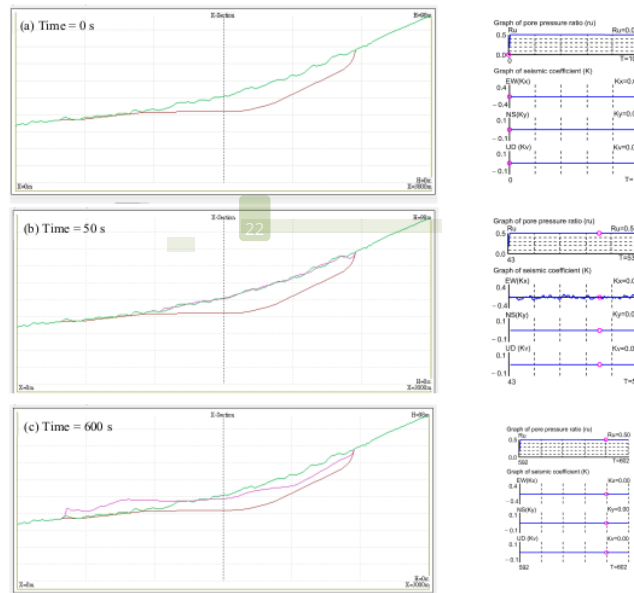
Figure 15. Results of LS-Rapid simulation for scenario 2 (pre-slide geometry and high GWT). (Note: "green" and "pink" lines represent the slope geometries before and after computations, respectively; and "red" line is the assumed slip surface.)

The results of flowslide simulation for scenario 2 are illustrated in Figure 15, with various stages of sliding computation. scenario 2 is assumed for the case of the Petobo site when subjected to the 2018 earthquake shaking. The Petobo site had pre-slide geometry and a raised groundwater table as a result of the constant ground infiltration of the Gumbasa irrigation system and onsite paddy fields. The computed displacement and speed of the sliding mass are shown in Figure 17. As illustrated in Figures 15 and 17, the flowslide started at approximately the same time as the initiation of earthquake shaking. The sliding speed reached a maximum value of approximately 15 m/s at a computation time of 163 s, then gradually decreased and ceased at a computation time of 240 s. The maximum displacement was 581.7 m. The computed final configuration of the sliding mass is comparable to the observed post-slide geometry, as indicated by the green line in Figure 14, in terms of the

shape and sliding distance, implying that the simulation of scenario 2 would result in a significant flowslide that resembles the 2018 Petobo slide.

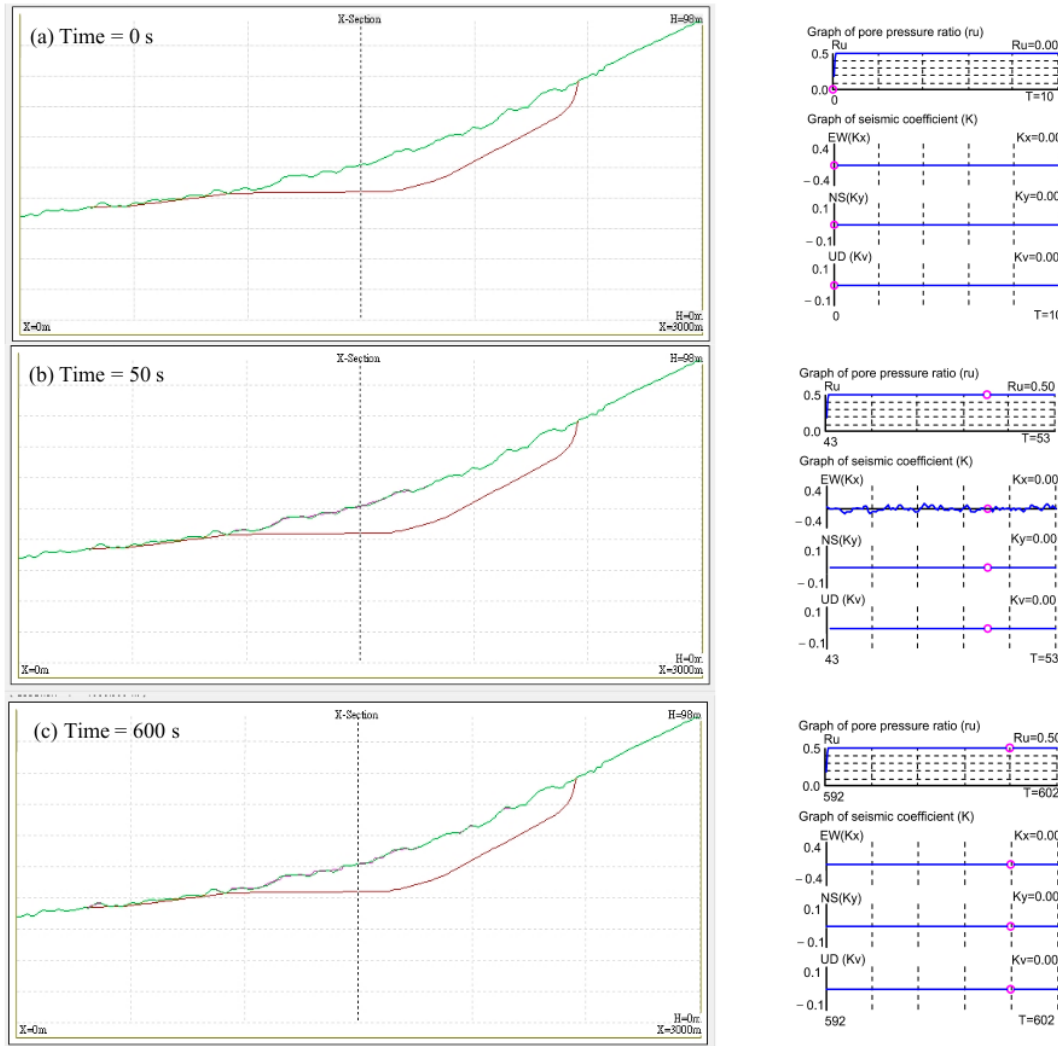
Figure 16. Results of LS-Rapid simulation for scenario 3 (pre-slide geometry and low GWT). (Note: "green" and "pink" lines represent the slope geometries before and after computations, respectively; and "red" line is the assumed slip surface.)

The results of scenario 3 are presented in Figures 16 and 17. This scenario was used to examine the likelihood of the 2018 Petobo flowslide in the case of no infiltration of surface water (from irrigation system and wet paddy fields) and a low groundwater table of the site. As shown, the Petobo slope would not initiate a flowslide after the 2018 earthquake shaking if the deposit was desiccated and the groundwater level was low, even if some liquefiable zones were identified at depth in the middle portion of the site (i.e., BH-2). The results indicate that the slope stopped moving at a computation time of 45 s after earthquake shaking, and the maximum displacement of the slope was only about 1 m.

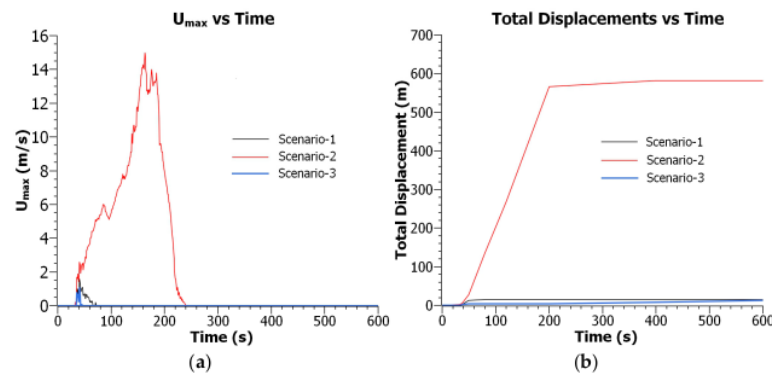
Figure 17. Results of LS-Rapid simulation in scenario 1, scenario 2, and scenario 3. (**a**) Maximum velocity vs. time, and (**a**) total displacements vs. time.

the slope after earthquake shaking and soil liquefaction. The simulation indicated that the sliding was initiated at a computation time of approximately 33 s after the start of earthquake shaking and ceased at approximately 240 s (Figure 17). The total time of sliding would appear to be much shorter than the witness accounts, as detailed by Kusumawardani et al. [8]. The computed configuration of the slope after sliding, however, resembles the final geometry of the onsite failed slope, in terms of its shape and the sliding distance.
