Understanding of Petobo liquefaction flowslide by 2018.09.28 Palu-Donggala Indonesia earthquake based on site reconnaissance

Keywords Liquefaction flowslide · Site reconnaissance · Morphological characterisation · 2018 Palu earthquake

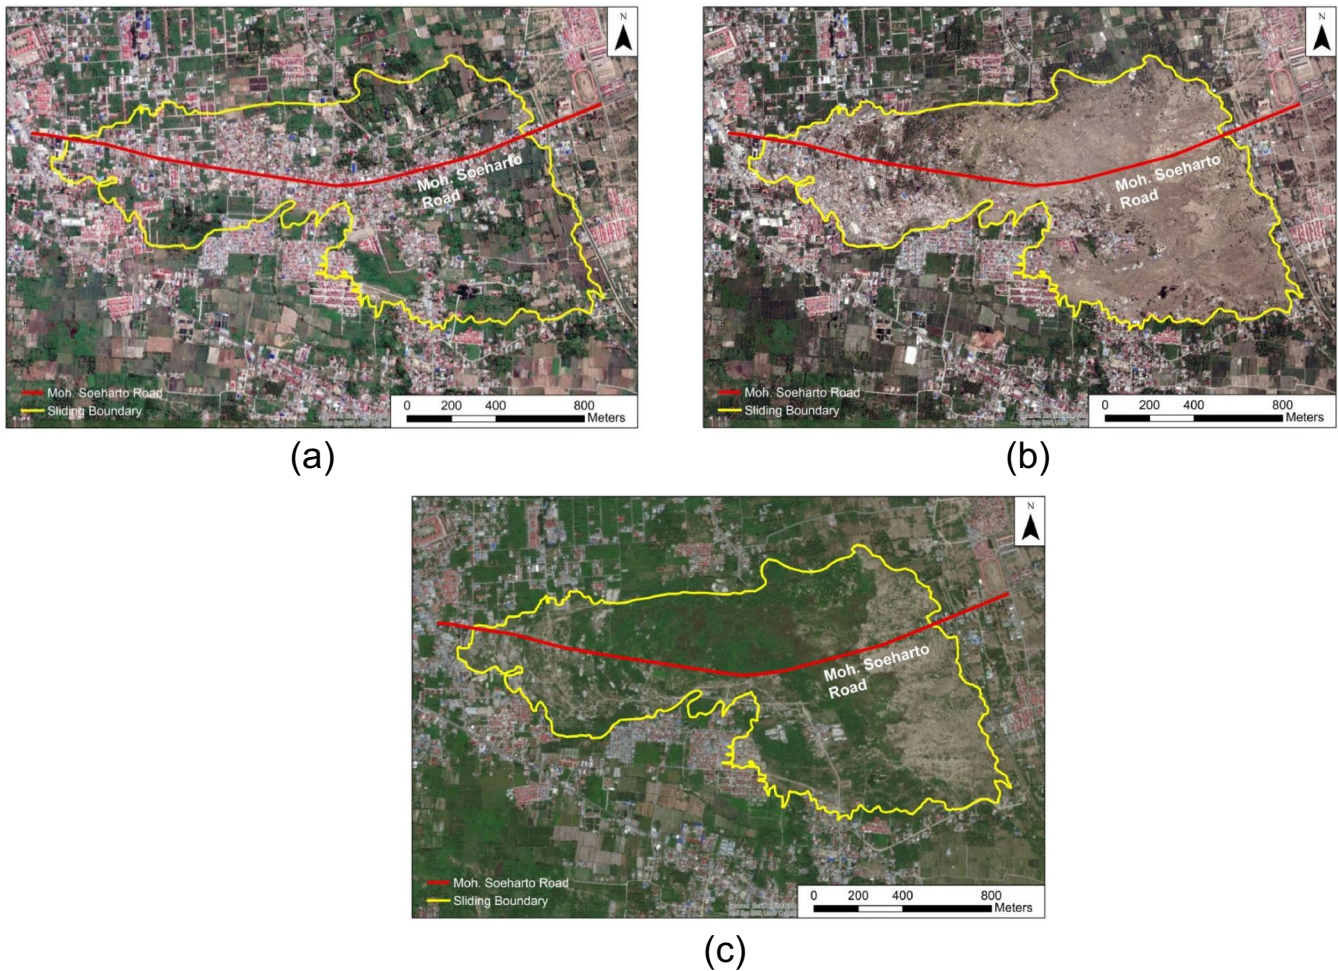
The earthquake caused land-use changes in Petobo area. Figure 6 illustrates the land-use changes at different periods. As shown in Fig. 6 a, the eastern and southern parts of the Petobo flowslide area before earthquake were mostly paddy fields, while residential area was densely populated in the western and middle parts. A main

road of Moh. Soeharto passed across the flowslide zone from east to west. The earthquake shaking obviously destructed the eastern part of site and swept away everything, such as people, properties and houses, westwards. Figure 6 b indicates the area hit by liquefaction flowslide was covered by debris on the surface in brown colour. Figure 6 c shows the condition of the site 1 year after the disaster. As can be seen, the area was almost preserved, as confirmed by our team during site investigation, where no reconstruction was noticed and the damaged infrastructures could be observed as an accumulation of ruined debris in the western part of flowslide area.

Fig. 6 Site conditions before and after earthquake are documented at three different times taken from Google Earth. **a** Before the slide on 2018.08.17, the site could be seen with dense population. **b** Four days after the slide on 2018.10.02. **c** Recent image on 2019.11.06

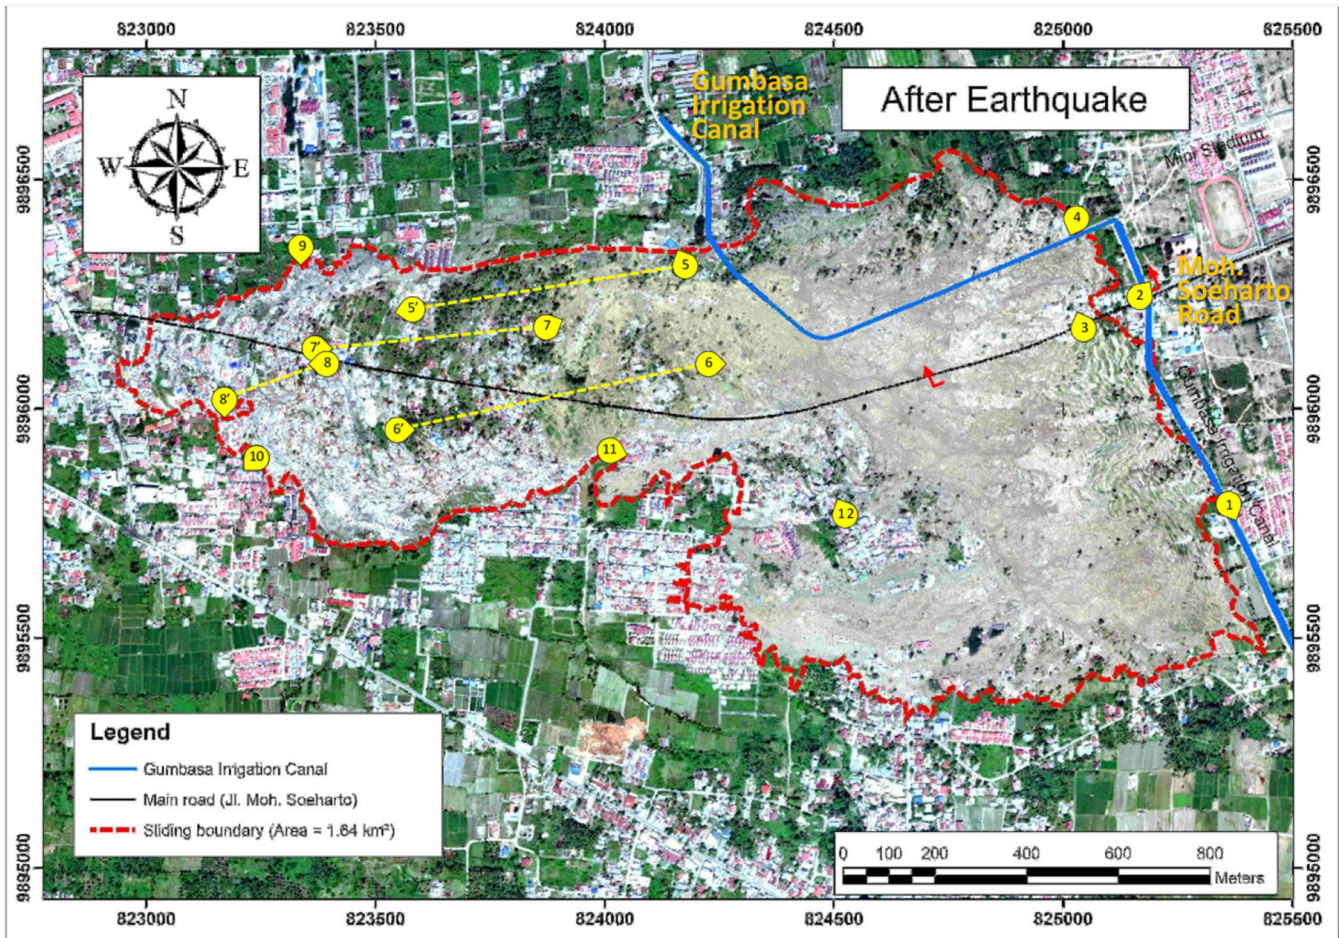
Fig. 9 Locations of key features at Petobo site for pre- and post-slide comparison, with also the location of mapped section along Moh. Soeharto road discussed in the later part of this paper. The base photo is taken from Google Earth satellite image of 2018.10.02

Google earth images prior to earthquake are compared with the results of our onsite observations for some key features at the site. Figure 9 indicates locations of the key features and Fig. 10 is the photo pairs of features for the comparison of variations before and after the earthquake.

Photos 1 and 2 show the Gumbasa irrigation canal located along the eastern boundary of the sliding area. As seen, the canal was unlined and full with water prior to the earthquake. However, the earthquake had triggered slippages of the ground, causing cracks and drainage of the canal. Photos 3 and 4 are for surface features at east side and northeast corner of the sliding area. As indicated, the ground had been seriously distorted and displaced, apparently the result of liquefaction spreading during the earthquake.

Photos 5–8 show four key features originally situated in the middle and western portions of the area. As seen in Fig. 9, these features had been displaced towards west with a distance of 250–700 m. Some of the features would appear to be structurally sound (Photo 6, mosque); however, some of them had been severe

damaged or torn (Photos 7 and 8, residential buildings). The phenomena would suggest the ground had been liquefied as a result of earthquake shaking and flowed, with driving forces and low resistance, for a large distance.

Photos 9–12 illustrate three surface features sitting around the western peripheral of the sliding area and one feature located near the previously mentioned undamaged area (Fig. 7b) to the southern portion of Petobo site. As shown in these

photos, the sliding debris had deposited and piled up on the ground to a height of 3~6 m, as compared with the adjacent unaffected area.

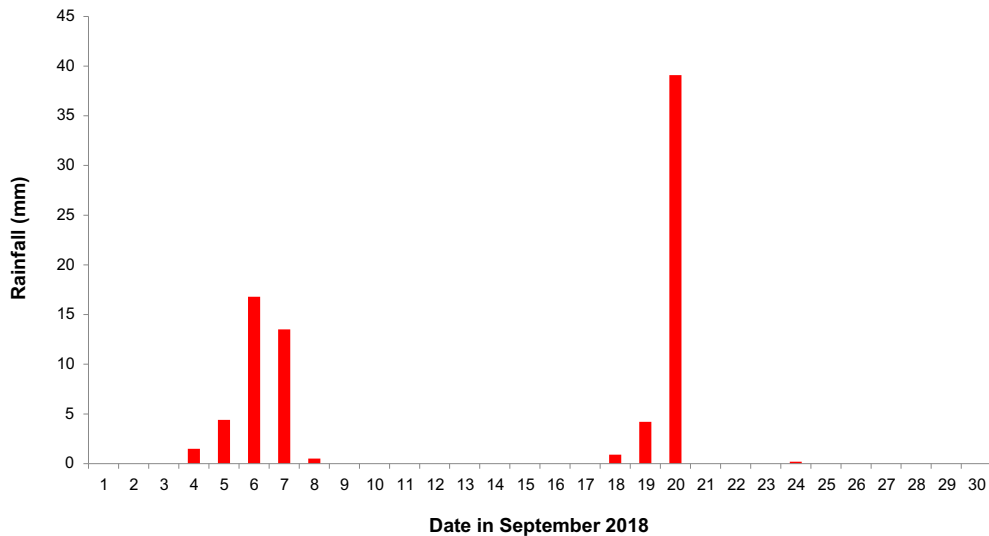
would be submerged at least by water about 30–50 cm above the soil surface for plantation purposes. Furthermore, the intensive irrigation systems to paddy fields from Gumbasa canal would constantly supply the local ground water tables under the paddy fields. In our opinion, the rainfall would appear to not really affect the increase of ground water table under the paddy fields as reference to Fig. 14, which clearly indicates the absence of rain a week before the flowslide occurred.

Fig. 14 Daily rainfall intensity during September 2018 in study area which clearly indicates the absence of rain a week before the flowslide occurred (Meteorological, Climatological and Geophysical Agency 2021)

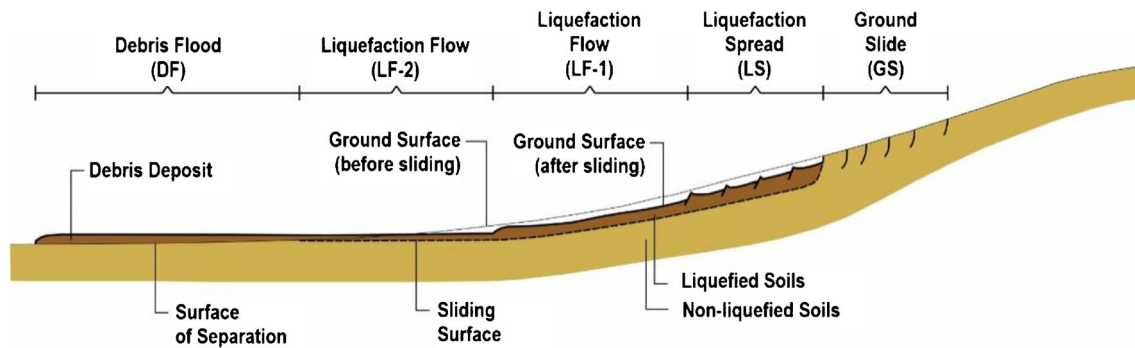
to the initiation and the progress of sliding in Petobo during the earthquake. To be consistent with the terminologies commonly adopted in geotechnical engineering as indicated by Hungr et al. (2014), we propose four types of morphological features for this study, as depicted in the schematic illustration shown in Fig. 17. The associated definitions of the morphological features are addressed below.

Ground slide “Ground slide” (GS) is a phenomenon of failure by the slippage of coherent earthen materials, as identified between Mileages 0~130 m of the mapped section (Fig. 15) and illustrated in Fig. 17. Generally, cracks or scarps are visible on the surface, which

divide the ground into several chunky earthen blocks. Ground slides may be triggered by a sudden increase in the inertia of ground, such as earthquake shaking, and/or due to a decrease or loss of the downslope supports, such as a cut at slope toe. The sliding/slip surfaces are basically passing through the intact earthen mass, which is not liquefied during the ground shaking.

Liquefaction spread “Liquefaction spread” (LS) is a phenomenon of failure by the laterally cyclic spreading of earthen crust due to underneath liquefied soils in the process of shaking, as appeared in the mapped section between Mileages 130~290 m (Fig. 15) and in Fig. 17. Surface manifestations of liquefaction spread may include a series of linear cracks or earthen peaks (ridges) with broken and lowered ground sideways (i.e., horst and graben terrain). Surface structures may be destroyed, tilted or distorted (elongated) as a result of the cyclic movements and spreading of earthen crust. Extruded liquefied sands may be found on the ground in areas of cracking and peaking. Liquefaction spreads are triggered by the liquefaction of underneath soils. Due to cyclic nature of shaking, the earthen crust will move back and forth laterally, resulting in a gradual spreading, and a lowering height as well, in a direction with less lateral restraints.

Liquefaction flow “Liquefaction flow” (LF) is a phenomenon of failure by the monotonic sliding or flowing of fully liquefied earthen materials, occurring primarily after the earthquake shaking, as depicted in Mileages 290~492 m and beyond of the mapped section (Fig. 15) and in Fig. 17. The ground surface of liquefaction flows is usually uneven and bumpy with extensive exposures of liquefied sands. Structures on the liquefied surface may sink (buried), tilt or float with the flow for a large distance. Liquefaction flows usually occur in an inclined ground in which the earthen materials are fully saturated and liquefied due to ground shaking. As a result of the gravity and/or additional driving forces from upper sides of the slope, such as by ground slips or liquefaction spreads, the liquefied earthen materials may start flowing downslope following the shaking. Liquefaction flow may proceed in

Fig. 17 Schematic illustration of types of morphological zonation observed in Petobo sliding area due to 2018 Palu-Donggala earthquake
