Landslides (2021) 18:3163–3182
 DOI 10.1007/s10346-021-01700-x
 Received: 9 December 2020
 Accepted: 13 May 2021
 Published online: 6 June 2021
 © Springer-Verlag GmbH Germany
 part of Springer Nature 2021

Rini Kusumawardani · Muhsung Chang · Togani Cahyadi Upomo · Ren-Chung Huang ·
 Muhammad Hamzah Fansuri · Galih Ady Prayitno

Understanding of Petobo liquefaction flowslide by 2018.09.28 Palu-Donggala Indonesia earthquake based on site reconnaissance

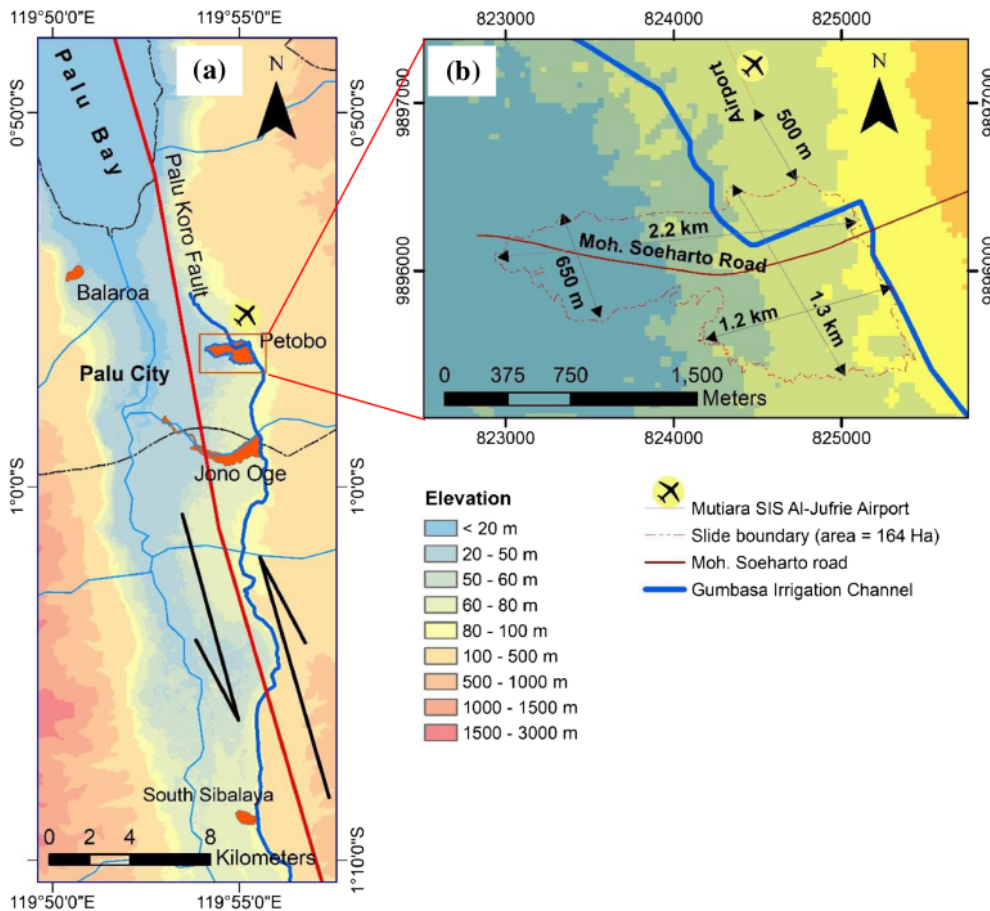
Fig. 2 (a) Flowslide locations after Palu-Donggala earthquake of 2018.09.28. (b) Dimensions of Petobo flowslide. Credit: Base map adapted from GADM, base digital elevation model derived from JAXA's ALOS Global Digital Surface Model 30 m × 30 m resolution

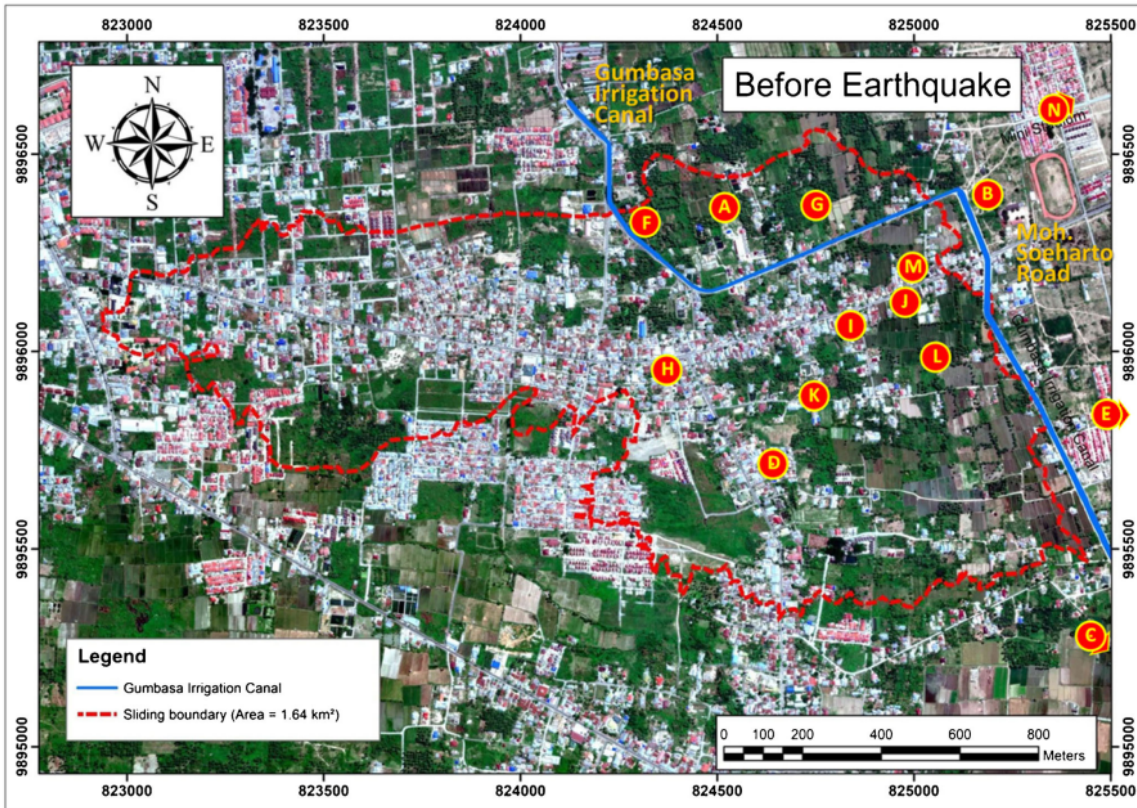
With respect to liquefaction phenomena, most of the interviewees observed the ground extruded by dark muddy water, resemblance to mortar, which was warm and with an erupted height up to around 2 m and 5 m, in the NE and SE portions, respectively, of the sliding area. Few big eruptions of sands were also observed near the central portion, approximately along Moh. Soeharto road of the sliding area, with eruptions up to a coconut tree high. For post-slide observations of the ground, most interviewees indicated the ground was very wet and soft, and some places were ponded with water up to 1 m. It took months for the ponded lands to be gradually retreated. In fact, when the research team of this study visited the site in early 2020, several locations in the middle portion of the sliding area were still ponded with water. Those waters were believed to have been formed as a result of extruded pore water due to severe liquefactions of the ground by the shaking.

Fig. 5 Locations where interviewed witnesses were in the Petobo area during 2018.09.28 Palu-Donggala earthquake. Based photo is taken from Google Earth satellite image of 2018.08.17

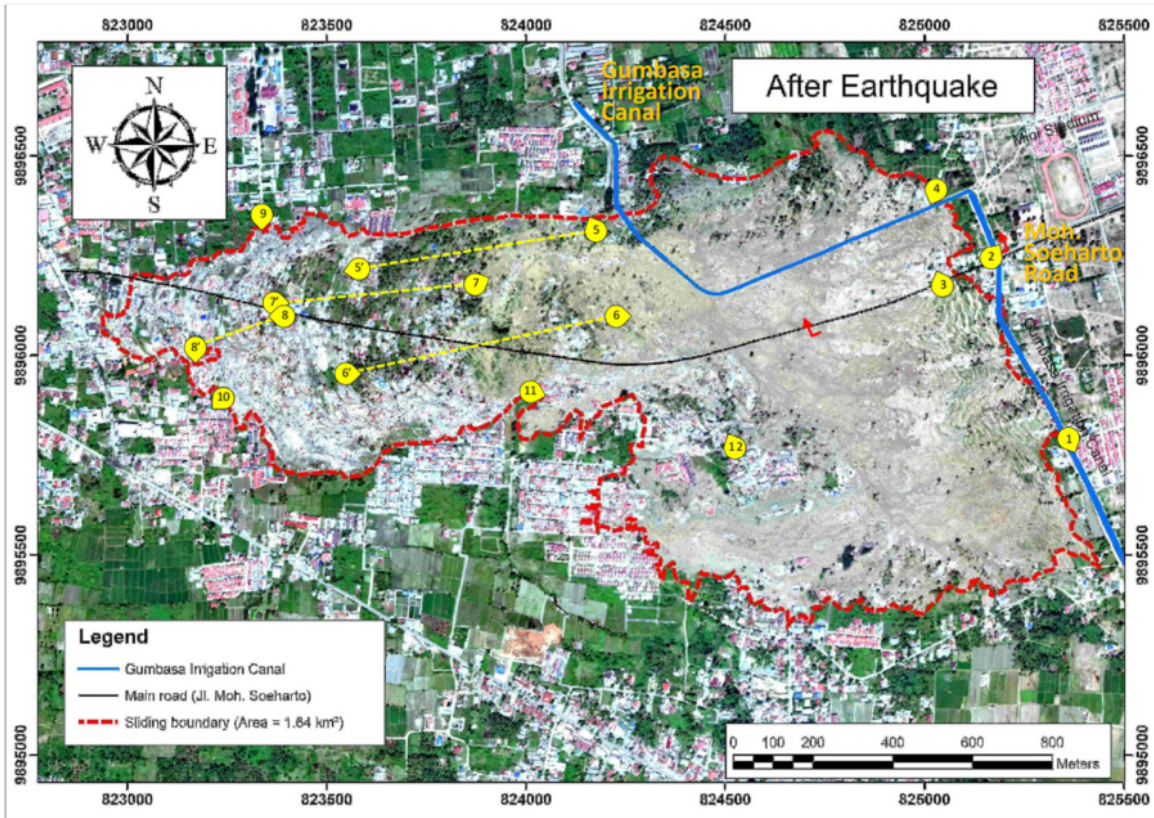
Fig. 9 Locations of key features at Petobo site for pre- and post-slide comparison, with also the location of mapped section along Moh. Soeharto road discussed in the later part of this paper. The base photo is taken from Google Earth satellite image of 2018.10.02

Photos 1 and 2 show the Gumbasa irrigation canal located along the eastern boundary of the sliding area. As seen, the canal was unlined and full with water prior to the earthquake. However, the earthquake had triggered slippages of the ground, causing cracks and drainage of the canal. Photos 3 and 4 are for surface features at east side and northeast corner of the sliding area. As indicated, the ground had been seriously distorted and displaced, apparently the result of liquefaction spreading during the earthquake.

Photos 5–8 show four key features originally situated in the middle and western portions of the area. As seen in Fig. 9, these features had been displaced towards west with a distance of 250–700 m. Some of the features would appear to be structurally sound (Photo 6, mosque); however, some of them had been severe

damaged or torn (Photos 7 and 8, residential buildings). The phenomena would suggest the ground had been liquefied as a result of earthquake shaking and flowed, with driving forces and low resistance, for a large distance.

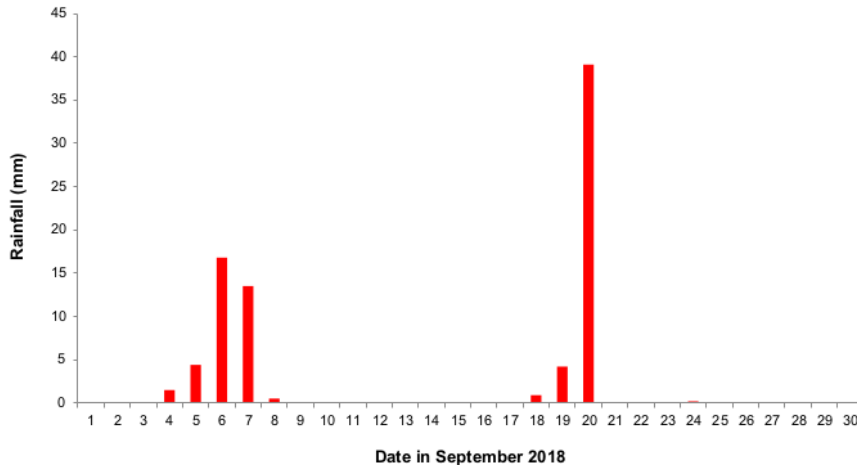
would be submerged at least by water about 30–50 cm above the soil surface for plantation purposes. Furthermore, the intensive irrigation systems to paddy fields from Gumbasa canal would constantly supply the local ground water tables under the paddy fields. In our opinion, the rainfall would appear to not really affect the increase of ground water table under the paddy fields as reference to Fig. 14, which clearly indicates the absence of rain a week before the flowslide occurred.

Fig. 14 Daily rainfall intensity during September 2018 in study area which clearly indicates the absence of rain a week before the flowslide occurred (Meteorological, Climatological and Geophysical Agency 2021)

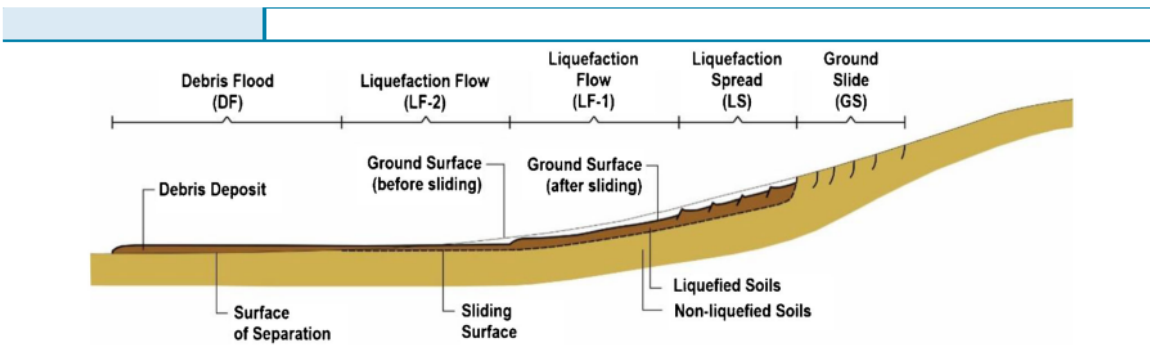
Ground slide “Ground slide” (GS) is a phenomenon of failure by the slippage of coherent earthen materials, as identified between Mileages 0–130 m of the mapped section (Fig. 15) and illustrated in Fig. 17. Generally, cracks or scarps are visible on the surface, which

divide the ground into several chunky earthen blocks. Ground slides may be triggered by a sudden increase in the inertia of ground, such as earthquake shaking, and/or due to a decrease or loss of the downslope supports, such as a cut at slope toe. The sliding/slip surfaces are basically passing through the intact earthen mass, which is not liquefied during the ground shaking.

Fig. 17 Schematic illustration of types of morphological zonation observed in Petobo sliding area due to 2018 Palu-Donggala earthquake

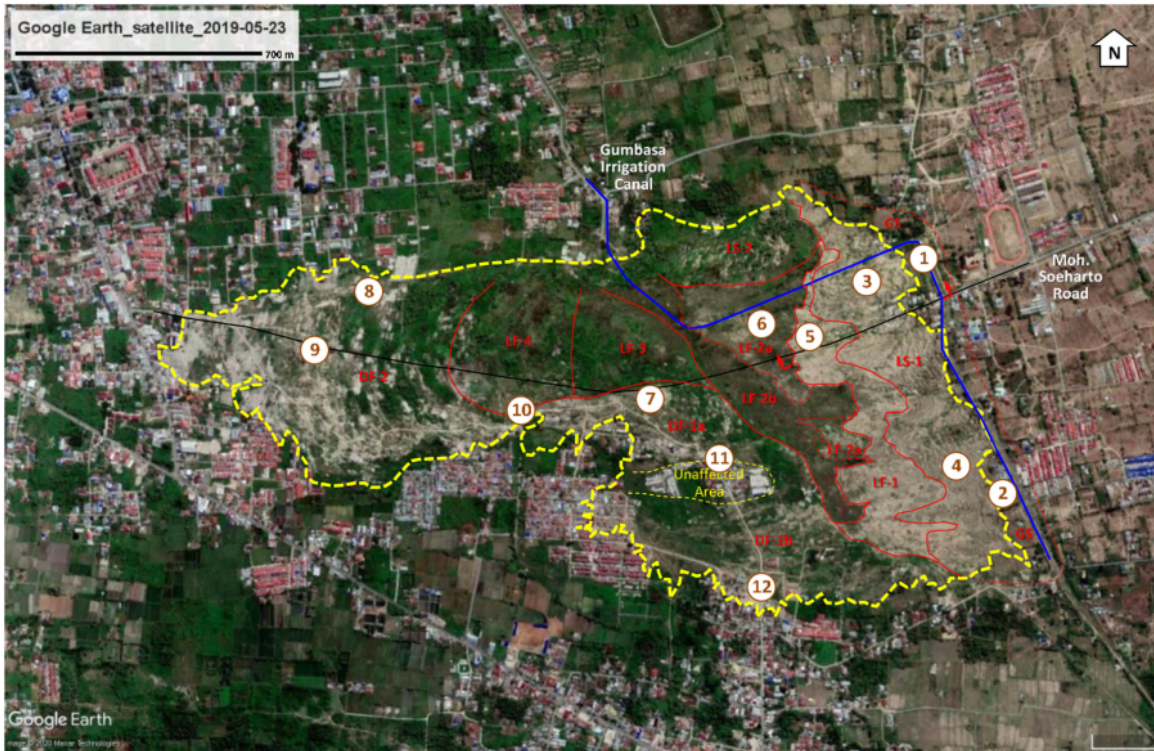
The characterised and defined morphological features, mainly based upon the mapping along Moh. Soeharto road, are further applied for the zonation of entire sliding area in Petobo, and the results are shown in Figs. 19 and 20. As seen in Fig. 19, the ground slide (GS) falls in a narrow zone approximately along Gumbasa

irrigation canal and in adjacent to the eastern boundary of the sliding area. Photos 1 and 2 of Fig. 20 show representative features (i.e. cracks and slides) of the ground slide surface. Liquefaction spread (LS) zone is neighbouring to the west of GS zone, with a width of about 300 m in east-west direction. Photos 3 and 4 of Fig.

Liquefaction flow (LF) zones are further to the west of the LS zone. As seen in Photos 5 and 6 of Fig. 20, the liquefaction flow surface is generally uneven and bumpy with extensive exposures of liquefied sands. During onsite investigation, we observed the liquefaction flow area could be subdivided into several small zones or stages, as depicted in Fig. 19. It is speculated that the causes might have been due to the changes in viscosity of liquefied soils during slide, the reoccurrence of post-shakings to the site or some other reasons yet to be found.

Debris flood (DF) zones are bordered to the west of LF zones, near the toes to the west and south of the sliding area (Fig. 19). The ground surface of DF zones was covered by the liquefied soils and construction debris from the upstream side, and raised up its elevation up to about 8 m from the existing ground. Photos 7–12 of Fig. 20 show the debris deposits on the east and south strands of the slide, with a mixed composition of liquefied soils and construction remains, as well as elevated grounds as compared with the adjacent buildings unaffected by the debris flooding.

Fig. 19 Zonation of morphological features at Petobo sliding area, with locations of photos of representative morphologic features showing in the subsequent figure, as well as the location of mapped section along Moh. Soeharto road
