**BUKTI KORESPONDENSI ARTIKEL PADA
JURNAL INTERNASIONAL BEREPUTASI**

| Judul | : | Understanding of Petobo liquefaction flowslide by 2018.09.28 Palu-Donggala Indonesia earthquake based on site reconnaissance |
| Jurnal | : | <i>Landslide Journal</i> |

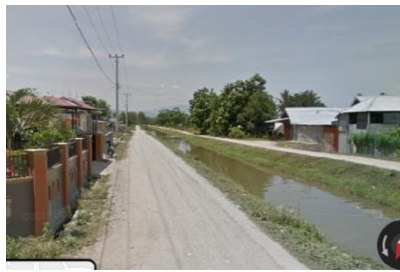
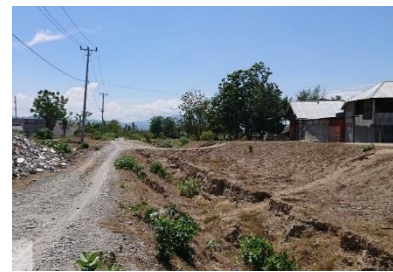
Photo 1. Before EQ (looking S)

Photo 1'. After EQ (looking S)

Fig. 10 Photo pairs showing some key features at Petobo site before and after the earthquake. Pre-earthquake photos are captured from Google street view. Locations of the photo pairs are indicated in the previous figure.

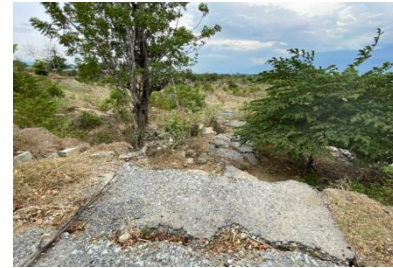
Photo 4. Before EQ (looking SW)

Photo 4'. After EQ (looking SW)

Photo 4 (Type: LS)

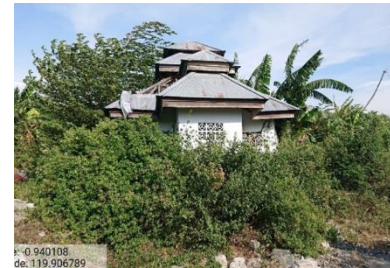
Photo 6. Before EQ (looking E)

Photo 6'. After EQ (looking E)

Photo 6 (Type: LF)

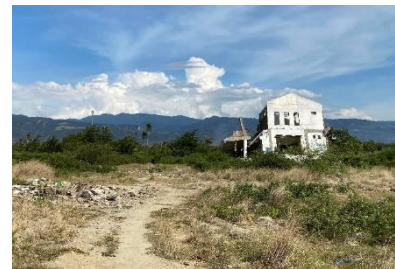
Photo 7. Before EQ (looking E)

Photo 7'. After EQ (looking E)

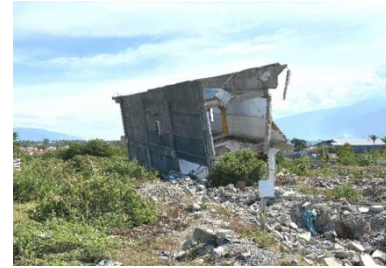
Photo 8. Before EQ (looking W)

Photo 8'. After EQ (looking S)

Photo 8 (Type: DF)

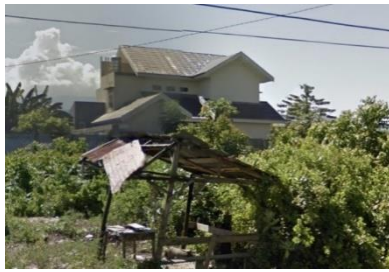
Photo 9. Before EQ (looking SE)

Photo 9'. After EQ (looking SE)

Photo 9 (Type: DF)

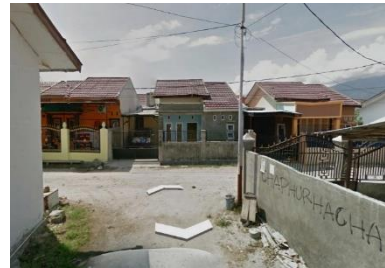
Photo 10. Before EQ (looking SW)

Photo 10'. After EQ (looking SW)

Photo 10 (Type: DF)

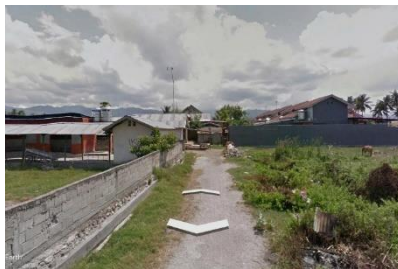
Photo 11. Before EQ (looking E)

Photo 11'. After EQ (looking E)

Photo 11 (Type: DF)

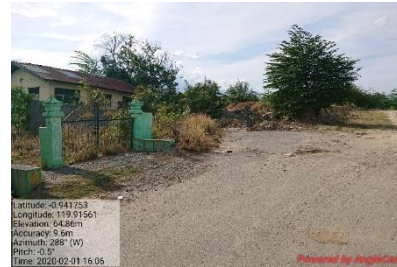
Photo 12. Before EQ (looking NW)

Photo 12'. After EQ (looking NW)

Photo 12 (Type: DF)

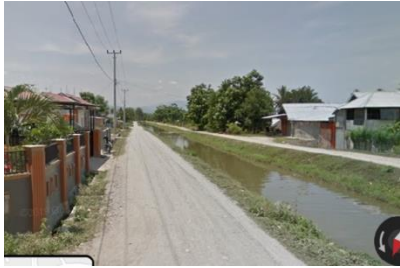
Photos 1 & 2 show the Gumbasa irrigation canal located along the eastern boundary of the sliding area. As seen, the canal was unlined and full with water prior to the earthquake. However, the earthquake had triggered slippages of the ground, causing cracks and drainage of the canal. Photos 3 & 4 are for surface features at east side and northeast corner of the sliding area. As indicated, the ground had been seriously distorted and displaced, apparently the result of liquefaction spreading during the earthquake.

Photo 1. Before EQ (looking S)

Photo 1'. After EQ (looking S)

As indicated by local residents and in Google Earth images, Gumbasa irrigation canal was constantly filled with water before the earthquake (Photos 1 & 2; Fig. 10) and the paddy fields were also inundated with water for about 8-months plantation time annually, which are based on our site reconnaissance as summarized in Table 1. During the plantation, the paddy fields would be submerged at least by water about 30-50 cm above the soil surface for plantation purposes. Furthermore, the intensive irrigation systems to paddy fields from Gumbasa canal which would constantly supply the local ground water tables under the paddy fields. In our opinion the rainfall would appear not really affect the increase of ground water table under the paddy fields as reference to Fig. 14, which clearly indicates the absence of rain a week before the flowslide occurred.

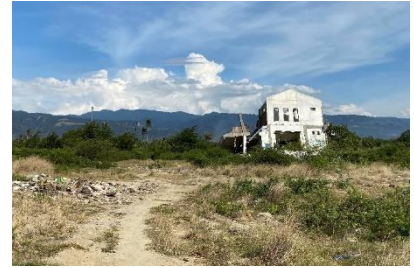
Photos 5~8 show four key features original situated in the middle and western portions of the area. As seen in Fig. 9, these features had been displaced towards west with a distance of 250~700 m. Some of the features would appear to be structurally sound (Photo 6, mosque), however, some of them had been severe damaged or torn (Photos 7 & 8, residential buildings). The phenomena would suggest the ground had been liquefied as a result of earthquake shaking and flowed, with driving forces and low resistance, for a large distance.

Photo 7. Before EQ (looking E)

Photo 7'. After EQ (looking E)

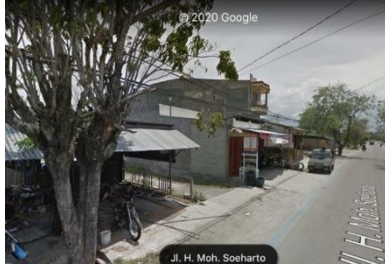
Photo 8. Before EQ (looking W)

Photo 8'. After EQ (looking S)

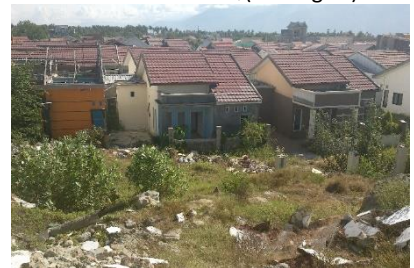
Photos 9~12 illustrate three surface features sitting around the western peripheral of the sliding area and one feature located near the previously-mentioned undamaged area (Fig. 7(b)) to the southern portion of Petobo site. As shown in these photos, the sliding debris had deposited and piled up on the ground to a height of 3~6 m, as compared with the adjacent unaffected area.

Photo 10. Before EQ (looking SW)

Photo 10'. After EQ (looking SW)

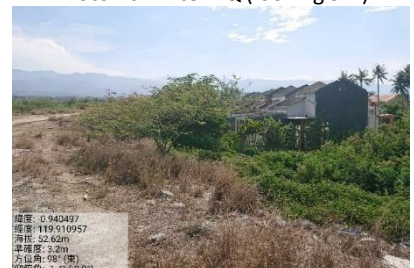
Photo 11. Before EQ (looking E)

Photo 11'. After EQ (looking E)

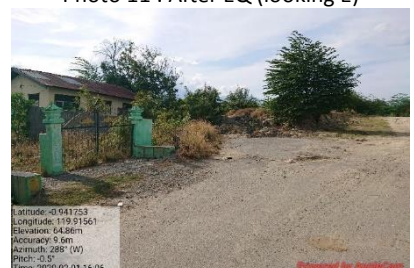
Photo 12. Before EQ (looking NW)

Photo 12'. After EQ (looking NW)

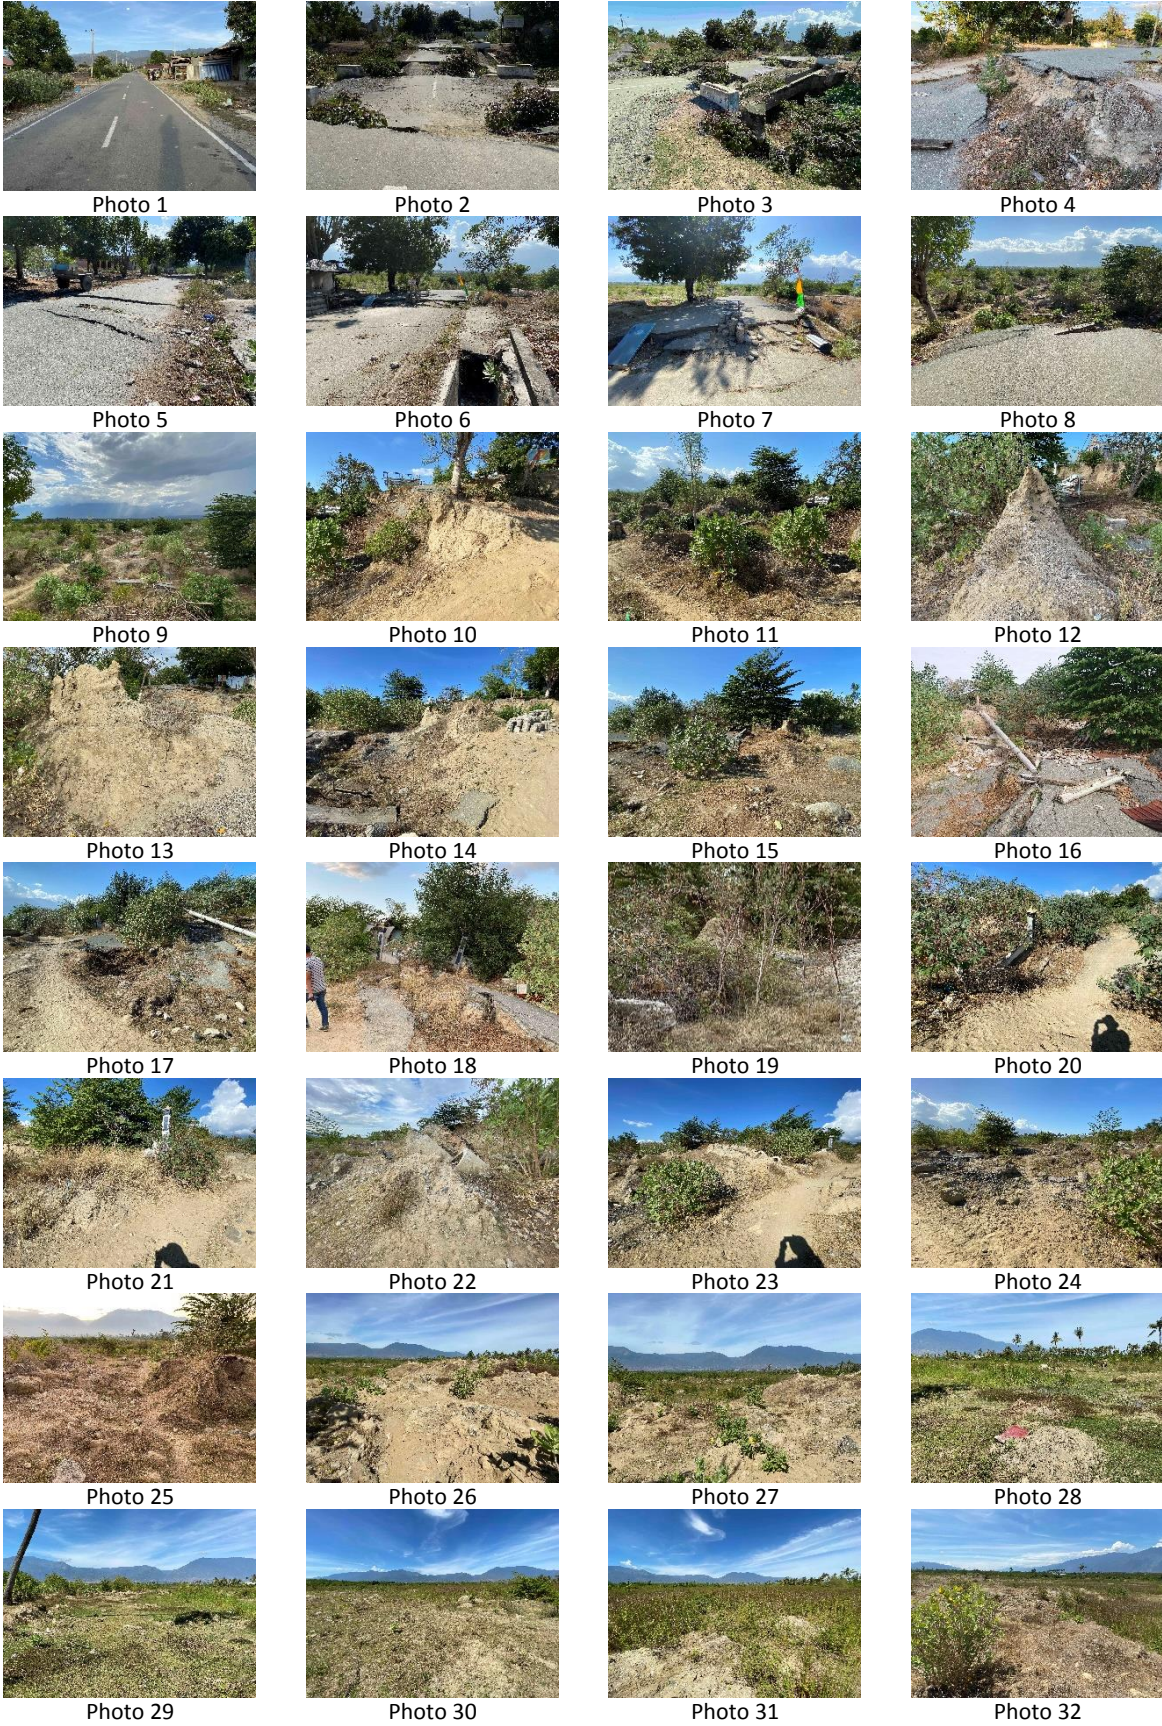
44 Within this range of mapping, we noticed several earthen ridges of 1~2 m high, an
45 example shown in Photo 12 (Fig. 16), which were observed periodically for
46 approximately 10~20 m distance apart. This phenomenon would appear to be in relation
47 to the testimonies by Witnesses G, K, L and M, who had indicated a wavy-form of
48 ground sliding, with vertical amplitudes of 1.5~2 m and travelling distances of around 15
49 m (Table 1). In view of the locations of witnesses during the earthquake, we expect
50
51
52
53
54
55
56
57
58
59
60
61
62
63
64
65

1 these peoples might have been experiencing a liquefaction spreading during the
2 earthquake shaking. Photos 18, 20~23 (Fig. 16) are indicative of tearing, tilting and
3 settling of houses and water pipes as a result of the spreading of the ground.

4 In the subsequent mapping range with Mileages 290~492 m, the ground elevations
5 once again dropped by additional 2~4 m. However, the surface appeared to be less
6 rugged, more gentle, and more abundant with extruded sands on the ground (Photo 25;
7 Fig. 16). The observed phenomena in this mapping range would suggest the ground
8 might have liquefied significantly during the shaking and flowed further to the west
9 (lower lands) after the earthquake. Photos 26 & 27 (Fig. 16) show the forefront of the
10 liquefaction flow.
11

12 For the lands further to the west of Mileage 492 m, the ground elevation decreased
13 substantially by 6 m or more. The ground became more flat, but wet, swampy and full of
14 aquatic plants that had prevented the research team to approach further. Photos 28~32
15 (Fig. 16) show distant views of the lower lands. As seen, the ground was exposed with
16 sands, water ponds and aquatic plants. These areas were also suggested a separate
17 stage of liquefaction flow that followed subsequently the previous flow stage as
18 identified in Mileages 290~492 m.
19
20
21
22
23
24
25
26
27
28
29
30
31
32
33
34
35
36
37
38
39
40
41
42
43
44
45
46
47
48
49
50
51
52
53
54
55
56
57
58
59
60
61
62
63
64
65

Fig. 16 Associated photos as indicated in the mapping sketch along Moh. Soeharto road to the east of Petobo sliding area.
