A retrospective view on liquefaction-induced flowslide and lessons learned - an example of Petobo failure incident during 2018 Palu-Donggala Indonesia earthquake

M. Chang¹, T.C. Upomo², R. Kusumawardani³, G.A. Prayitno⁴, N.M. Ermansyah⁵, and C.J. Yang⁵

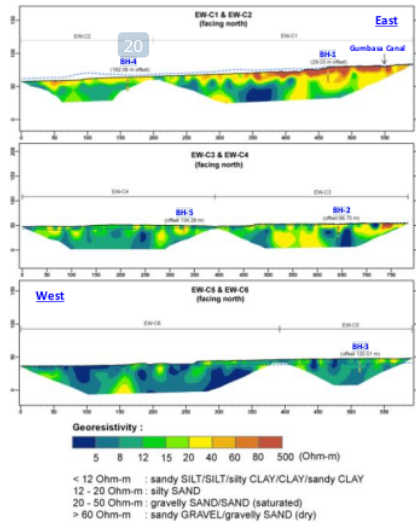
Our site reconnaissance revealed widespread liquefied soils on the surface of upper and middle portions of the sliding area. As shown in Figure 5, the exposed liquefied soils on surface were generally fine to medium sands, with inclusions of some earthen chunks or gravels which might have been carried and drifted by the flowslide. Based on results of borehole logging and geo-resistivity surveying, as shown in Figures 4 & 6, the shallower material profile along the EW cross-section of Petobo area could approximately be divided into three portions. In the upper portion of the sliding area, the earthen materials are generally gravelly sands or sandy gravels. The middle portion consists of mostly silty sands; while the lower portion comprises silty sands, sandy silts and silty clays. Laboratory classification tests, as illustrated in Figure 7, also indicate the grain-size distributions of soils within sliding mass fall in the range of liquefiable zone. It is certain that the in-situ soils are prone to liquefaction.

Figure 5. Wide-spread liquefied soils on the surface of Petobo slide: (up) general view, (down) close view; during 02/2020 site reconnaissance (Kusumawardani et al., 2021).

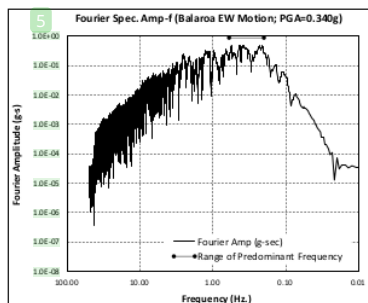
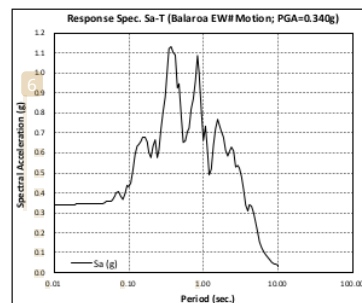
It is noticed that one large foreshock and several aftershocks were involved in this failure incident. As indicated in Figure 8, a foreshock ($M_w 6.1$) occurred approximately 3-hr before the main shock, some

Figure 8. Foreshock, mainshock, aftershocks of 2018 Palu-Donggala EQ (GEER, 2019).

Figure 9. Fourier spectrum and response spectrum of 2018.9.28 Palu-Donggala mainshock motion (EW component amplified to a PGA of 0.340g) recorded at Balaroa station.

Figure 9 shows the Fourier spectrum and the acceleration response spectrum of this input motion. As seen, Fourier spectrum indicates the predominant frequency of this motion is around 0.2~0.6Hz, or a predominant period of 1.6~5s. The acceleration response spectrum indicates a maximum spectra acceleration of more than 1.1g and the corresponding natural period of 0.35~0.85s. In view of average thickness and shear wave velocity of soil deposit, the estimated site period in Petobo area would be approximately 0.4~0.5s. In accordance, this earthquake motion would have been very severe and destructive to the Petobo site and the Palu valley as well.

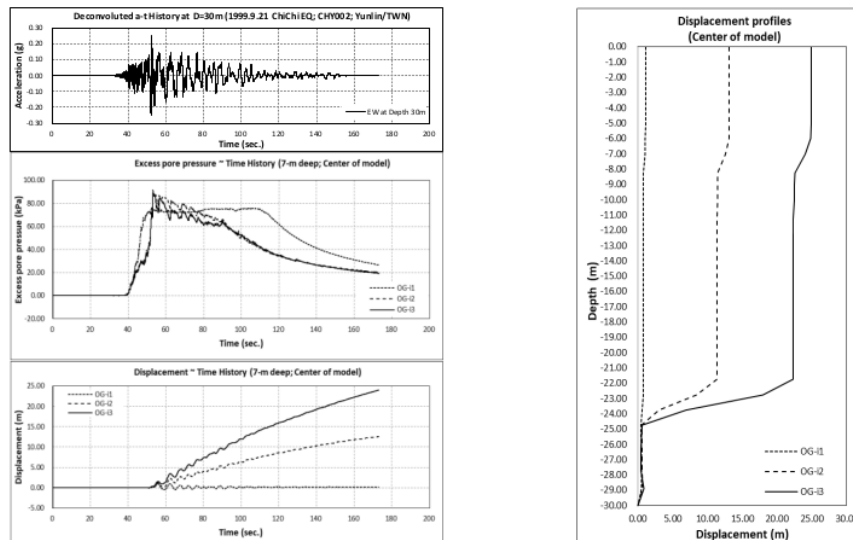
As a preliminary assessment of the influence of ground inclination on lateral deformation, an arbitrary soil deposit profile and an earthquake input motion were selected, as indicated in Hamzah et al. (2022). The inclination of the ground (i) varies from 0 to 6 degrees, and the results are shown in Figure 10.

Figure 10. Verifications of liquefaction-induced flowslide behavior with different ground inclinations by OpenSeesPL (Ground surface inclination: $i_1=0$ / level ground, $i_2=3deg.$, and $i_3=6deg.$).

The soil deposit adopted in this exercise is 30m in depth, where the top 24.75m consists of very-loose to medium sands and the bottom 5.25m is loose to medium silt and clay. For the very-loose to medium sands, the assigned material data includes: $\phi' = 29^\circ \sim 33^\circ$, $c' = 0.2 \sim 0.4 \text{ kPa}$, $G_{max} = 55 \sim 75 \text{ MPa}$, $B_{max} = 150 \sim 200 \text{ MPa}$, and $K_h = 6.6 \times 10^{-5} \text{ m/s}$. For the loose to medium silts, the assigned material data includes: $\phi' = 29^\circ \sim 33^\circ$, $c' = 0.35 \text{ kPa}$, $G_{max} = 55 \sim 75 \text{ MPa}$, $B_{max} = 150 \sim 200 \text{ MPa}$, and $K_h = 1 \times 10^{-7} \text{ m/s}$. For the medium clay, the assigned material data includes: $\phi' = 0$, $c' = 43 \text{ kPa}$, $G_{max} = 60 \text{ MPa}$, $B_{max} = 300 \text{ MPa}$, and $K_h = 1 \times 10^{-9} \text{ m/s}$. The groundwater table is 3.84m below the ground. The input motion is based on the 1999 Chi-Chi earthquake of Taiwan recorded at Station CHY002, with $a_{max} = 0.250 \text{ g}$ as illustrated in the upper left of Figure 10. Results of time histories in excess pore pressure generation as well as lateral displacement at a depth of 7m are shown in the two lower left graphs. The displacement profile of entire deposit at the end of shaking is shown on the right of this figure.
