**9th International Congress on
Environmental Geotechnics**

A retrospective view on liquefaction-induced flowslide and lessons learned - an example of Petobo failure incident during 2018 Palu-Donggala Indonesia earthquake

M. Chang¹, T.C. Upomo², R. Kusumawardani³, G.A. Prayitno⁴, N.M. Ermansyah⁵, and C.J. Yang⁵

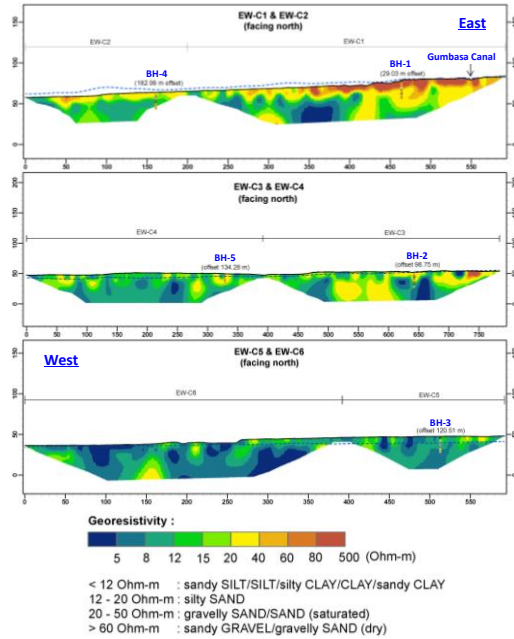
Figure 6. Results of geo-resistivity surveying along EW cross-section (Moh. Soeharto Rd.) of Petobo area during 02/2020; (up) E-segments, (middle) mid-segments, (down) W-segments.

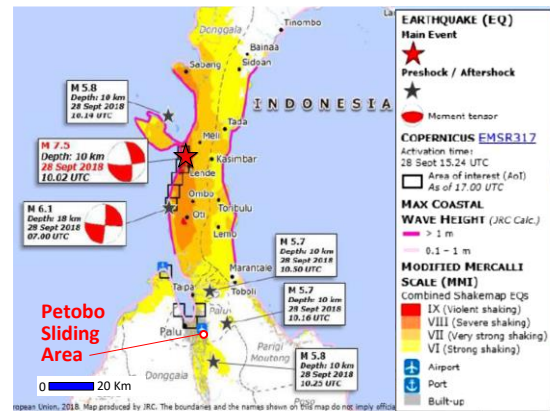
It is noticed that one large foreshock and several aftershocks were involved in this failure incident. As indicated in Figure 8, a foreshock ($M_w6.1$) occurred approximately 3-hr before the main shock, some

Figure 8. Foreshock, mainshock, aftershocks of 2018 Palu-Donggala EQ (GEER, 2019).

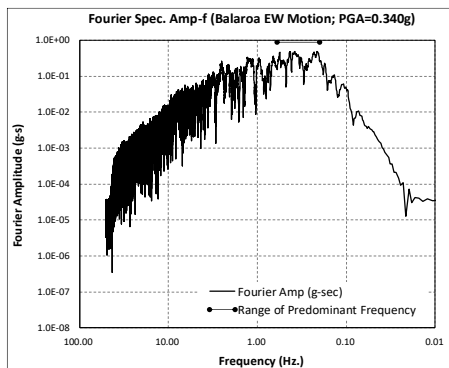
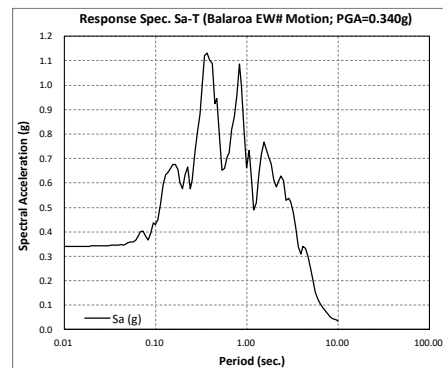
Figure 9. Fourier spectrum and response spectrum of 2018.9.28 Palu-Donggala mainshock motion (EW component amplified to a PGA of 0.340g) recorded at Balaroa station.

Figure 9 shows the Fourier spectrum and the acceleration response spectrum of this input motion. As seen, Fourier spectrum indicates the predominant frequency of this motion is around 0.2~0.6Hz, or a predominant period of 1.6~5s. The acceleration response spectrum indicates a maximum spectra acceleration of more than 1.1g and the corresponding natural period of 0.35~0.85s. In view of average thickness and shear wave velocity of soil deposit, the estimated site period in Petobo area would be approximately 0.4~0.5s. In accordance, this earthquake motion would have been very severe and destructive to the Petobo site and the Palu valley as well.

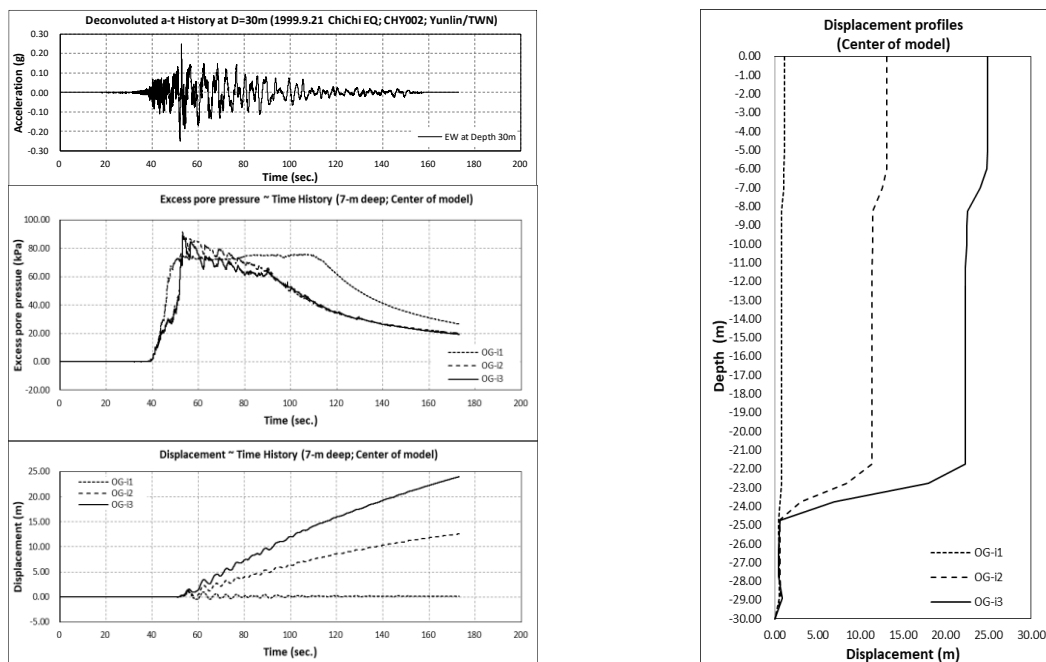
As a preliminary assessment of the influence of ground inclination on lateral deformation, an arbitrary soil deposit profile and an earthquake input motion were selected, as indicated in Hamzah et al. (2022). The inclination of the ground (i) varies from 0 to 6 degrees, and the results are shown in Figure 10.

Figure 10. Verifications of liquefaction-induced flowslide behavior with different ground inclinations by OpenSeesPL (Ground surface inclination: $i_1=0$ / level ground, $i_2=3\text{deg.}$, and $i_3=6\text{deg.}$).

The soil deposit adopted in this exercise is 30m in depth, where the top 24.75m consists of very-loose to medium sands and the bottom 5.25m is loose to medium silt and clay. For the very-loose to medium sands, the assigned material data includes: $\phi' = 29^\circ \sim 33^\circ$, $c' = 0.2 \sim 0.4 \text{ kPa}$, $G_{max} = 55 \sim 75 \text{ MPa}$, $B_{max} = 150 \sim 200 \text{ MPa}$, and $K_h = 6.6 \times 10^{-5} \text{ m/s}$. For the loose to medium silts, the assigned material data includes: $\phi' = 29^\circ \sim 33^\circ$, $c' = 0.35 \text{ kPa}$, $G_{max} = 55 \sim 75 \text{ MPa}$, $B_{max} = 150 \sim 200 \text{ MPa}$, and $K_h = 1 \times 10^{-7} \text{ m/s}$. For the medium clay, the assigned material data includes: $\phi' = 0$, $c' = 43 \text{ kPa}$, $G_{max} = 60 \text{ MPa}$, $B_{max} = 300 \text{ MPa}$, and $K_h = 1 \times 10^{-9} \text{ m/s}$. The groundwater table is 3.84m below the ground. The input motion is based on the 1999 Chi-Chi earthquake of Taiwan recorded at Station CHY002, with $a_{max} = 0.250 \text{ g}$ as illustrated in the upper left of Figure 10. Results of time histories in excess pore pressure generation as well as lateral displacement at a depth of 7m are shown in the two lower left graphs. The displacement profile of entire deposit at the end of shaking is shown on the right of this figure.
