An Overview Study of Flowslide Liquefaction in Petobo, Palu, Indonesia

Togani Cahyadi Upomo^{1,2}, Muhsiang Chang³, Rini Kusumawardani², Galih Ady Prayitno³, Ren-Chung Huang³, Muhammad Hamzah Fansuri⁴

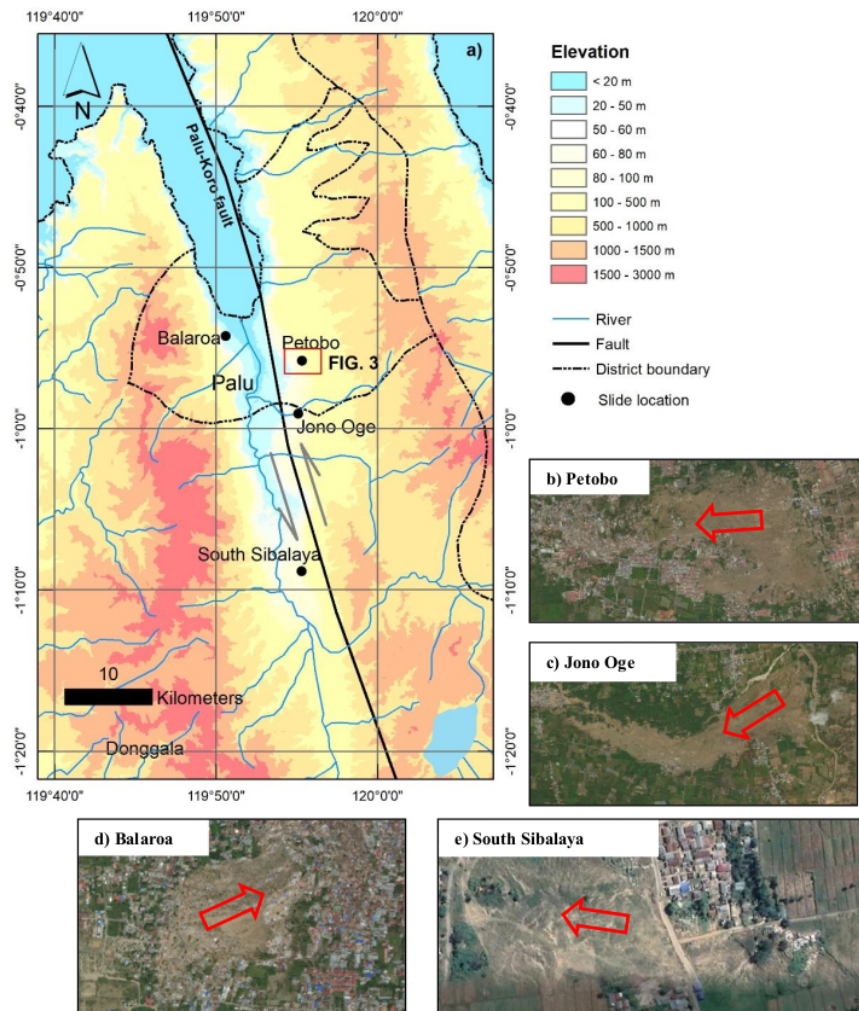
Figure 2. Slide locations of Balaroa, Petobo, Jono Oge and South Sibalaya. The main active fault taken and redraw from [7]. The satellite photo of Balaroa, Petobo, Jono Oge and South Sibalaya taken from Digitalglobe 2 October 2018.

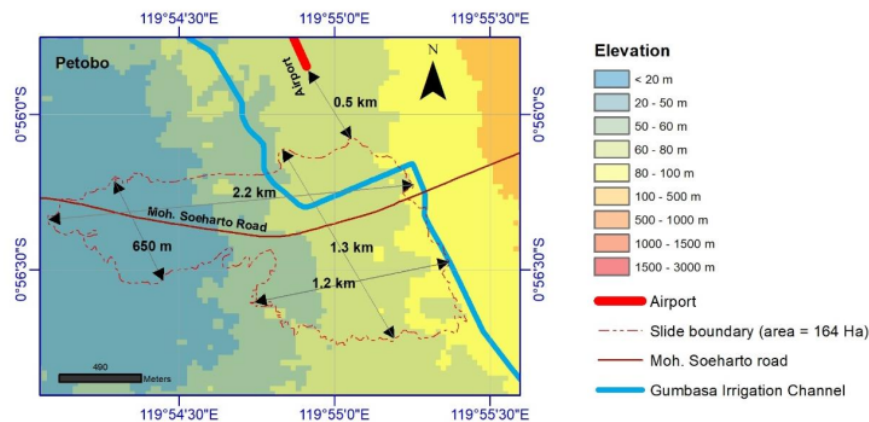
Figure 3. Location of Petobo Slide

The study area, as shown in Figure 3, is located in Petobo village, southern part of Palu city, Central Sulawesi, Indonesia. Palu city is the capital of Central Sulawesi. The figure indicates the area affected by the sliding is 164 Ha, which covers approximately the entire village of Petobo.

The lengths of sliding along the south and north boundaries are about 1.2 km and 2.2 km, respectively. In addition, the widths of sliding on the east and west sides are around 1.3 km and 0.65 km, respectively. At the east part, the sliding area is bordered by 9 m wide Gumbasa irrigation canal. Rice paddy fields served by irrigation canal are located to the west of the canal. Resident area is mostly located in the middle part from east to the west along Moh. Soeharto road. Approximately 744 buildings were completely demolished and buried [12]. The international airport of Palu city situated approximately 0.5 km to the north of the study area.

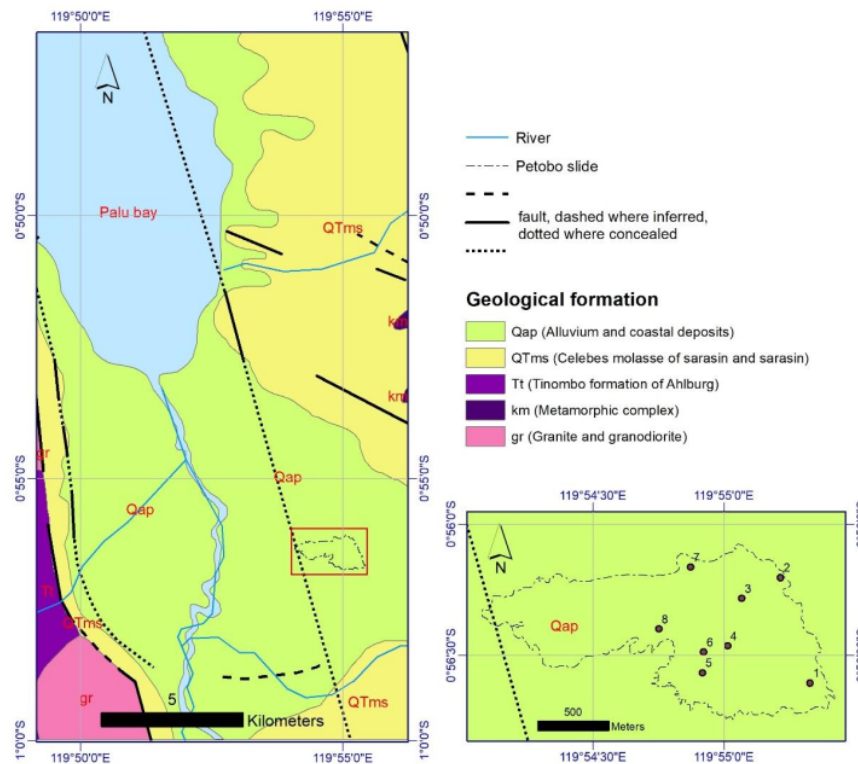
The geological condition in Palu consists of two rock formations, namely celebes molasse of sarasin and sarasin (QTms) and alluvium and coastal deposits (Qap) [13]. Celebes molasse of sarasin and sarasin is of middle Miocene age and a deposition of shallow sea. Alluvium and coastal deposit is of Holocene age. Formation QTms consists of weakly consolidated conglomerate, sandstone, mudstone, coral limestone and marl. Gravel, sand, mud and coral limestone are included in the formation. The entire area of Petobo slide is in Formation Qap, where gravel, sand and mud can be found in the area. Figure 4 shows geological map in Palu and Petobo area.

Figure 4. Geological map in Palu and Petobo [12]
