An Overview Study of Flowslide Liquefaction in Petobo, Palu, Indonesia

Togani Cahyadi Upomo^{1,2}, Muhsiong Chang³, Rini Kusumawardani², Galih Ady Prayitno³, Ren-Chung Huang³, Muhammad Hamzah Fansuri⁴

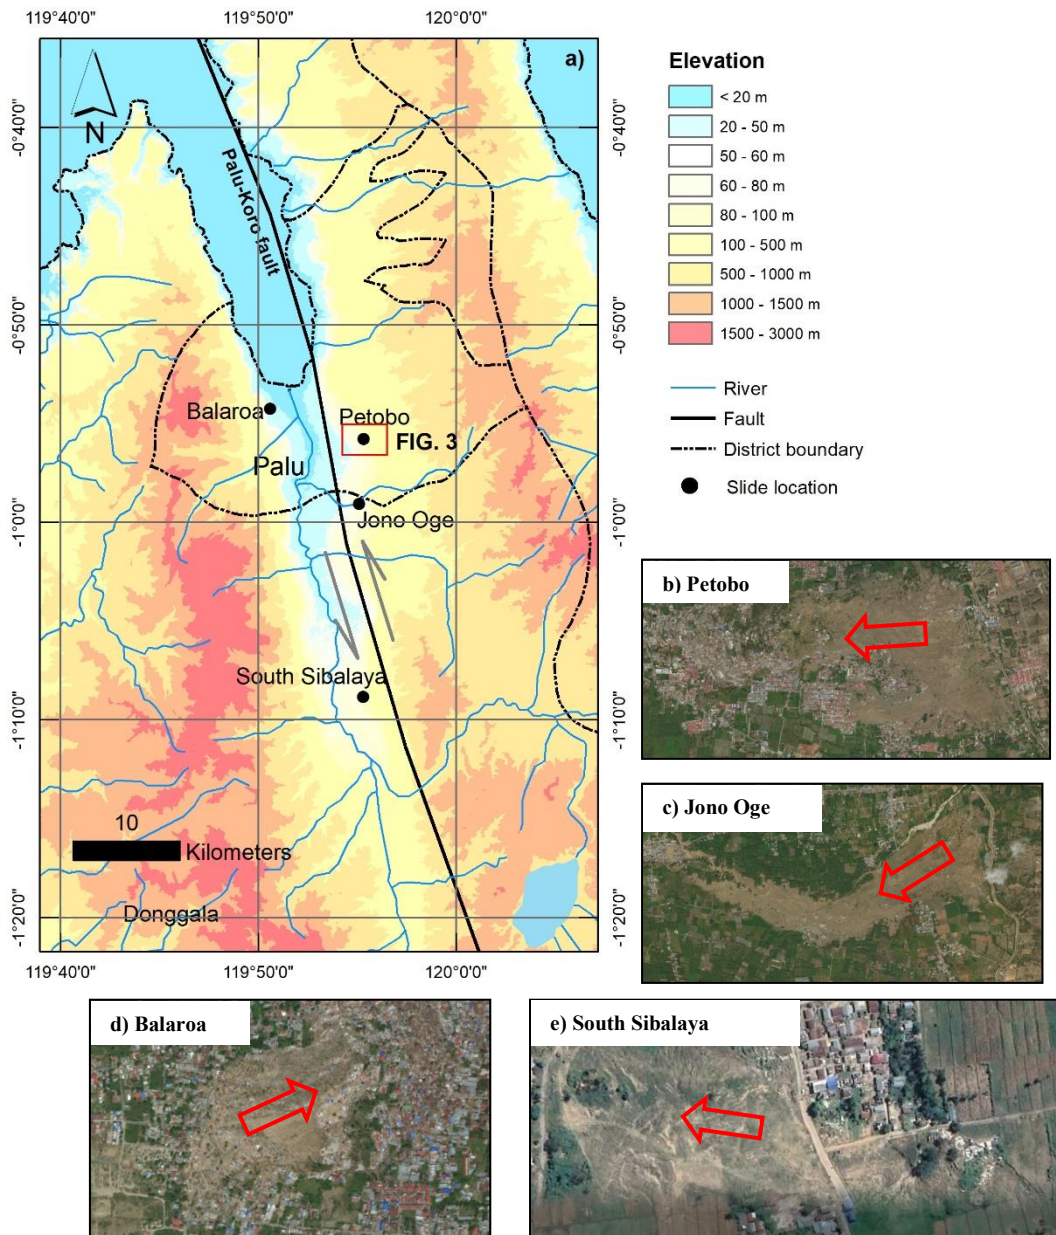
Immediately after the main shock of Palu-Donggala earthquake, extensive slides induced by liquefaction of soils hit several locations of inland and tsunamis struck along the bay of Palu [8-10]. More than 4000 people died or missing, and around 170,000 people evacuated in Palu city, Donggala and Sigi villages [11]. The locations of extensive slide were in the areas of Balaroa, Petobo, Jono Oge and South Sibalaya. The largest sliding area was in Jono Oge. However, Petobo area had suffered the greatest impact from the slide. Figure 2 presents the slide locations in Balaroa, Petobo, Jono Oge and South Sibalaya.

Figure 2. Slide locations of Balaroa, Petobo, Jono Oge and South Sibalaya. The main active fault taken and redraw from [7]. The satellite photo of Balaroa, Petobo, Jono Oge and South Sibalaya taken from Digitalglobe 2 October 2018.

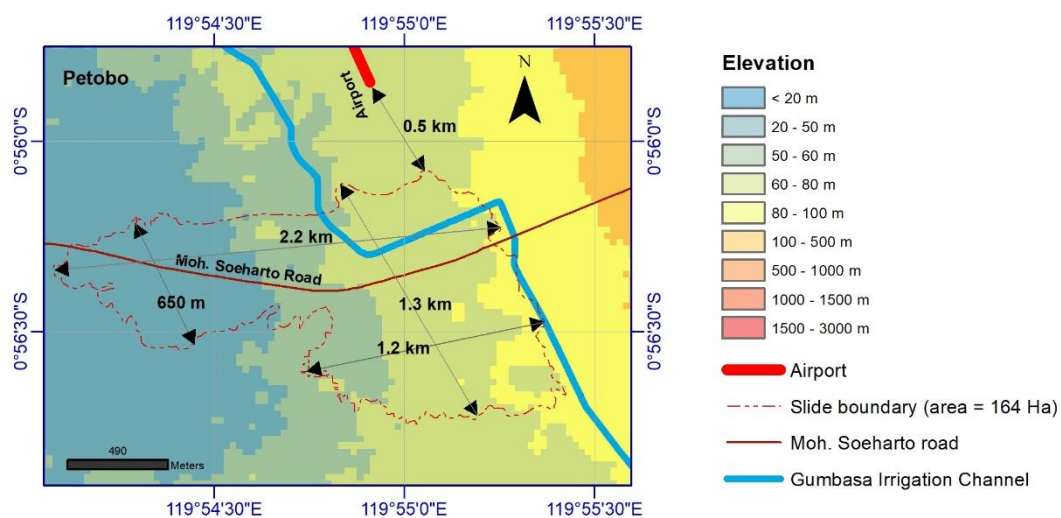
The study area, as shown in Figure 3, is located in Petobo village, southern part of Palu city, Central Sulawesi, Indonesia. Palu city is the capital of Central Sulawesi. The figure indicates the area affected by the sliding is 164 Ha, which covers approximately the entire village of Petobo.

The lengths of sliding along the south and north boundaries are about 1.2 km and 2.2 km, respectively. In addition, the widths of sliding on the east and west sides are around 1.3 km and 0.65 km, respectively. At the east part, the sliding area is bordered by 9 m wide Gumbasa irrigation canal. Rice paddy fields served by irrigation canal are located to the west of the canal. Resident area is mostly located in the middle part from east to the west along Moh. Soeharto road. Approximately 744 buildings were completely demolished and buried [12]. The international airport of Palu city situated approximately 0.5 km to the north of the study area.

Figure 3. Location of Petobo Slide
