# Morphoconservation analysis on Kali Garang as a river conservation effort

## Morphoconservation analysis on Kali Garang as a river conservation effort

**Abstract.** The main problem of Kali Garang is that when there is rain in the upstream area there will be a flood. The high population growth in the upstream area cause problems waste, erosion and sedimentation. The purpose of this study was to find out the community's concern for the river and apply morphoconservation analysis for river utilization, protection and preservation. The research was carried out on the banks of the Kali Garang at the upstream, middle and downstream sections. The data were collected through observation, interview and measurement. The analysis data used was morphoconservation analysis. Morpho aspect analysis was based on upstream, middle and downstream regions. While the conservation aspect is based on activities of utilization, protection and preservation. Community care for the river is good enough. The existence of village work activities is a form of river care. In the upstream, the concerned people utilize the river for their daily needs. In the middle, there is no utilization activity because of

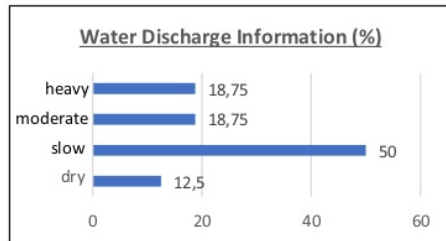
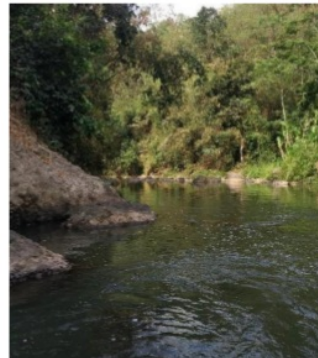
Figure 2. River Debit Graph Figure

The condition of water discharge at 16 location observation points shows that in general the water discharge is relatively slow with a percentage of 50% of the 16 observation locations. This condition occurs in areas with relatively flat topography, especially in the downstream area. Dry flow conditions occur in the upstream area with relatively steep topography and dry water sources. The percentage of this condition is 12.5%. Percentage of heavy water flow of 18.75%. The percentage of moderate water flow is 18.75%.

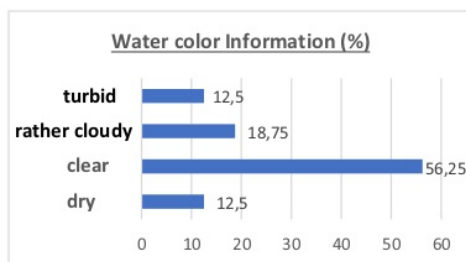
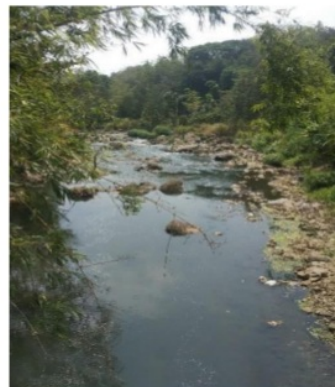
Figure 4. Water Color Percentage Graph

The dry season greatly affects the color of water. In general, the color of Garang river water in the dry season tends to be clear, but in some observation locations, the water color tends to be cloudy and even black. The condition is caused by human activity and waste littering the stairs Ruma h Garang river resulting flow of water becomes turbid and the color becomes blackish - brown.

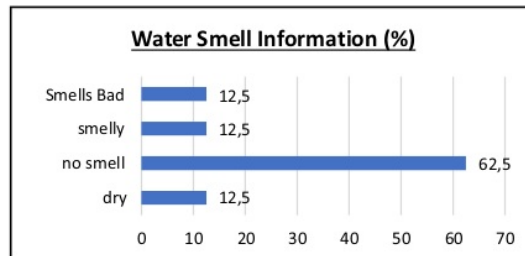
**Figure 6.** Smell Percentage Graph with Observation Location  
Source: Data Processing Results, 2018.

In general, the Garang river condition does not smell. 65% of the 16 samples of Garang river water do not smell. 12.5% foul-smelling, 12.5% smelly and 12.5% in dry conditions. The smell that arises in water is the result of decay of waste that is disposed of by people who do not care about the river.

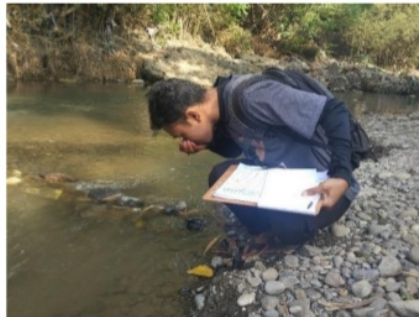
**Figure 7.** Checking smell in water

Smelling water shows that the water is not suitable for consumption. The smell of water is caused by the decay of garbage and household waste which is directly thrown into the river. The poor condition of Garang river water can be a serious problem.

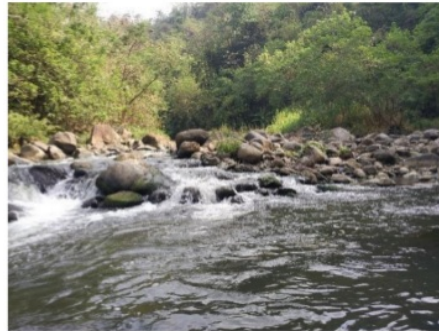
**Figure 8.** Riverbed Material

The riverbed material affected by the aerial base of the Garang River is divided into four type is land, sand, gravel, and crack. These materials are formed due to the influence of the former activity of old Ungaran mountain.

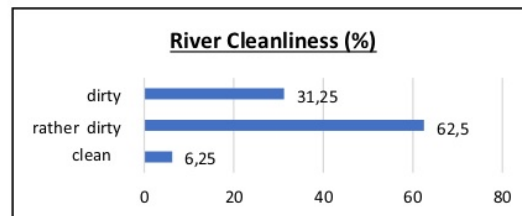
**Figure 9.** Graph of River Hygiene Percentage with Observation Location

In general, Garang River is a less clean river. The habit of disposing of garbage in sungi is a habit that is still commonplace even though some people are aware of the importance of maintaining the river. The existence of a waste bank is one of the efforts made to accommodate the garbage problems of people living in the Upper Garang watershed area. However, the importance of public awareness of the importance of maintaining river cleanliness is still lacking.

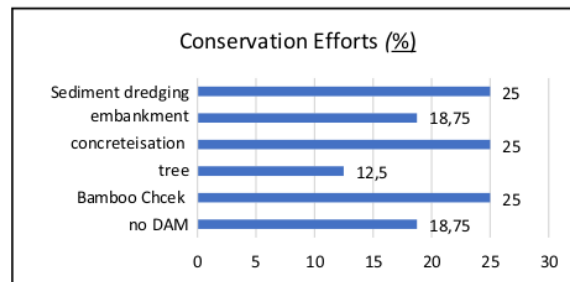
**Figure 10.** Percentage of Conservation Business Graph  
Source: Data Processing Results, 2018.

Conservation efforts carried out by the government or related institutions in the Upper Garang watershed area are among others 18.75% are river bank. Activities, 25% are bank concrete concrete activities, and 25% are DAM check payment activities. Conservation efforts carried out by the community include 25% of the activity of dredging sediments, and 12.5% in the form of planting bamboo trees. Meanwhile, 18.75% of the area there is no river conservation effort.

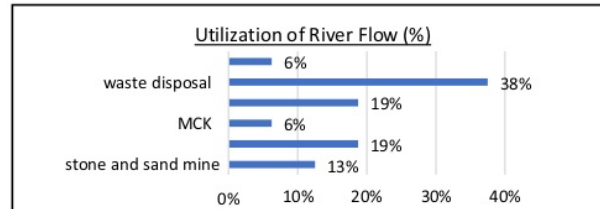
**Figure 12.** Graph of Percentage of Flow of Utilization

Most people still use the Garang river to waste, which is 38%. Furthermore, other river utilization activities include; 19% for irrigation activities, 19% for fishing, 13% for rock and sand mining, and 6% for MCK activities. Of all existing activities, rock and sand mining, irrigation and fishing are activities that do not damage the river.

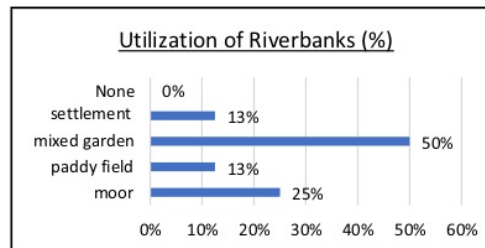
**Figure 13.** Graph of Percentage of Expenditure Utilization

Utilization of riverbanks in the form of mixed gardens and moor is the activity that dominates the use of the Garang River. 50% of the Garang river river is used for mixed gardens, 25% for dry fields, 13% for settlements, and 13% for rice fields.
