Morphoconservation analysis on Kali Garang as a river conservation effort

D L Setyowati^{1*}, T Aarsal², Hardati¹, Suroso¹ and K Z Prabowo¹

¹Department of Geography, Faculty of Social Science, Semarang State University, Semarang, Indonesia

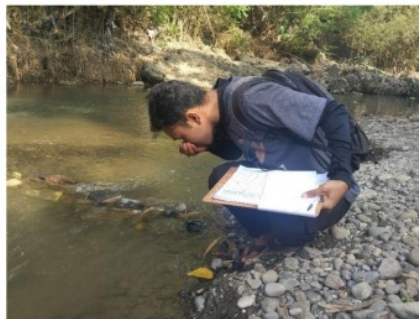
Figure 7. Checking smell in water

Smelling water shows that the water is not suitable for consumption. The smell of water is caused by the decay of garbage and household waste which is directly thrown into the river. The poor condition of Garang river water can be a serious problem.

In general, the Garang river condition does not smell. 65% of the 16 samples of Garang river water do not smell. 12.5% foul-smelling, 12.5% smelly and 12.5% in dry conditions. The smell that arises in water is the result of decay of waste that is disposed of by people who do not care about the river.

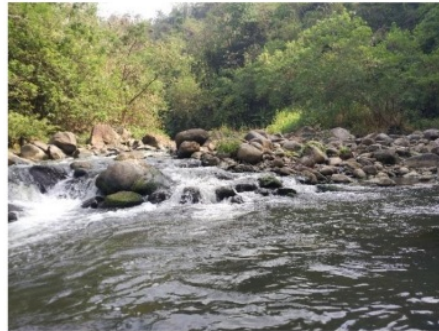
Figure 8. Riverbed Material

The riverbed material affected by the aerial base of the Garang River is divided into four type is land, sand, gravel, and crack. These materials are formed due to the influence of the former activity of old Ungaran mountain.

Some of the communities around Garang River use stone and gravel materials for sale . Mining of rocks and sand is carried out in the downstream area. The community conducts mining in the rainy season. This is done because the quality and quantity of stones and sand is better

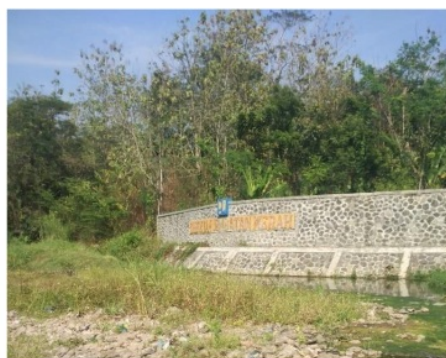
Figure 15 . DAM Check Building

One form of maintenance for Garang River is river clean and sediment dredging. The activity of dredging sediments in the downstream area has become their livelihood. The results of dredging of sediments in the form of rocks and sand they can sell or they use themselves as building materials. Other river maintenance is concreteisation of river banks, building check dam and planting of hard plants such as bamboo is an effort to reduce and inhibit the flow of water so it does not get too tight so that erosion can be reduced.
