Morphoconservation analysis on Kali Garang as a river conservation effort

D L Setyowa^{1*}, T Aرسال², P Hardati¹, Suroso¹ and K Z Prabowo¹

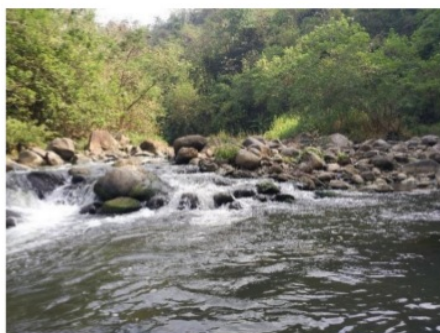
Figure 8. Riverbed Material

The riverbed material affected by the aerial base of the Garang River is divided into four type is land, sand, gravel, and crack. These materials are formed due to the influence of the former activity of old Ungaran mountain.

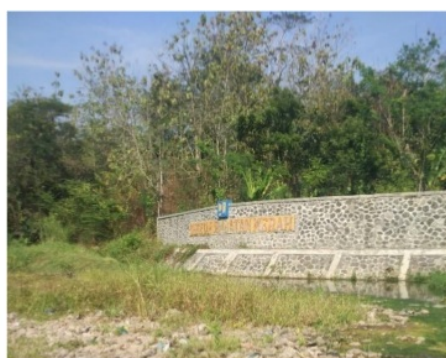
Figure 15 . DAM Check Building

In general, the physical condition of Garang river began to be well organized. This condition is evidenced by the building check DAM, warning board and appeals do not dispose of waste, and build embankment and concreted banks of several locations observation. At some points of observation the Garang River condition can be said to be poorly maintained or tend to be damaged. Factors that cause development activities and human activities that cause these problems. Disposal of household waste in the river is normal. This condition is exacerbated by the absence of the role in the local government in dealing with the problem. People assume that they do not need to care because they do not wear.
