**BUKTI KORESPONDENSI ARTIKEL PADA
JURNAL INTERNASIONAL BEREPUTASI**

| Judul | : | Understanding of Petobo liquefaction flowslide by 2018.09.28 Palu-Donggala Indonesia earthquake based on site reconnaissance |
| Jurnal | : | <i>Landslide Journal</i> |

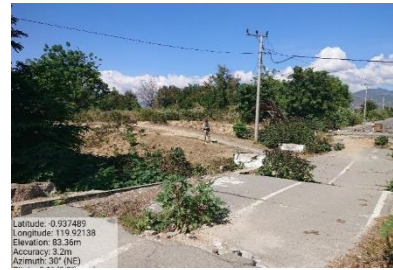
Photo 2. Before EQ (looking NE)

Photo 2'. After EQ (looking NE)

Photo 2 (Type: GS)

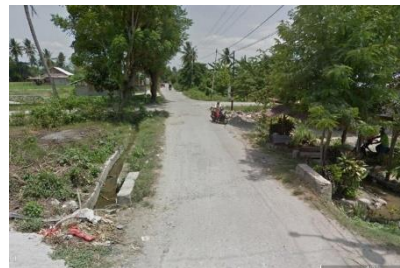
Photo 4. Before EQ (looking SW)

Photo 4'. After EQ (looking SW)

Photo 4 (Type: LS)

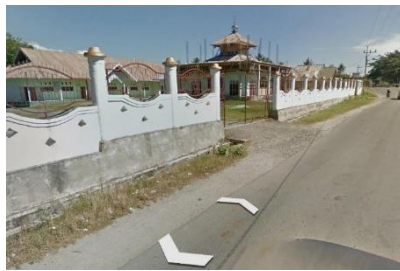
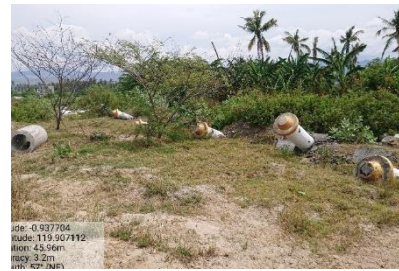
Photo 5. Before EQ (looking NW)

Photo 5'. After EQ (looking W)

Photo 5 (Type: LF)

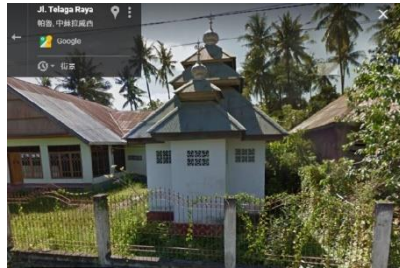
Photo 6. Before EQ (looking E)

Photo 6'. After EQ (looking E)

Photo 6 (Type: LF)

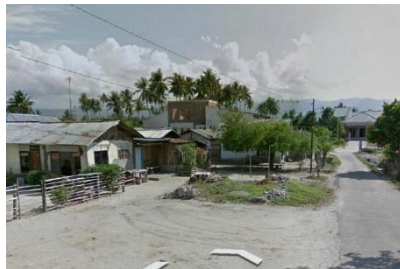
Photo 7. Before EQ (looking E)

Photo 7'. After EQ (looking E)

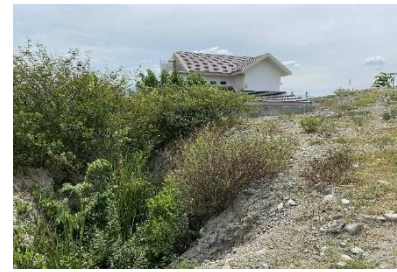
Photo 9. Before EQ (looking SE)

Photo 9'. After EQ (looking SE)

Photo 9 (Type: DF)

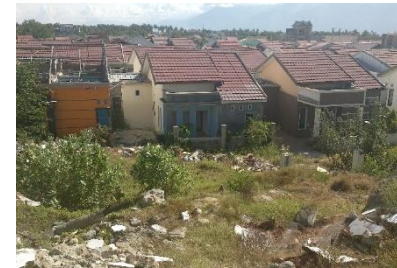
Photo 10. Before EQ (looking SW)

Photo 10'. After EQ (looking SW)

Photo 10 (Type: DF)

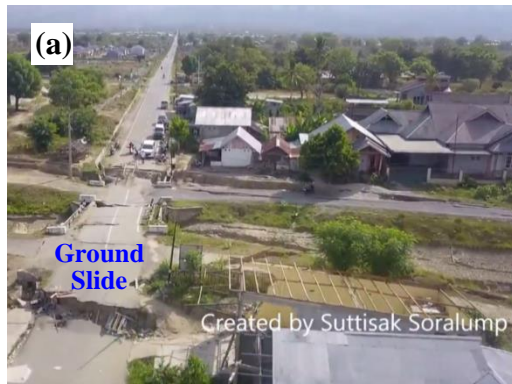
Fig. 18 Morphological features observed from the snapshots of drone videos by Soralump (2018). **a** Photo of the ground slide feature along Moh. Soeharto road to the east boundary of Petobo slide (facing east). **b** Photo of the features of liquefaction spread, liquefaction flow, and debris flood on the south-eastern portion of Petobo slide (facing west).

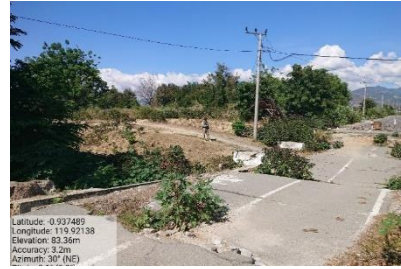
Photos 1 & 2 show the Gumbasa irrigation canal located along the eastern boundary of the sliding area. As seen, the canal was unlined and full with water prior to the earthquake. However, the earthquake had triggered slippages of the ground, causing cracks and drainage of the canal. Photos 3 & 4 are for surface features at east side and northeast corner of the sliding area. As indicated, the ground had been seriously distorted and displaced, apparently the result of liquefaction spreading during the earthquake.

Photo 2. Before EQ (looking NE)

Photo 2'. After EQ (looking NE)

As indicated by local residents and in Google Earth images, Gumbasa irrigation canal was constantly filled with water before the earthquake (Photos 1 & 2; Fig. 10) and the paddy fields were also inundated with water for about 8-months plantation time annually, which are based on our site reconnaissance as summarized in Table 1. During the plantation, the paddy fields would be submerged at least by water about 30-50 cm above the soil surface for plantation purposes. Furthermore, the intensive irrigation systems to paddy fields from Gumbasa canal which would constantly supply the local ground water tables under the paddy fields. In our opinion the rainfall would appear not really affect the increase of ground water table under the paddy fields as reference to Fig. 14, which clearly indicates the absence of rain a week before the flowslide occurred.

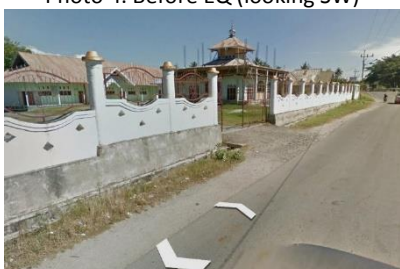
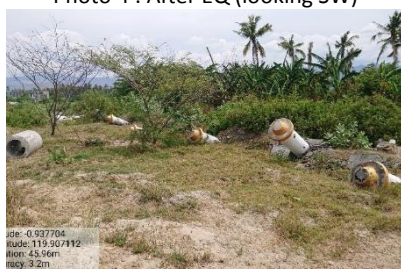
Photos 5~8 show four key features original situated in the middle and western portions of the area. As seen in Fig. 9, these features had been displaced towards west with a distance of 250~700 m. Some of the features would appear to be structurally sound (Photo 6, mosque), however, some of them had been severe damaged or torn (Photos 7 & 8, residential buildings). The phenomena would suggest the ground had been liquefied as a result of earthquake shaking and flowed, with driving forces and low resistance, for a large distance.

Photo 5. Before EQ (looking NW)

Photo 5'. After EQ (looking W)

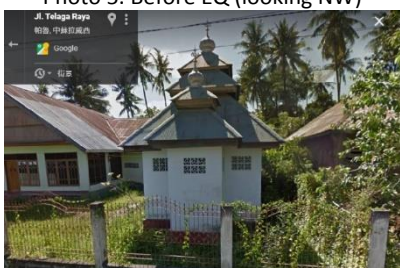
Photo 6. Before EQ (looking E)

Photo 6'. After EQ (looking E)

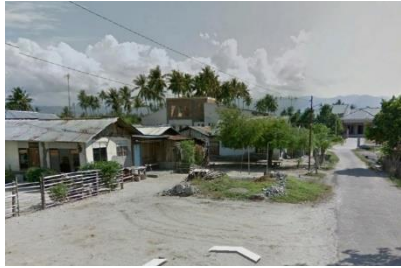
Photo 7. Before EQ (looking E)

Photo 7'. After EQ (looking E)

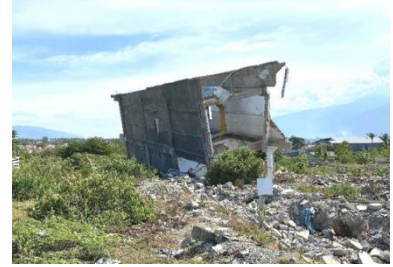
Photo 8. Before EQ (looking W)

Photo 8'. After EQ (looking S)

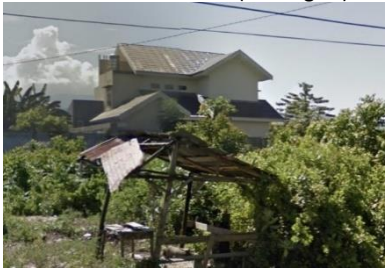
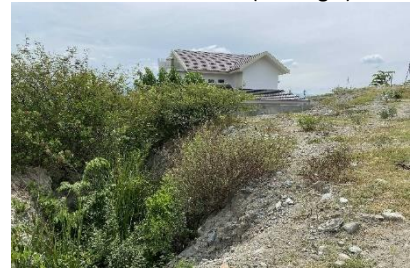
Photos 9~12 illustrate three surface features sitting around the western peripheral of the sliding area and one feature located near the previously-mentioned undamaged area (Fig. 7(b)) to the southern portion of Petobo site. As shown in these photos, the sliding debris had deposited and piled up on the ground to a height of 3~6 m, as compared with the adjacent unaffected area.

Photo 9. Before EQ (looking SE)

Photo 9'. After EQ (looking SE)

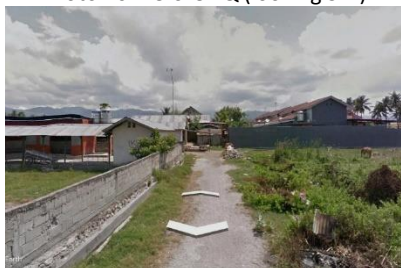
Photo 11. Before EQ (looking E)

Photo 11'. After EQ (looking E)
